Animas Environmental Services, LLC

RE: Status Update Report for the BMG Homestead Ranch #2 Well Location
SW¼, SW¼ of Section 34, T25N, R2W, Rio Arriba County, New Mexico
Incident Number - nJK1206030214

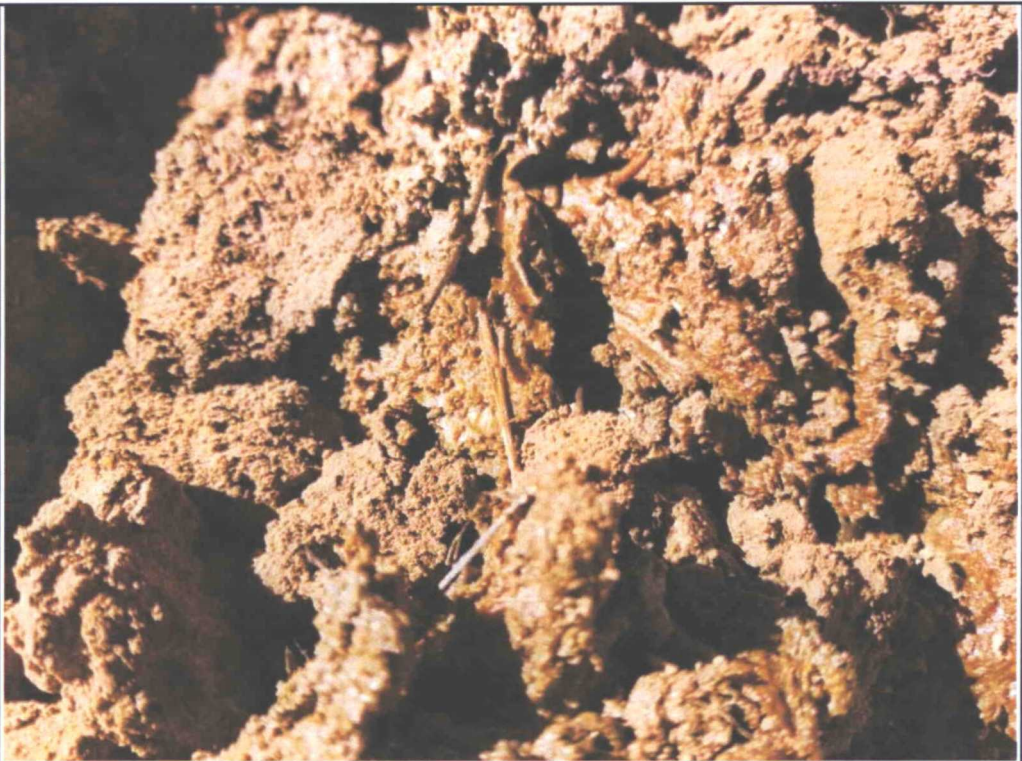
Photo #3

On November 8, 2017, BMG's excavation efforts discovered evidence of historic contamination at the site believed to be not associated with the 2008 event. At approximately 4 feet below ground surface (bgs), BMG unearthed debris comprised of surface trash, weeds and vegetation, timbers and a crushed/cut drum. The material in the drum consisted of soils saturated with product and what appeared to be paraffin. The soil layers in the area showed signs of prior disturbance. The debris was located central to the site location, with the waste drum being found to the east and south of the 2008 event, as shown in Figure 2. Photographic documentation is attached.

Client: BMG	
Project: Homestead Ranch #2	
Taken by: Sam Glasses	
November 8, 2017	
AES Project No: 080202	Description: Contamination found in the area of the uncovered waste drum.

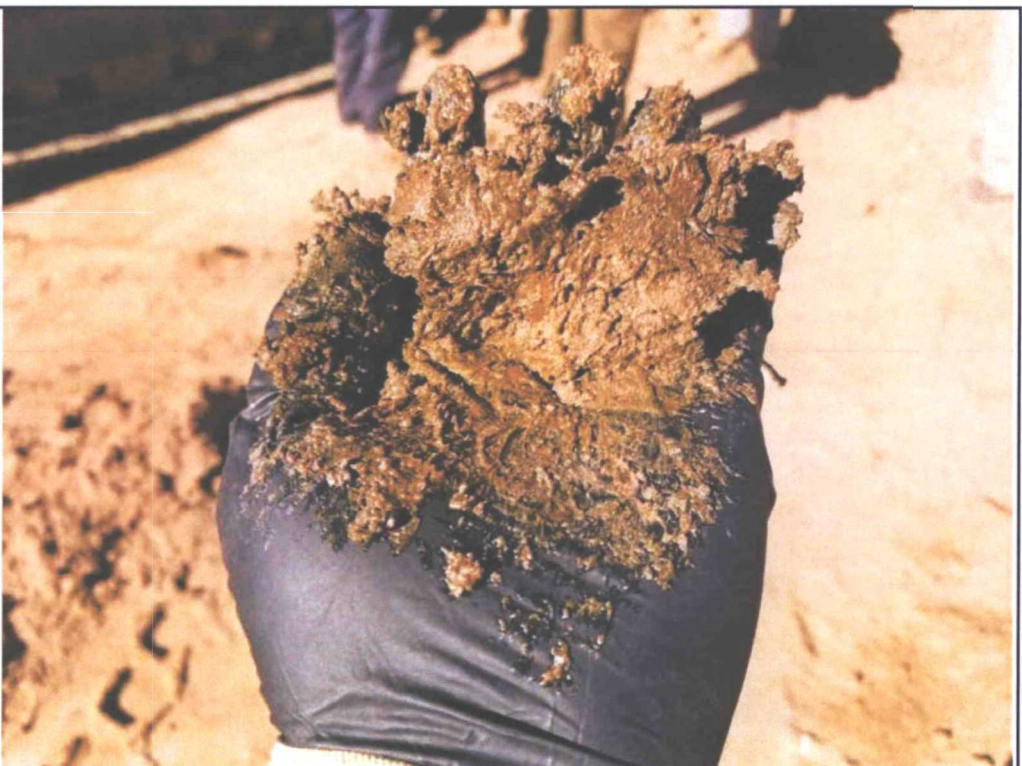
Photo #4

Client: BMG	
Project: Homestead Ranch #2	
Taken by: Sam Glasses	
November 8, 2017	
AES Project No: 080202	Description: Contamination found in the area of the uncovered drum.

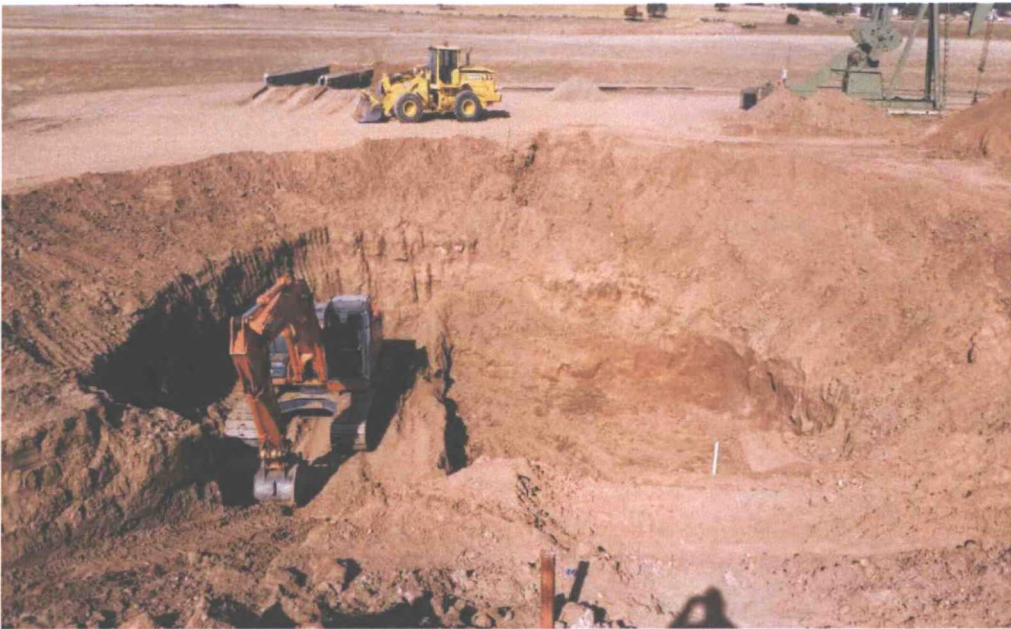
Photo #5

Client: BMG	
Project: Homestead Ranch #2	
Taken by: Sam Glasses	
November 8, 2017	
AES Project No: 080202	Description: Excavation as of November 16, 2017.
