Release Notification and Corrective Action

Name of Company: Enduring Resources, LLC	Contact: James McDaniel
Address: 332 Road 3100, Aztec, New Mexico 87410	Telephone No.: 505-636-9731
Facility Name: W Lybrook Unit #716H	Facility Type: Well Site (Oil)

Enduring Resources, LLC
Spill Closure Report
W Lybrook Unit #716H
30-045-35813

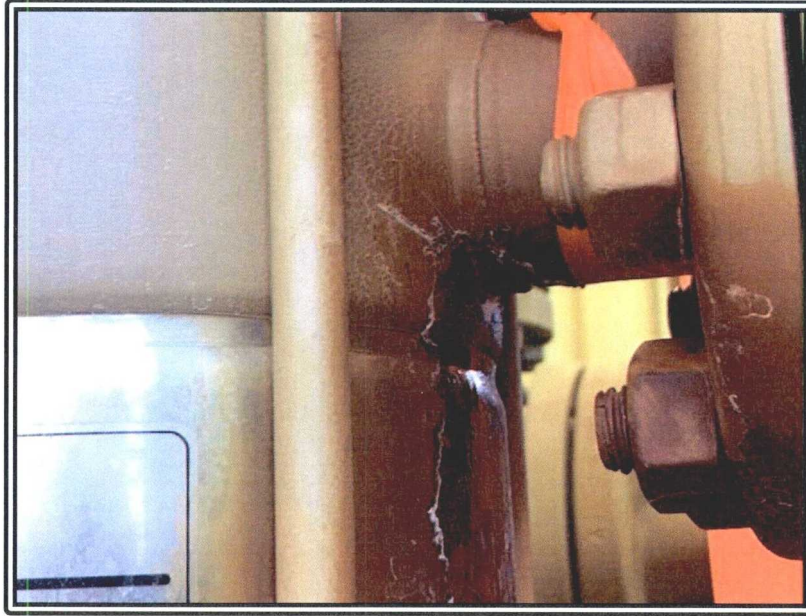
On May 11, 2018, a leak was discovered in the water transfer line of the LACT at the W Lybrook Unit 761H well site. Approximately 29 bbls of water was spilled inside the lined containment berm. (See photos). The LACT was shut in and the leak stopped. The line was repaired and the well was put back into service.

PHOTO 3: Leak Point

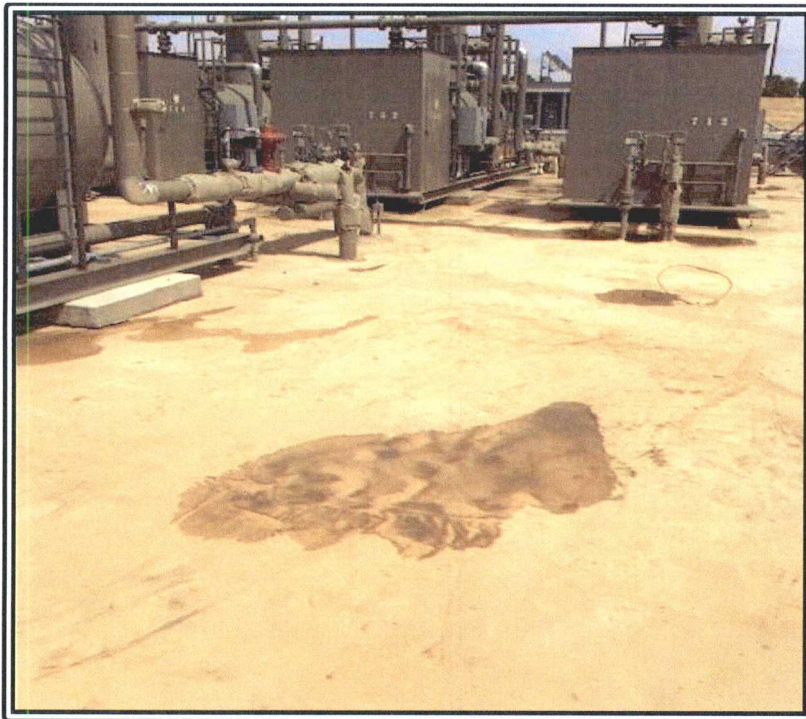
PHOTO 4: Containment Area After Cleanup (View 1)

A volume of 29 bbls of produced water was released inside the lined containment area. A water truck was dispatched, and all 29 bbls of water was recovered. The liner was visually inspected for integrity issues, and none were discovered. Final pictures of the site after the water was recovered are attached. No further action is required regarding this incident.

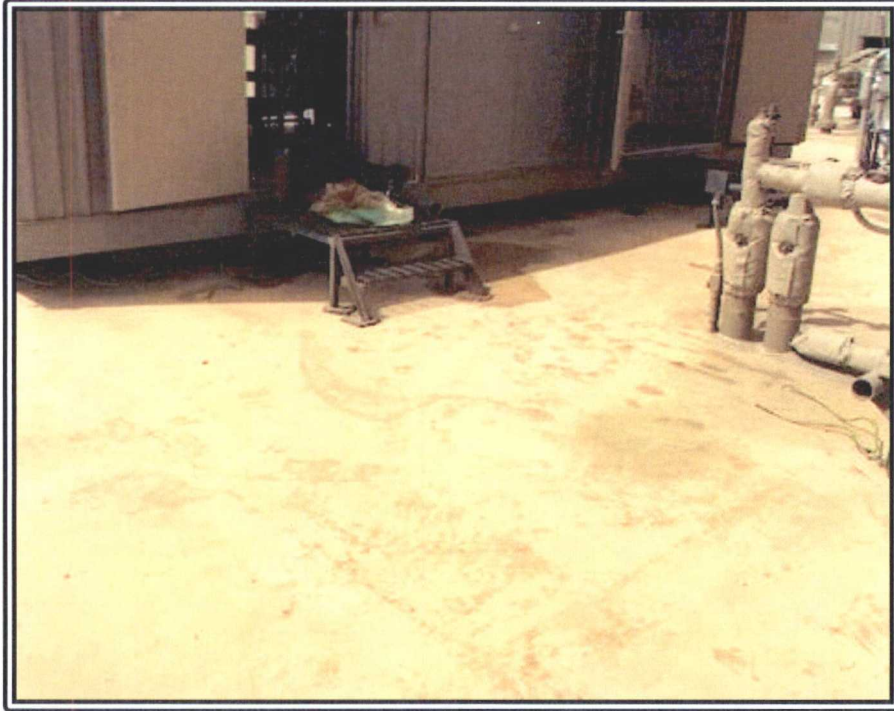
PHOTO 5: Containment Area After Cleanup (View 2)

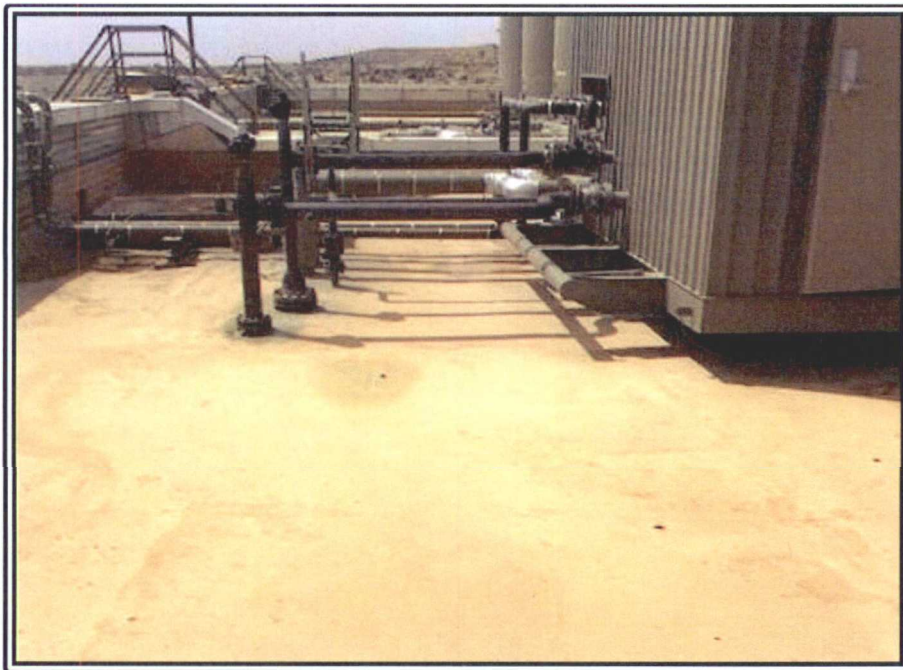
PHOTO 6: Containment Area After Cleanup (View 3)

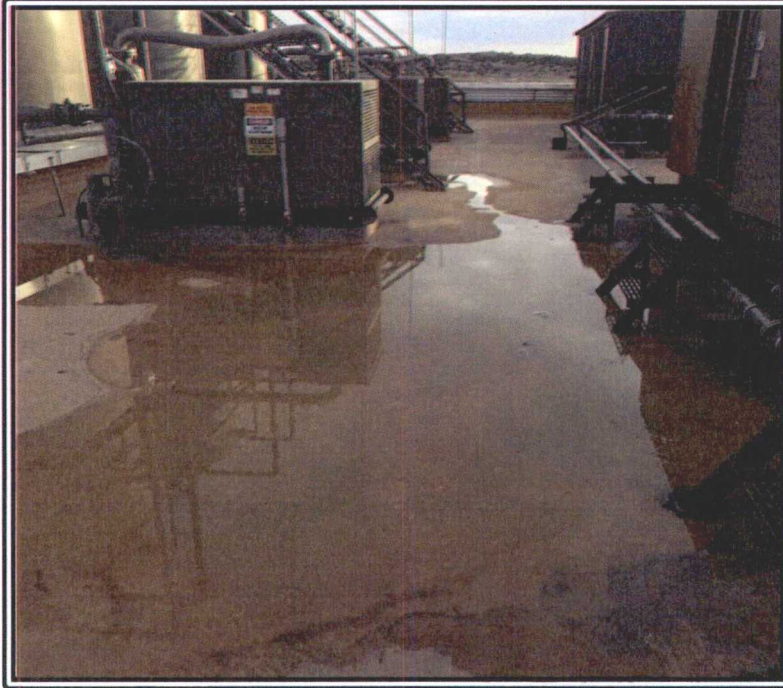
PHOTO 1: Containment area holding spill produced water. (View 1)

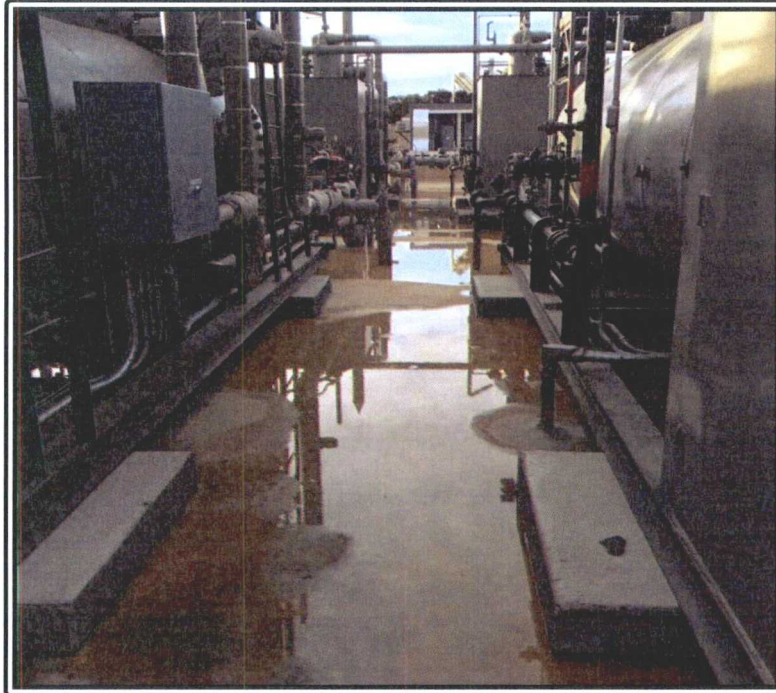
PHOTO 2: Containment area holding spill produced water. (View 2)
