Site Name Lybrook A12-2306 01H
Date Release Discovered 7/28/2018

RE: CONFIRMATION SAMPLING DOCUMENTATION FOR THE LYBROOK A12 2306 01H UNIT A WELL SITE, RIO ARRIBA COUNTY, NEW MEXICO

**SITE PHOTOGRAPHY
SPILL ASSESSMENT AND CLOSURE REPORT
ENCANA OIL AND GAS INC.
LYBROOK A12 2306 01H UNIT A
PROJECT NUMBER 11195-0228
AUGUST 2018**

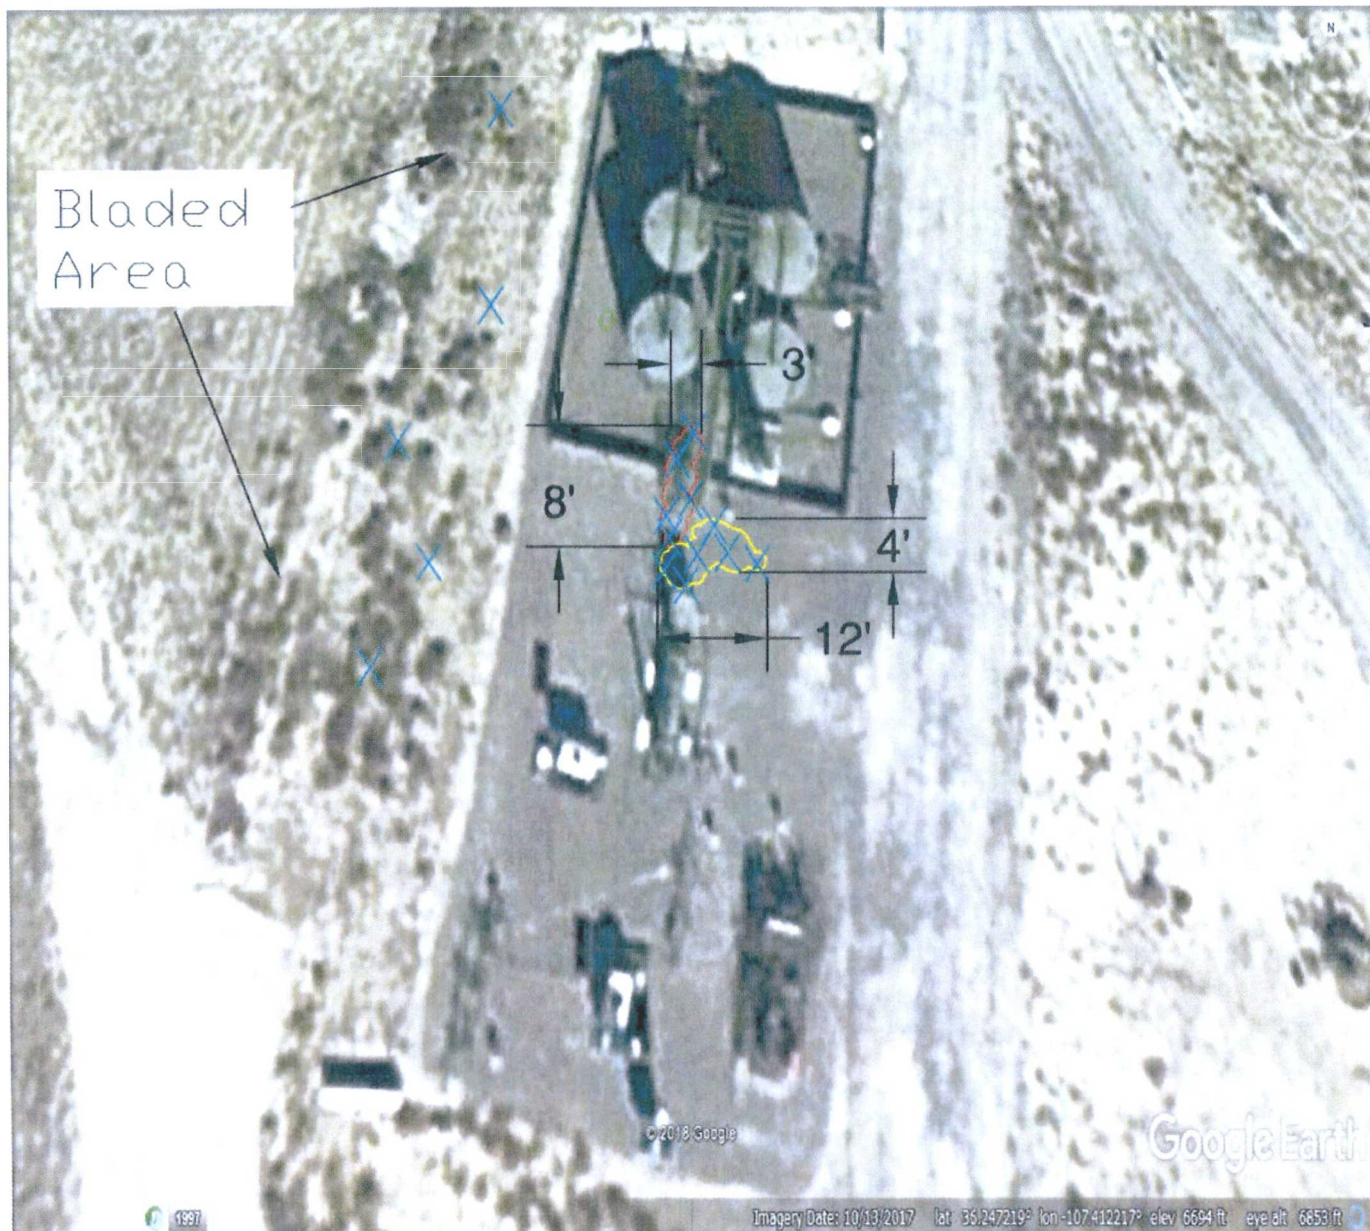
FIGURE NO. 2

- Per 19.15.29.12 The closure report needs to include a scaled site and sampling diagram. For a more detailed explanation of a site map reference 19.15.29.11.A(1)
- C-141 is photocopied and the details some details are illegible.

Taking a quick glance I think the site map and impacted areas need to be redone. Encana needs to provide a Detailed site map that include impacted areas, sample area, has a scale, north arrow etc. Please see 19.15.29.12 NMAC for the requirements of the closure report.

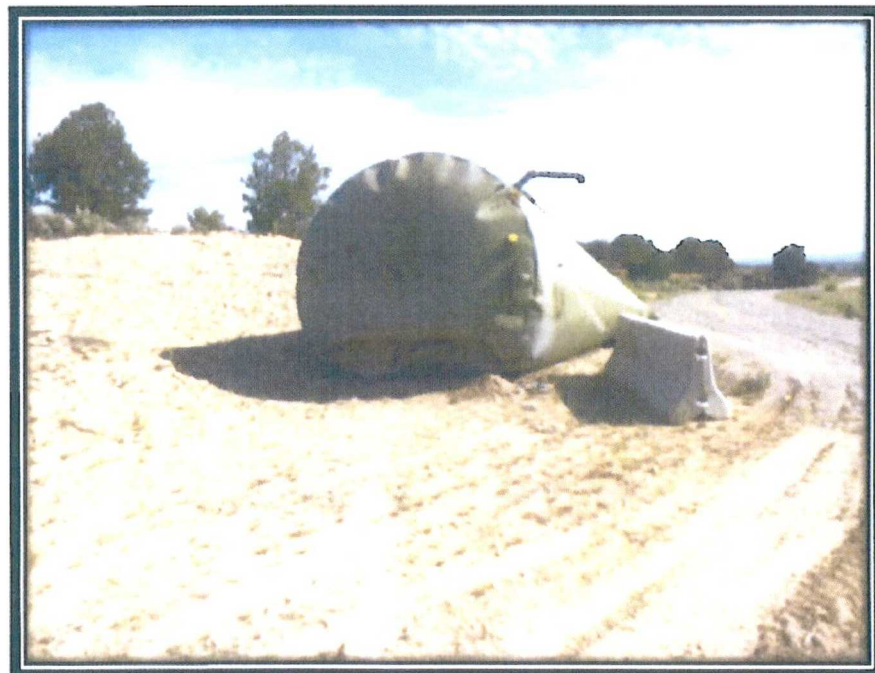
Picture 2: View of Tank Struck by Lightning

When the operator arrived at the Lybrook A12 facility on July 28 it appeared that there had been a lightning strike because the produced water tank was blown out of the containment and roughly 100 feet north of the containment. A vac truck was dispatched to the site the next day to recover liquid in the containment. The area of greatest impact was also bladed to turn the soil and ensure that impacted soil could volatilize clean. Additionally, Encana is working to repair the secondary containment that was blown out of shape due to the lightning.

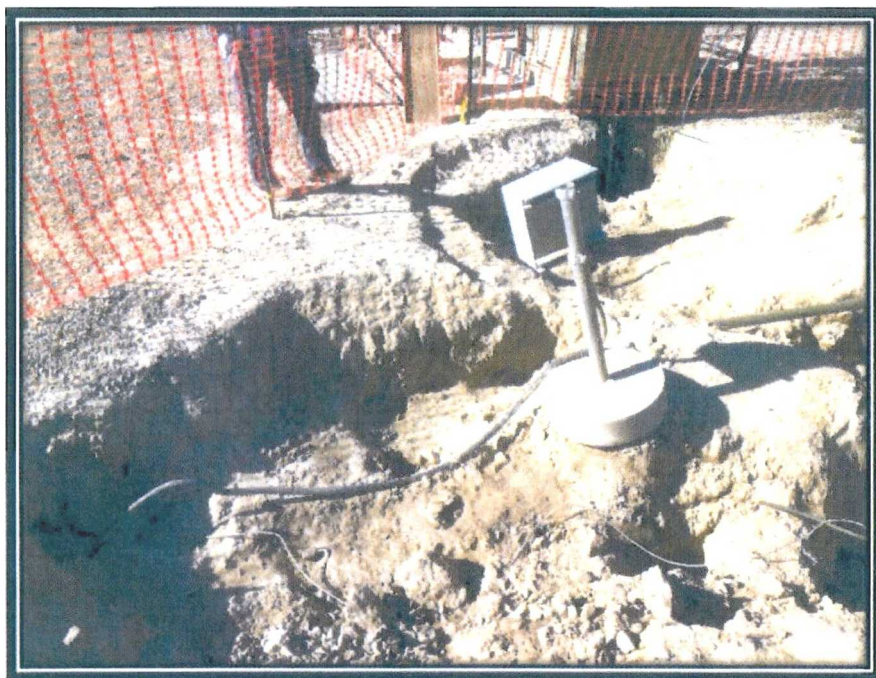
twelve (12) feet by four (4) feet by one (1) foot to three (3) feet bgs. *Section 2* measured approximately eight (8) feet by three (3) feet by two (2) feet bgs. The area under the liner (*Under Liner*) was also excavated to the extents of approximately two (2) feet by one (1) foot by six (6) inches bgs. One (1) five (5) point composite sample was collected from *Section 1*, *Section 2*, *under the liner*, and along the western edge of the location (*Bladed Area*) due to splatter from the tank and the manifold located on top of the tanks when they broke apart with New Mexico Oil Conservation Division (NMOCD), Mr. Cory Smith, and Bureau of Land Management (BLM) representative, Mr. Abiodun "Emanuel" Adeloje, as witnesses; see *Field Notes* and *Site Map*. The samples were screened in the field for organic vapors using a PID. All four samples returned results of 0.0 ppm OV. The samples were placed into individual laboratory provided four (4) ounce jars, capped headspace free, and transported on ice under strict chain of custody to Envirotech's Analytical Laboratory to be analyzed for TPH (DRO/GRO/ORO) using USEPA Method 8015D, benzene and total BTEX using USEPA Method 8260B, and chlorides using USEPA Method 300.0. The samples returned results below the regulatory standards all constituents analyzed; see enclosed *Analytical Results* and *Summary of Analytical Results*. Envirotech, Inc. recommends *No Further Action* in regards to this incident.

Picture 3: View of *Section 1*

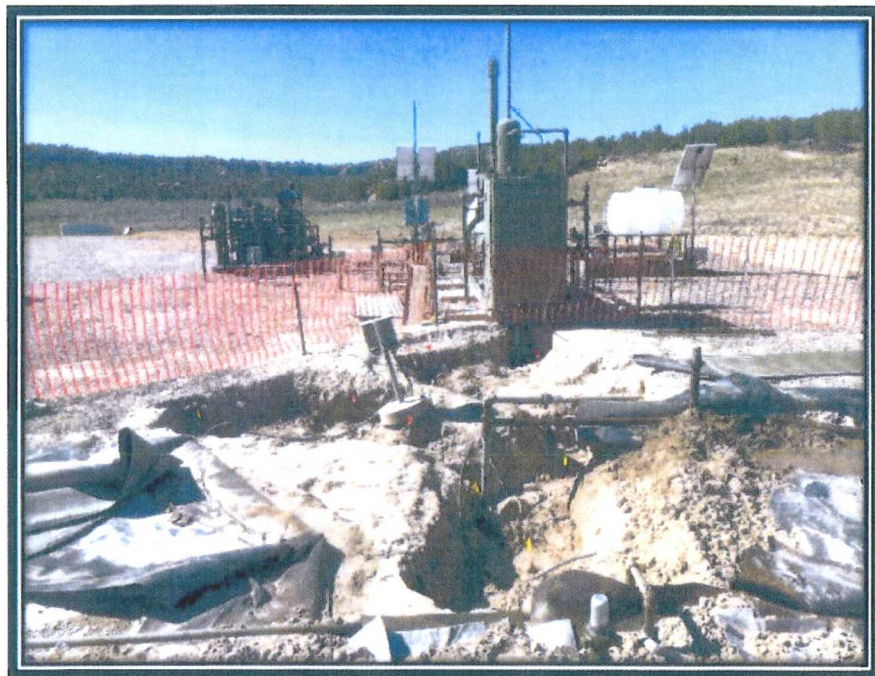
Picture 4: View of Sampling Locations (Orange Flags) in *Section 1*

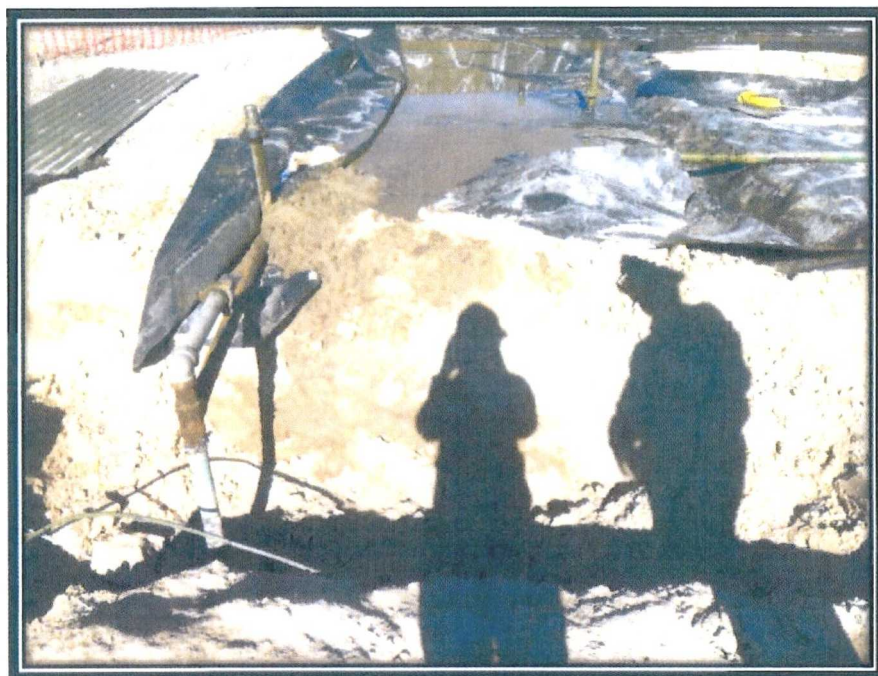
Picture 5: View of *Section 2*

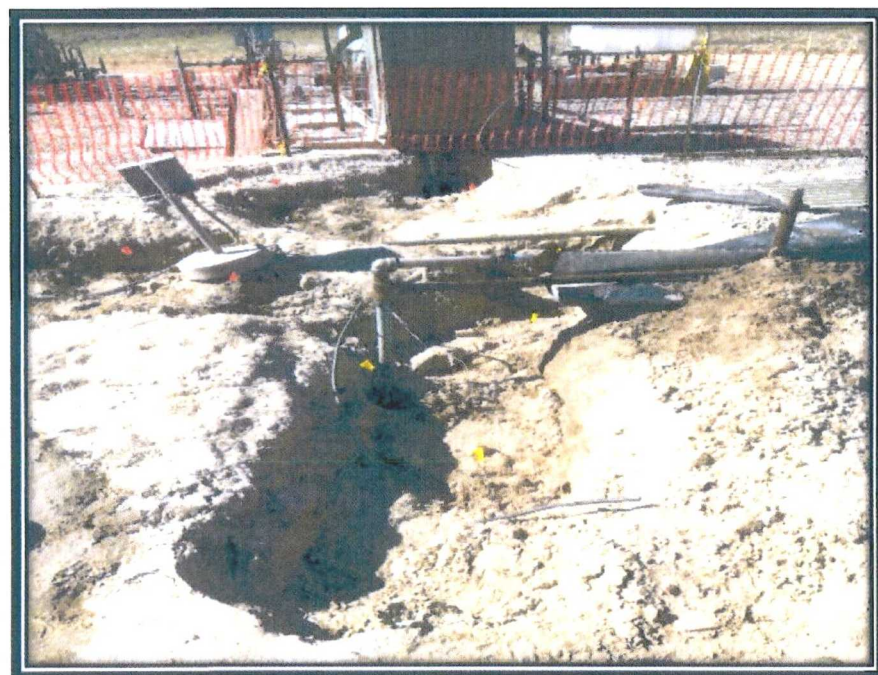
Picture 6: View of Sampling Locations (Yellow Flags) in *Section 2*

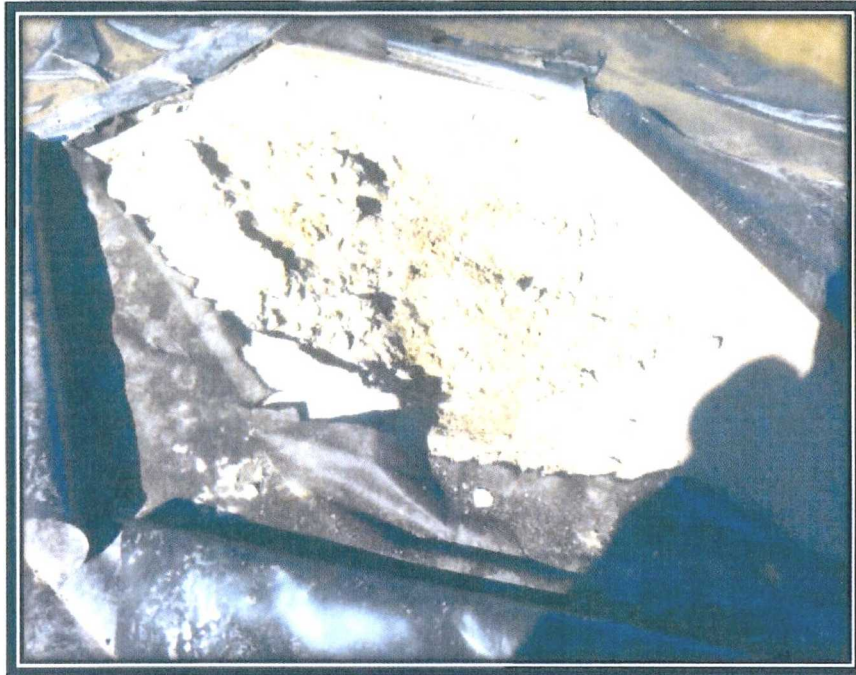
Picture 7: View of *Under Liner* Excavation

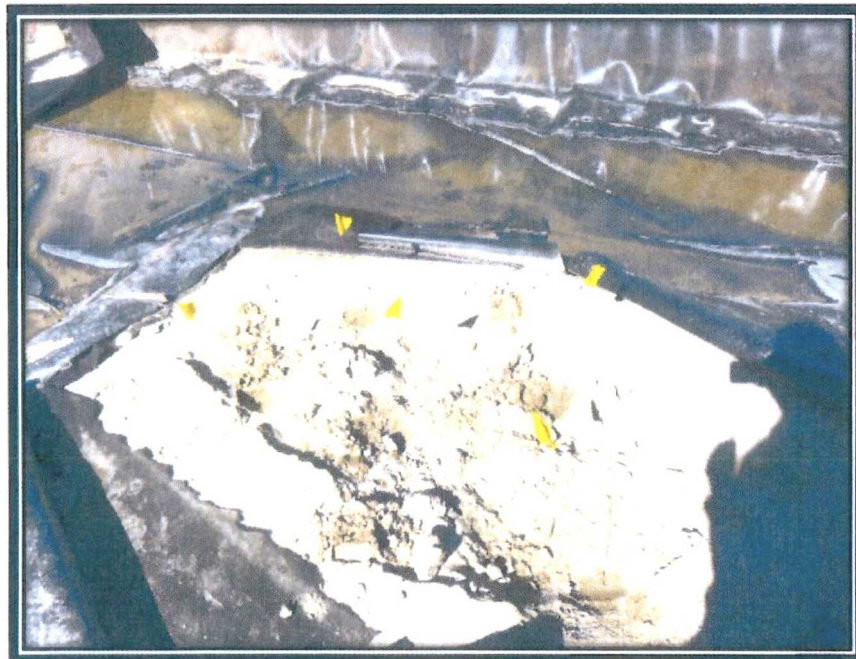
Picture 8: View of Sampling Locations (Yellow Flags) in *Under Liner*

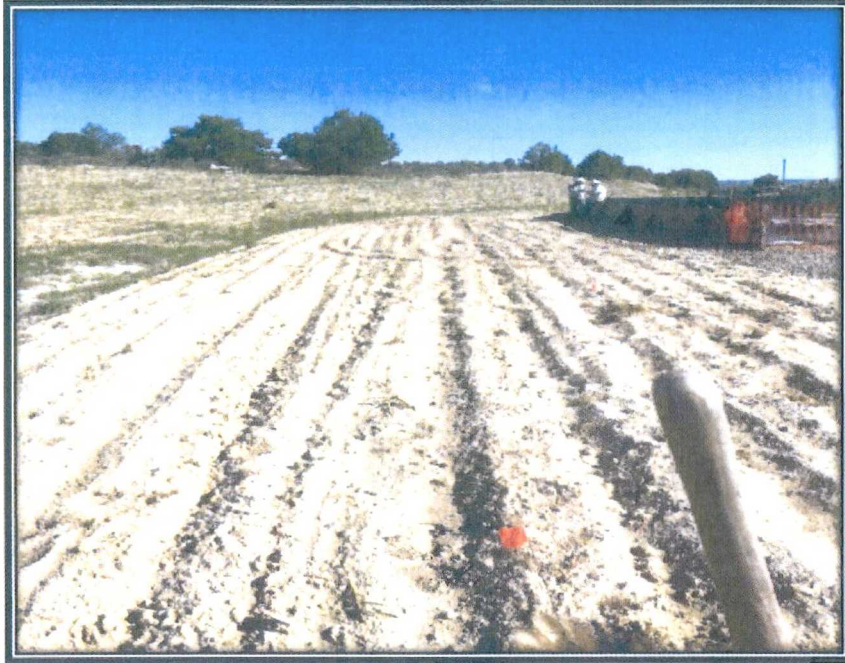
Picture 9: View of *Bladed Area* and Sampling Locations (View 1)

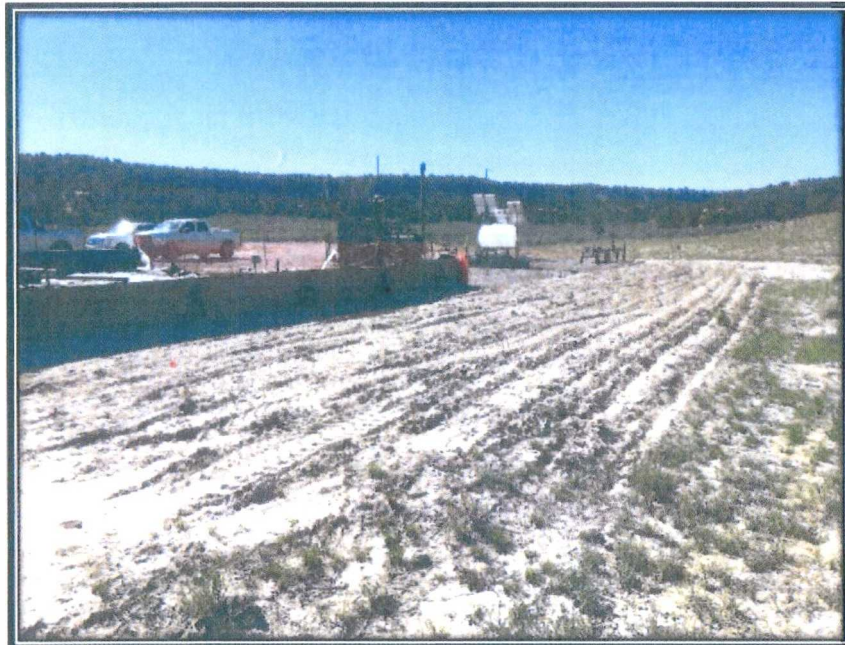
Picture 10: View of *Bladed Area* and Sampling Locations (View 2)
