2. Name of Operator MERIDIAN OIL	_ 7.	Unit Agreement Name
3. Address & Phone No. of Operator PO Box 4289, Farmington, NM 87499 (505) 326-9700		Well Name & Number Klein #26E API Well No.

4. Location of Well, Footage, Sec., T, R, M 790'FSL, 1750'FEL Sec.33, T-26-N, R-6-W, NMPM	11.	Field and Pool Basin Dk/Blanco MV County and State Rio Arriba Co, NM
Subsequent Report — Recompletion — Plugging Back	ction X Cha New Non Wat	inge of Plans Construction -Routine Fracturing er Shut off

Klein # 26E T26NR06WSec33UnitO Dakota/Mesaverde Immediate Plug & Abandonment

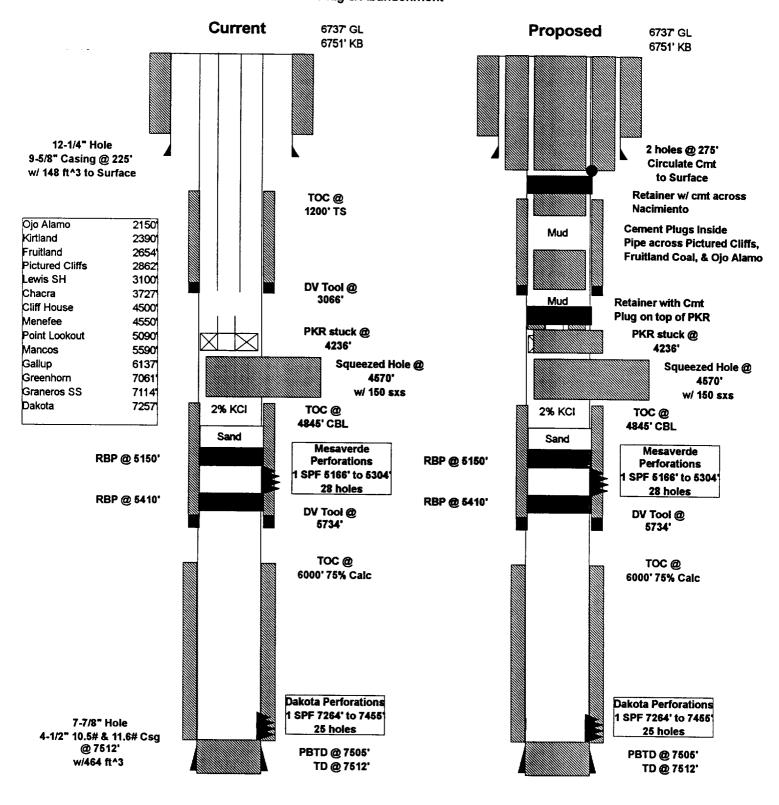
Klein # 26E

For the next nine (9) days, various milling, cutting, & jarring trips failed to remove the packer. On day twelve (12) of workover operations, the casing failed to hold pressure. This failure indicated that the fishing & cutting operations had gone outside of the 4-1/2" casing.

Since the two (2) retrievable bridge plugs would have to be pulled out of the hole past this rupture, and the repaired casing withstand a potential 2000 psi flowing pressure from the prior foam stimulation, the decision to plug and abandon the wellbore was made. Each of the bridge plugs had been pressure tested in excess of any foreseeable pressure.

- 3. Plug # 1. PU 4-1/2" cement retainer. TIH on 2-3/8". Set retainer @ 4100'. Test casing to 500psi. Establish & record rate below retainer. Mix & pump 64 sxs Class 'B' cement (100% Excess) below retainer. Unsting & pump 2 sxs cement on top of retainer. This will cover the packer area for 100' inside & outside of pipe from 4236' to 4075'. Reverse out & TOOH.

- 4. RU wireline. Run GR-CBL-CCL from current PBTD to surface. Note DV tool @ 3066'. Ensure cement coverage is behind pipe across Pictured Cliffs (2862' Top), Fruitland (2654' Top), and Ojo Alamo (2150' Top). Ensure cement coverage behind pipe is 50' above and below these above mentioned formations. Contact Production Engineering for squeeze procedure if the above cement coverage is not sufficient.

- 5. Plug # 2. Spot 15.5 bbls 9.0 ppg 50 visc mud inside pipe from 4075' to 3100'. PU and reverse out with water. LD unneeded jts.
- 6. Plug # 3. Spot 38 sxs Class 'B' 15.6 ppg cement w/ 2% CaCl inside casing. This will bring cement coverage inside & outside pipe from 3100' to 2600', coverage of Pictured Cliffs & Fruitland. PU and reverse out with water. LD unneeded its.

- 7. Plug # 4. Spot 5 bbls 9.0 ppg 50 visc mud inside pipe from 2600' to 2300'. PU and reverse out with water. LD unneeded its.
- 8. Plug # 5. Spot 16 sxs Class 'B' 15.6 ppg cement w/ 2% CaCl inside casing. This will bring cement coverage inside & outside pipe from 2300' to 2100', coverage of the Ojo Alamo. PU and reverse out with water. LD unneeded its.

- 9. Plug # 6. Spot 24 bbls 9.0 ppg 50 visc mud inside pipe from 2100' to 580'. PU and reverse out with water. TOOH & LD unneeded jts.
- 10. RU wireline. Perforate 2 0.50" squeeze holes @ 580' (This will cover Nacimiento). RD wireline.

- 11. Plug # 7. PU 4-1/2" cement retainer. TIH on 2-3/8". Set retainer @ 530'. Test casing to 500 psi. Establish & record rate below retainer. Mix & pump 24 sxs below retainer(100% Excess). Unsting & pump 4 sxs cement on top of retainer. This will place a 100' plug inside & outside pipe across the Nacimiento from 580' to 480'. Pull up.

- 12. Plug # 8. Continue to place 15.5 sxs Class 'B' 15.6 ppg cement inside pipe from 480' to 275'. Reverse out. TOOH & LD remaining tubing.

- 13. RU wireline. Perforate 2 0.50" squeeze holes @ 275' (50' below surface casing shoe). RD wireline.
- 14. Plug # 9. Estabish rate down casing and out bradenhead. Mix & circulate 131 sxs Class 'B' 15.6 ppg cement w/ 2% CaCl (50% Excess) down casing and out bradenhead. This will place cement inside & outside to surface.
- 15. Cut off WH below casinghead. Install dry hole marker per governmental regulations.
- 16. RD & move to next location.
