Sundry Notices and Reports on Wells

8. Well Name & Number  
Huerfano Unit #71

## Tubing Repair Procedure

Huerfano Unit No. 71  
DPNO 51074A  
Kutz Pictured Cliffs West Field  
1650' FNL & 1840' FWL, Section 9, T-26-N, R-10-W  
San Juan County, NM

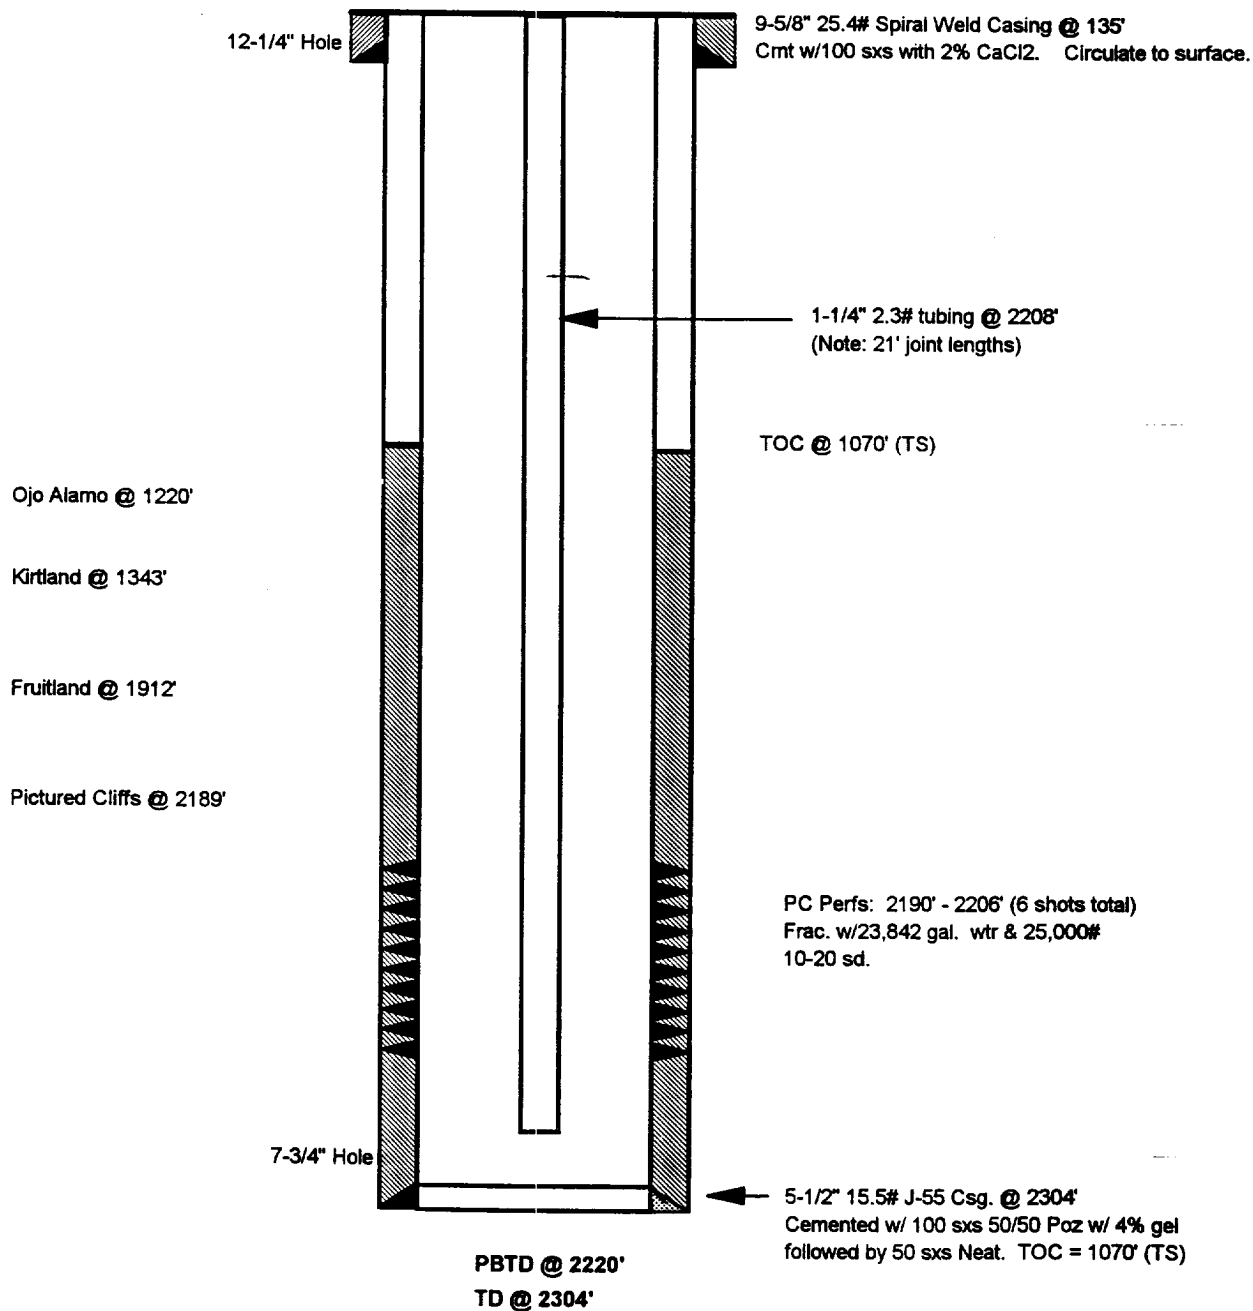
# Huerfano Unit No. 71

**Project Summary:** The Huerfano Unit No. 71 is a Pictured Cliffs producer drilled in 1956. This well was producing approximately 190 MCFD in mid-1995 when the well developed either 1) a hole in (or parted) tubing, 2) a casing failure or 3) both. In June of 1997 the lease operator attempted to blow down the tubing and found that the tubing and casing pressure dropped together. This would indicate a shallow hole or part in the tubing. However, the production curve leads us to think there may be a casing failure also. There are 1.4 BCF of remaining reserves associated with this well.

Note: 6/10/97 - Blew down tbg for 7 min. Tbg & Csg pressures fell together indicating a hole in the tubing (probably shallow).
