BURLINGTON RESOURCES

San Juan 29-7 Unit #58

SF-078425 30-039-07556

BRADENHEAD TEST REPORT

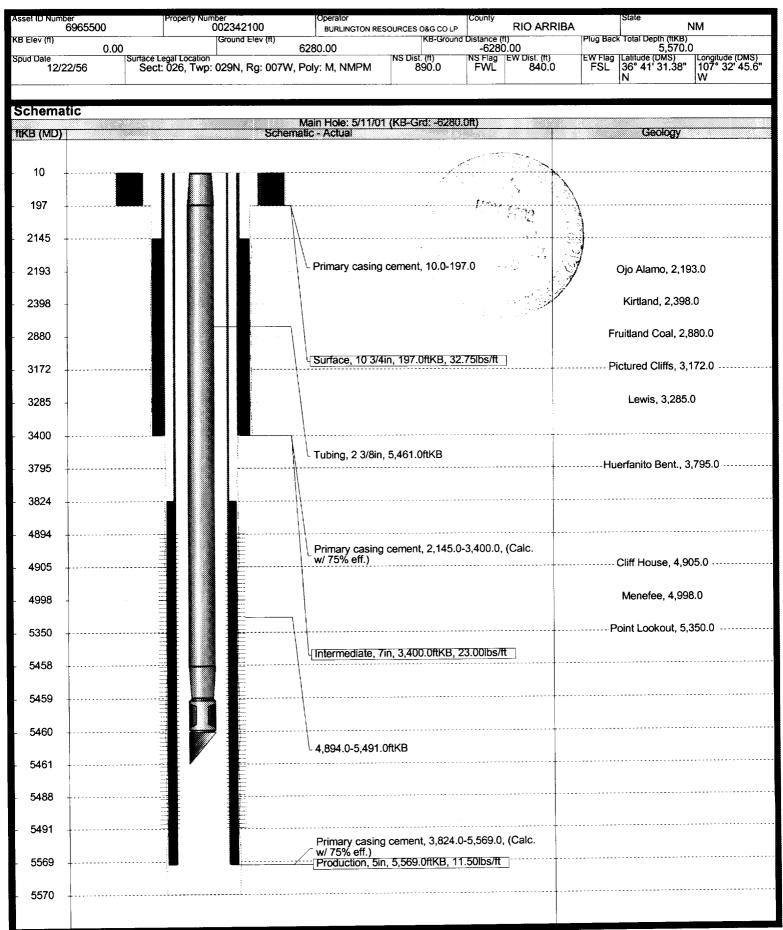
SAN JUAN 29-7 UNIT 58 WellView - Schematic

The San Juan 29-7 Unit #58 well has pressure on the intermediate but not on the bradenhead. The intermediate casing string is landed into the Lewis and the top of cement on the production string covers the Huerfanito Bentonite. See the attached wellbore schematic for more detail.

Since the well is located north of the Chacra line, there is only one zone exposed. Therefore correlative rights are protected and we believe no remedial action is necessary.
