BURLINGTON RESOURCES

Re: San Juan 29-7 Unit #56
CTP0219720112 ~~022006 0202607633~~
30-039-60102 021978812
SF-077842
990'FNL, 990'FEL, Section 15-29-7

BRADENHEAD TEST REPORT

SAN JUAN 29-7 UNIT 56

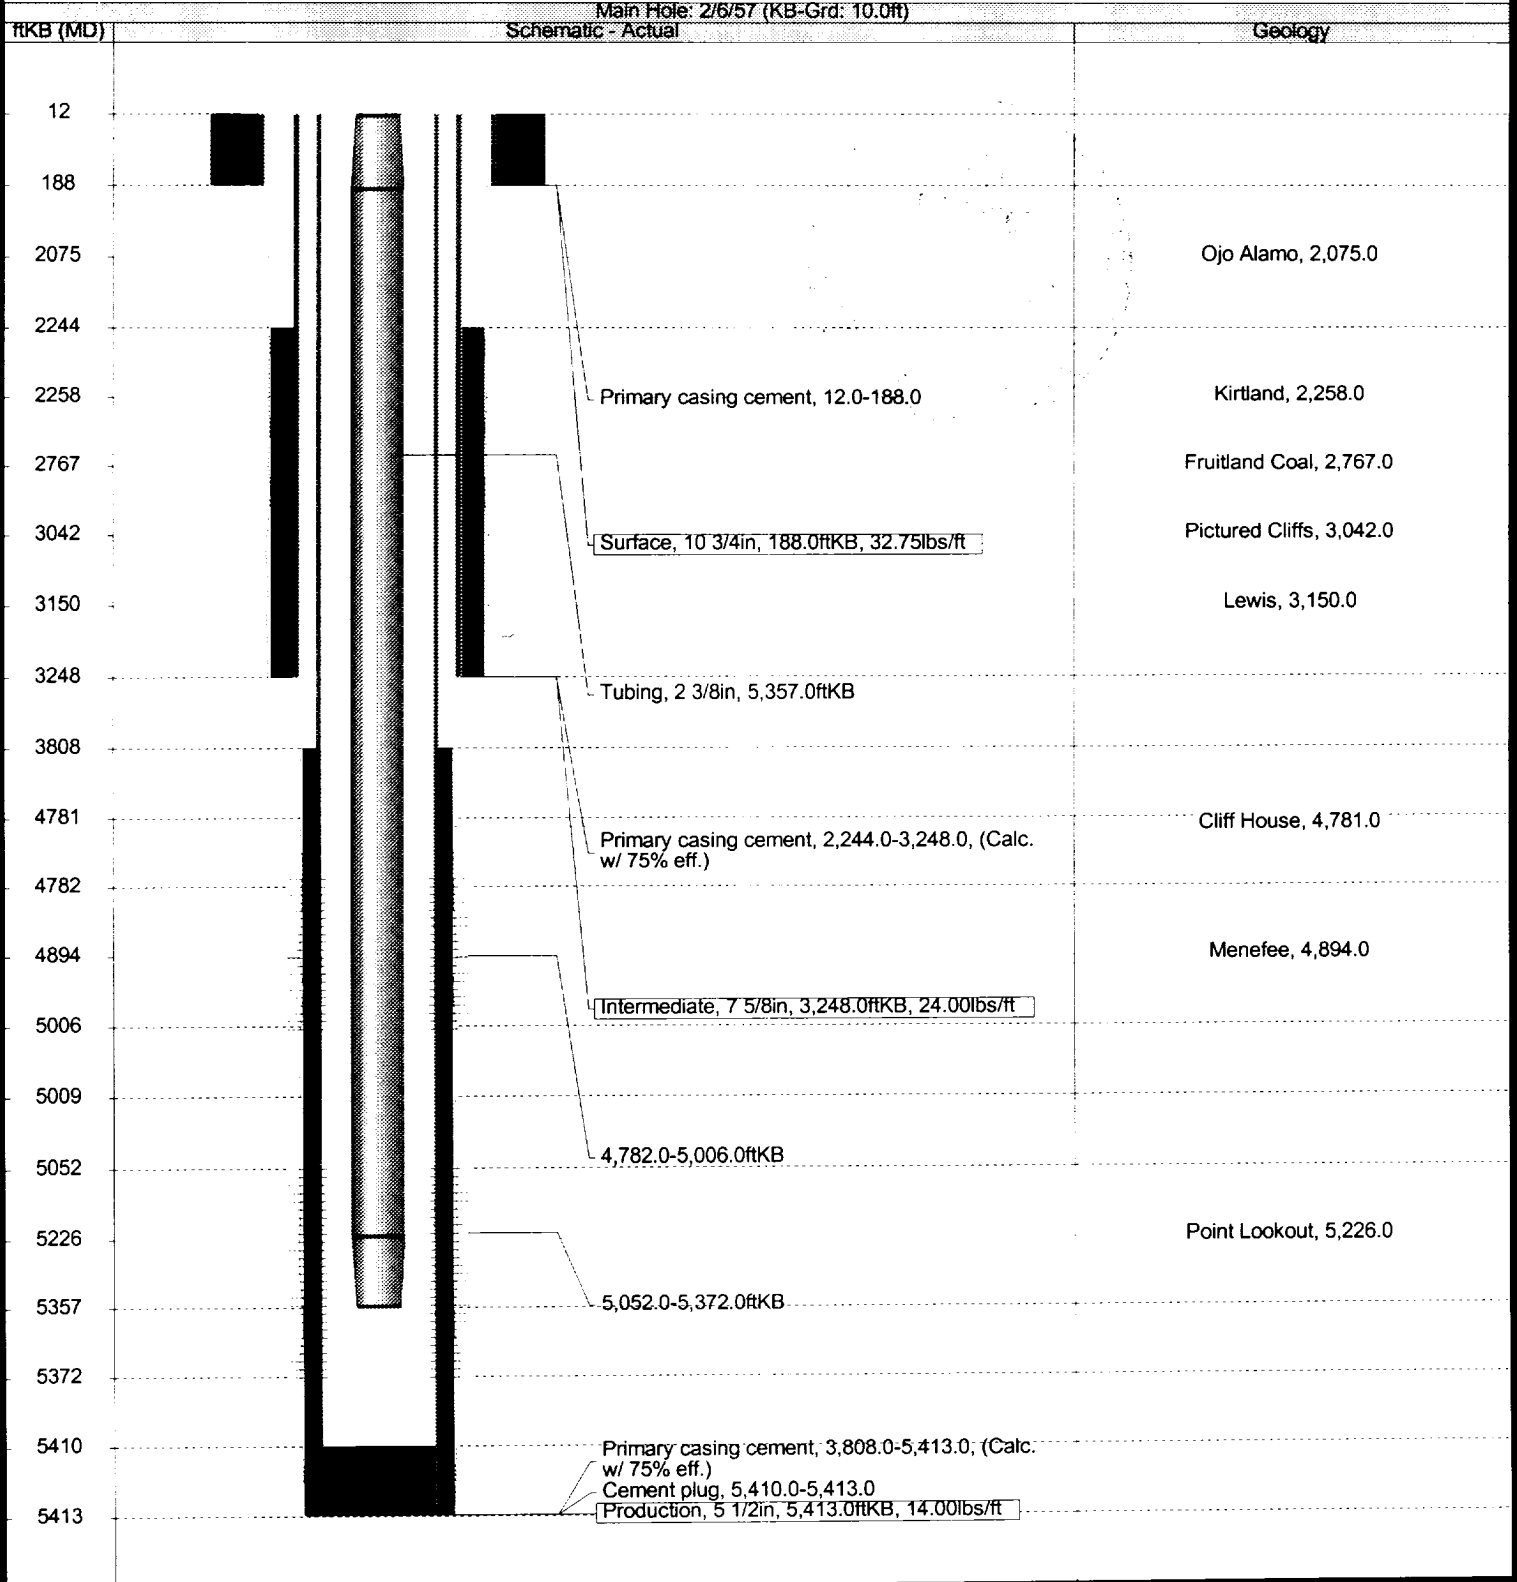
Schematic

The San Juan 29-7 Unit #56 well has pressure on the intermediate but not on the bradenhead. The intermediate casing string is landed into the Lewis and the top of cement on the production string covers the Cliff House. See the attached wellbore schematic for more detail.

Since the well is located north of the Chacra line, there is only one zone exposed. Therefore correlative rights are protected and we believe no remedial action is necessary.
