Union Texas
Petroleum

March 27, 1985

RE: Saiz No. 1 Well Basin Dakota pool
K 1840' FSL; 2310' FWL
Section 20, T29N, R11W, N.M.P.M.
San Juan County, New Mexico

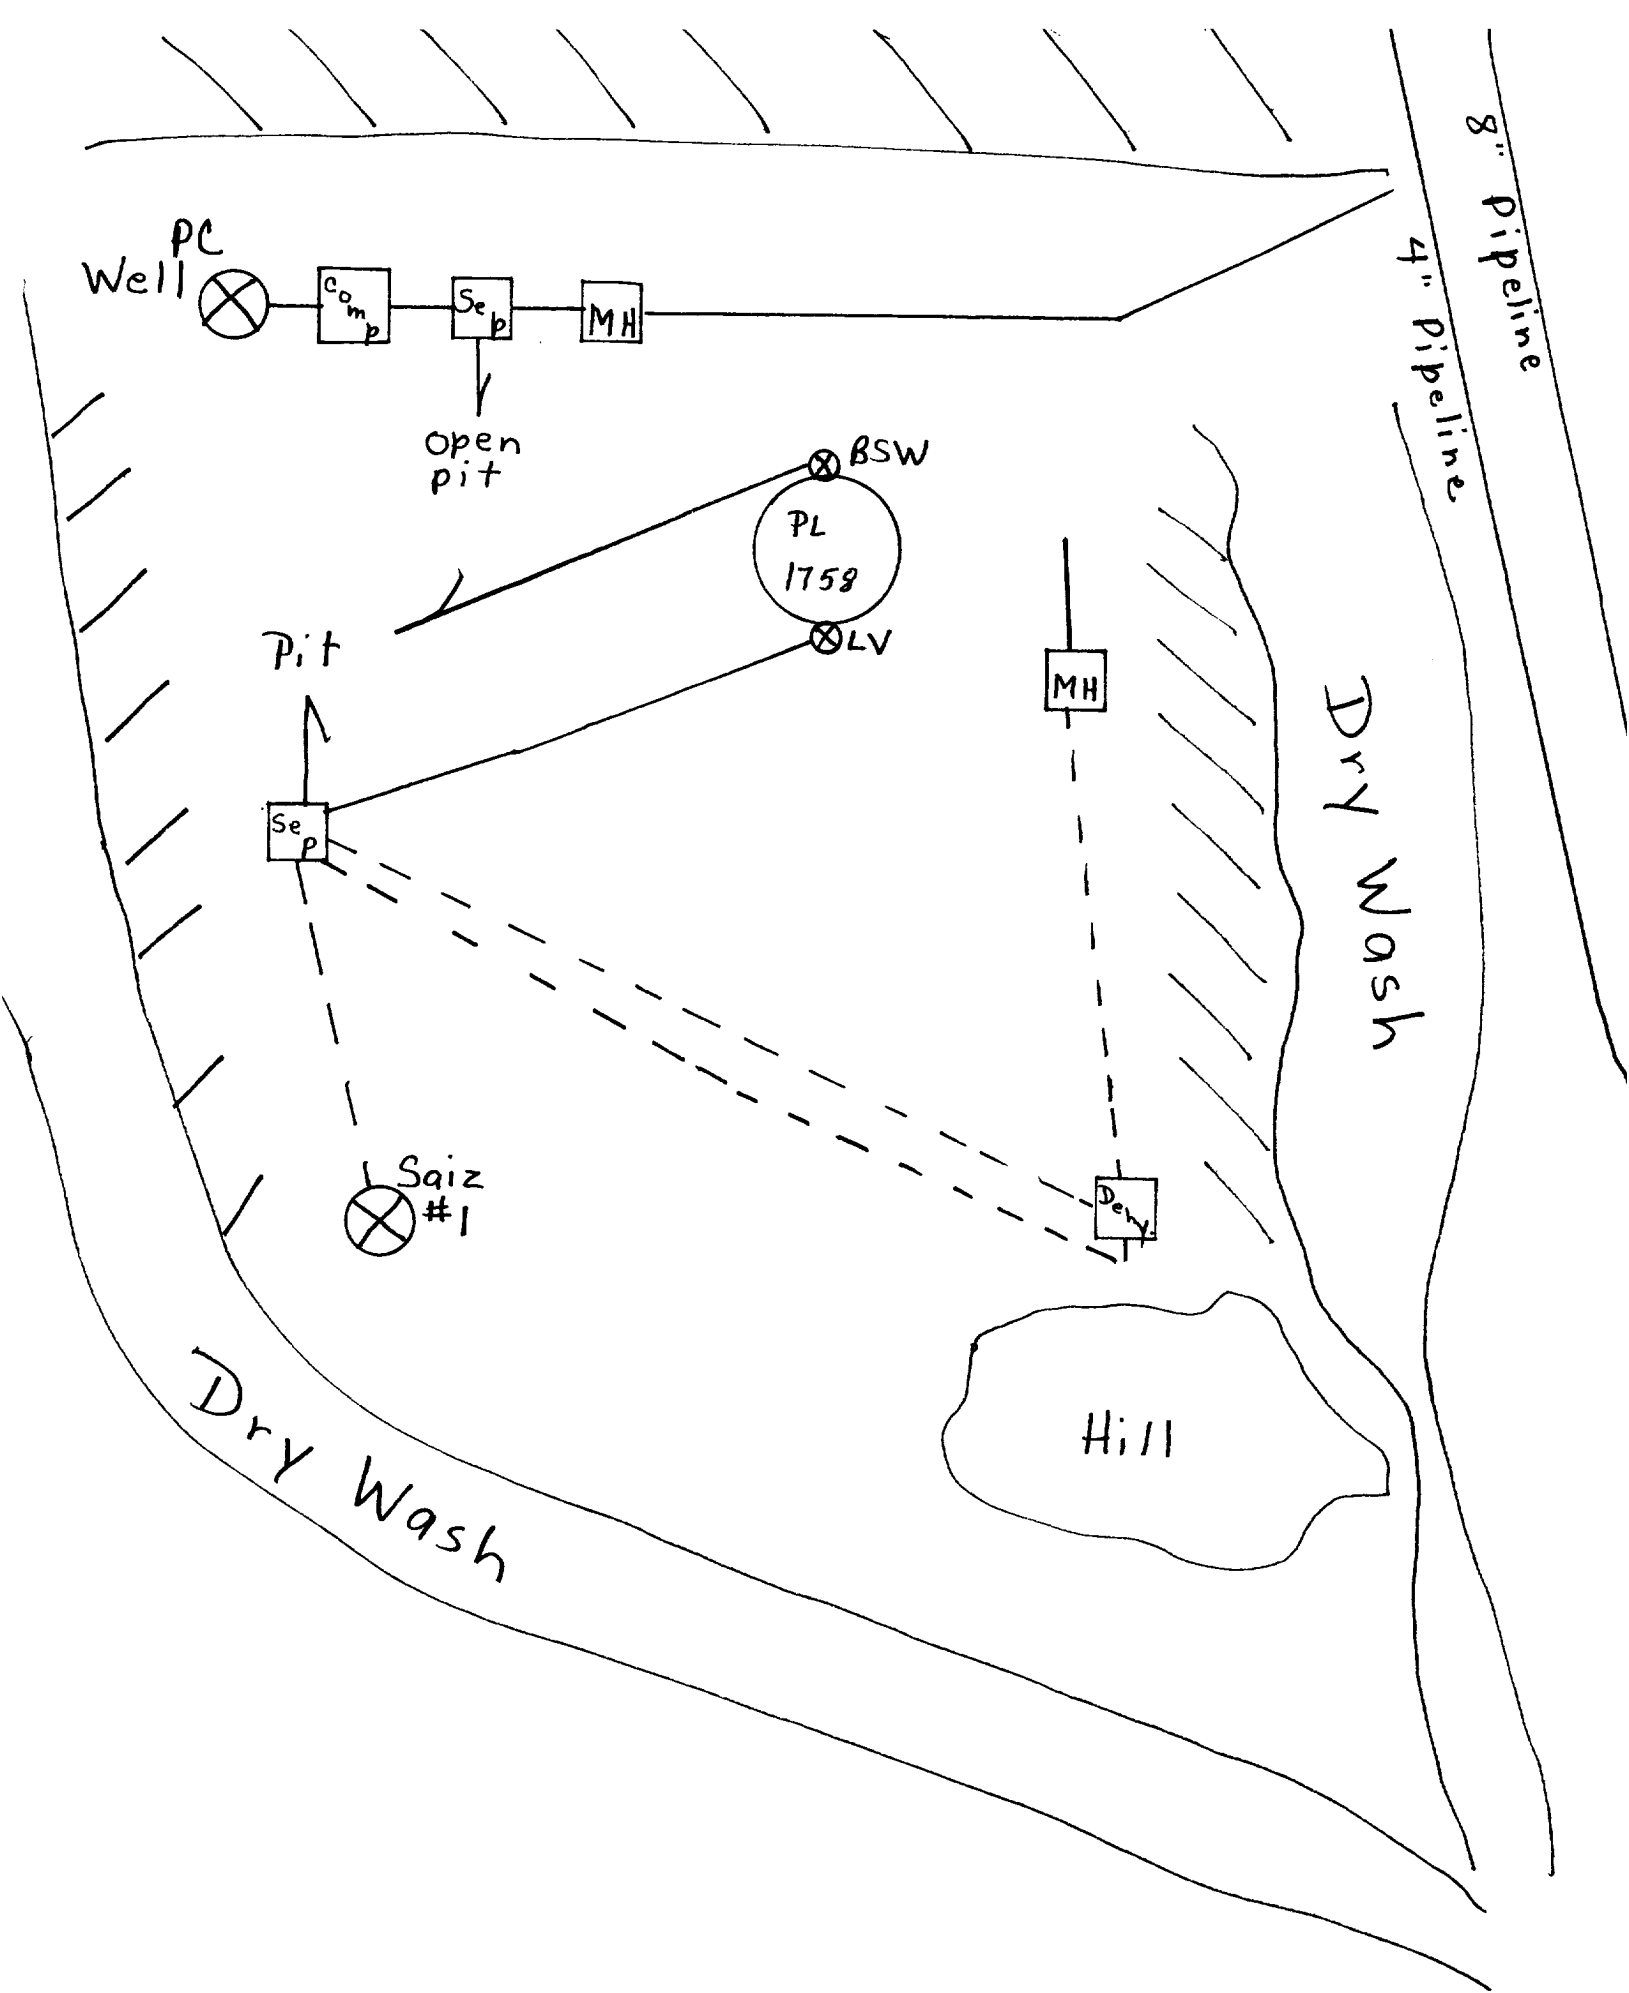
(See attached Schematic)

On March 15, 1985, Mr. Charles Gholson, Deputy Oil and Gas Inspector for the State of New Mexico, Energy and Minerals Department of the Oil Conservation Division, Division III called to report an oil seepage east of our Saiz No. 1 well. The seepage was directly adjacent to the east side of the location in a natural dry drainage area running north and south. The water course drains into a second dry water course running from northwest to southeast. The oil seepage had not yet entered into the northwest to southeast water course, but surface seepage indicated that the seepage had progressed about 300 feet and was within 50 feet of entering the second dry water course.

The Gas Company of New Mexico dehydrator had a scrubber on the dehydrator skid with an automatic dump valve which vented into an open, unlined pit adjacent to the oil seepage. This line from the scrubber to the open pit was removed and a new line was installed to dump back into the low pressure separator and into our stock tank.

Mr. Gholson then recommended that we dig the entire seepage area up and burn any oil or gas encountered as it was dug up to remove the oil and gas. This was subsequently done for the entire area of oil contamination to a depth of 10 feet. It was subsequently determined that the contamination source appeared to be from the open, unlined pit installed by Gas Company of New Mexico and used to dump oil into from the scrubber on their dehydrator. This pit was removed and the area dug up and the contamination burned.

It is estimated that approximately 50 BBLs of oil were lost into this pit causing the seepage.

We have left two open holes in the area which has been dug out and will be monitored by Mr. Gholson and ourselves for assurance that the seepage has been stopped.
