Sundry Notices and Reports on Wells

8. Well No.
Mary Wheeler #1

9. Pool Name or Wildcat
Basin Dakota

Procedure to Repair Tubing & Test Casing

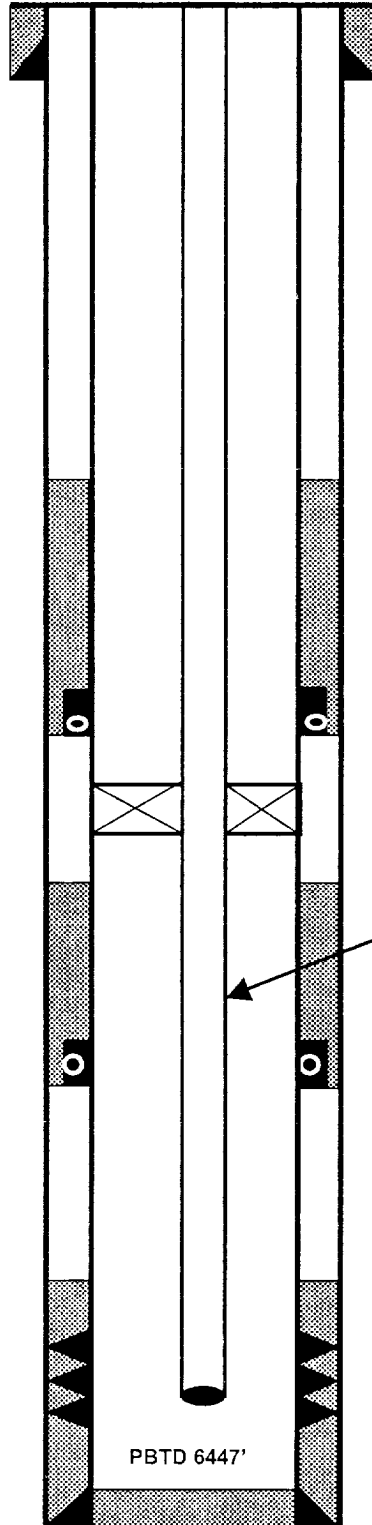
Mary Wheeler #1

March '?? Early in wells life it was worked over to prevent contamination of surrounding water wells. Apparently spotted cement under a packer at 760'; tagged soft cement at 1110', and drilled out to 1975'. No Sundry Notice in NMOCD for this work.

Objective: Repair bad tubing.
Pressure test casing.

Mar ?: Casing repair from 1110' to 1975'

Packer @ 2607'

2-3/8" tubing at 6339'
(appx. 205 joints)
