WORKOVER PROCEDURE -- TUBING REPAIR

TURNER FEDERAL #2
Blanco Mesaverde
Sec. 13, T3CN, R10W
San Juan Co. New Mexico
DPNO: 47941A

Turner Federal #2

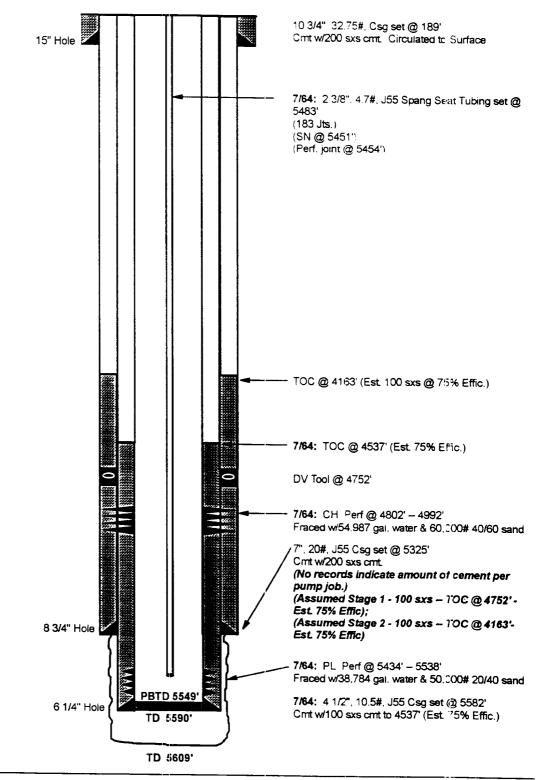
CURRENT -- 12-12-96

7/64: Pull tubing, tubing parted. Cut tubing and left perforated and anchor joints in hole. Ran 4 1/2" casing, cmt. perf, and frac. Land 2 3/8" tubing @ 5483'.
