State of New Mexico Energy, Minerals and Natural Resources Department Oil Conservation Division

WORKOVER PROCEDURE -- TUBING REPAIR

BROOKHAVEN COM A #2
Blanco Mesaverde
Sec. 16. T31N, R10W
San Juan Co., New Mexico
DPNO: 6590

Brookhaven Com A #2

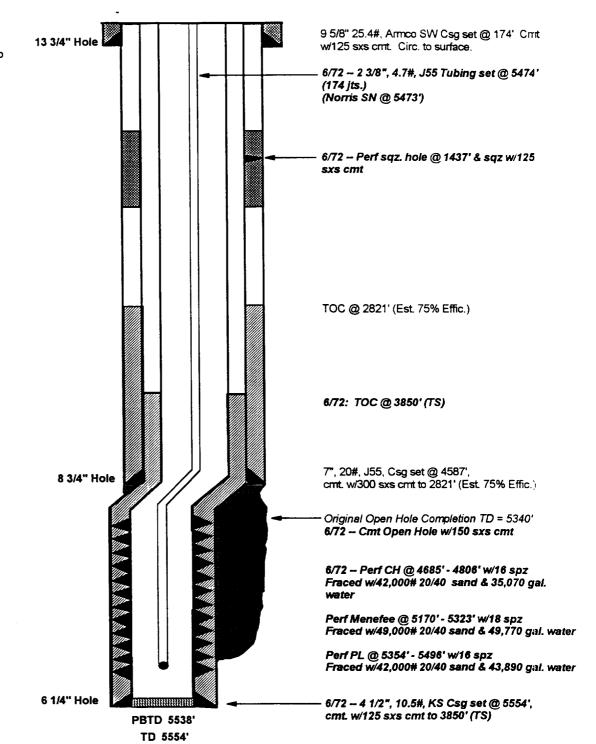
6/72: Cut off stuck tubing, cement open hole & perfed & squeezed Oio Alamo @ 1437'. Sidetracked with 4 1/2" casing. Perfed, fraced & landed 2 3/8" tubing.

- 4. TIH and tag bottom. Record depth. TOH with 2 3/8" tubing (174 jts.). Inspect tubing and replace all bad joints. (Note any buildup of scale, and notify Operations Engineer. If tubing is excessively scaled, acid wash may be run in perforations).

- 5. PU and RIH with 3 7/8" bit and 4 1/2" casing scraper to PBTD, 5538'. TOH and LD bit and scraper.
- 6. RIH open ended with tubing, SN one joint off bottom, (rabbit tubing in derrick before running in hole). CO with air. Land tubing @ bottom perforation, 5496'.
