WORKOVER PROCEDURE -- TUBING REPAIR

San Juan 32-9 Unit #40 DPNO 69891 Blanco Mesaverde Sec. 30, T32N, R09W San Juan County, New Mexico

San Juan 32-9 Unit #40

Current -- 11-28-95

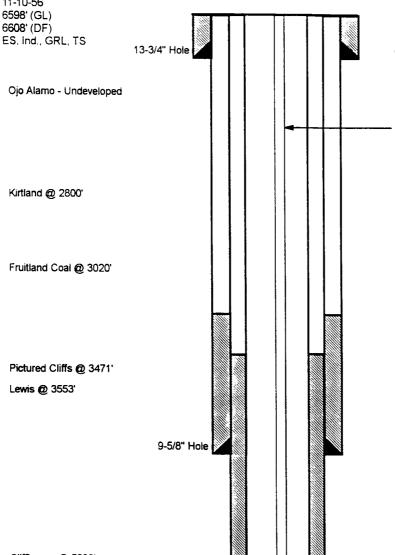
10-3/4", 32.75# csg. set @ 177' Circ. 125 sx cmt to surface

2-3/8" EUE tbg. set @ 5842' Bullplugged w/3' perf sub (188 jts., 5830')

7-5/8", 26.4#, J55 csg. set @ 3733' cmt. w/250 sx. TOC @ 3200' (TS)

Cliffhouse Perfs @ 5423'-5427', 5431'-5444', 5451'-5457', 5478'-5486'

Squeezed perf @ 5500' w/120 sx cmt.

Point Lookout Perfs @ 5774'-5780', 5792'-5796', 5806'-5818', 5828'-5842'.

5-1/2", 15.5#, J55 csg. set @ 5911" Cmt. w/300 sx, TOC @ 3400' (TS)

PBTD @ 5855' TD @ 5920'
