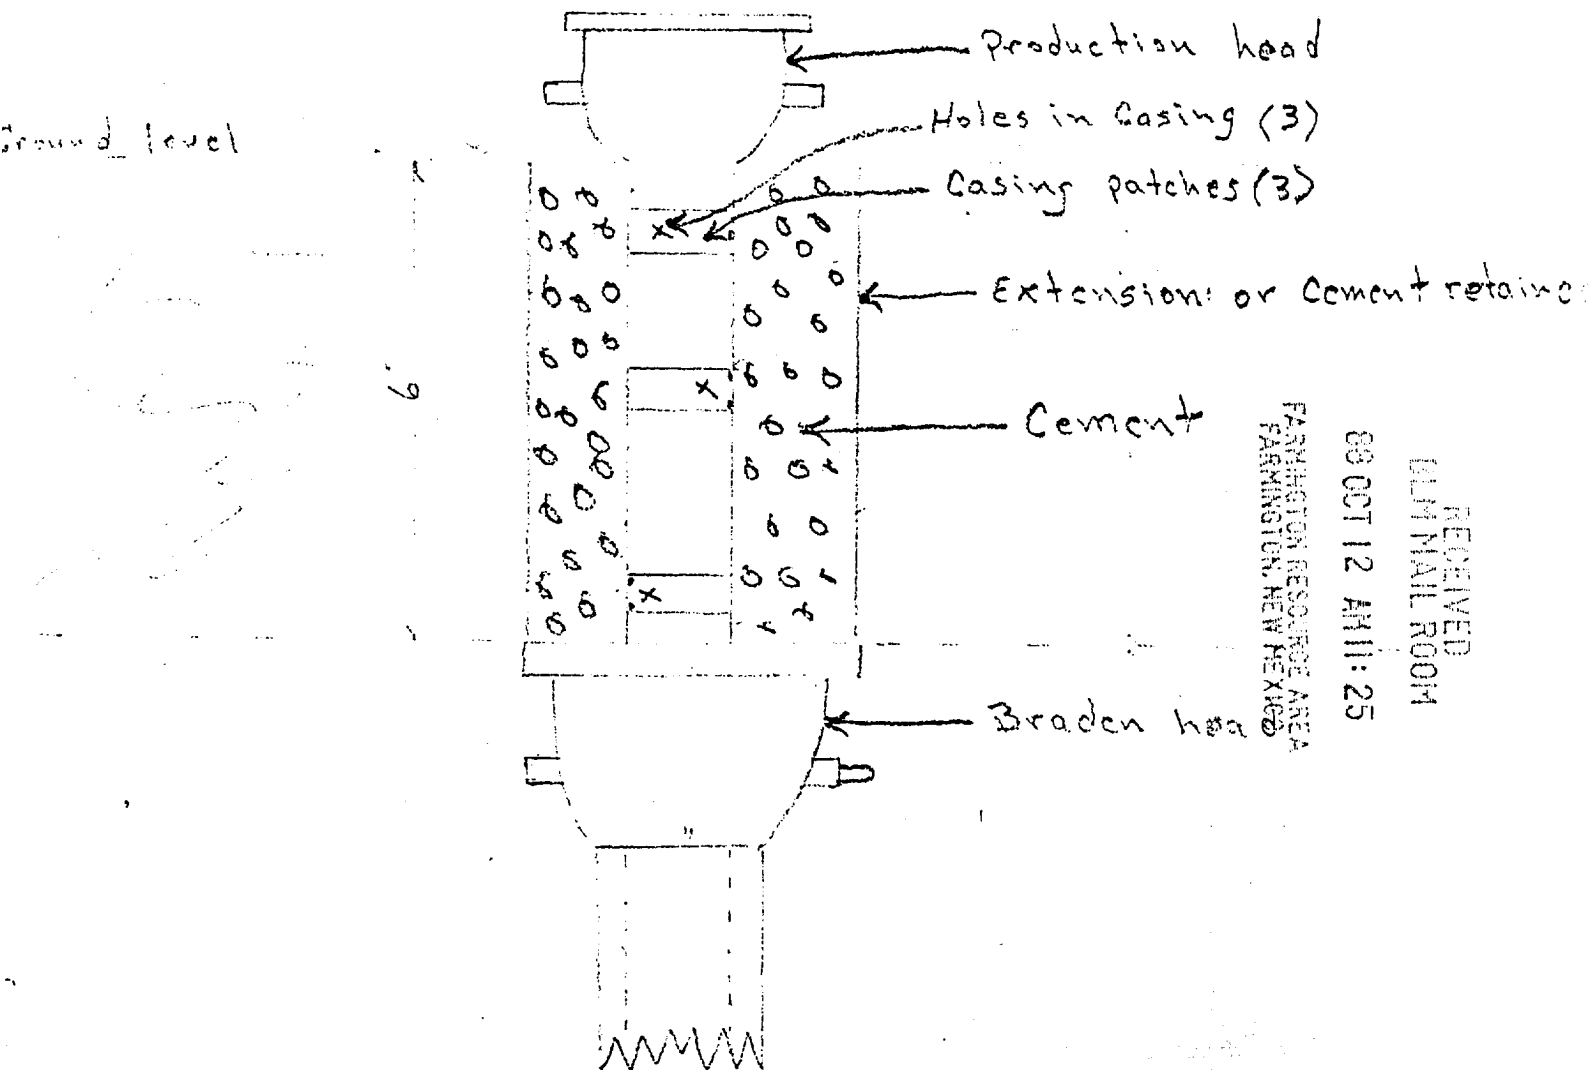
Caseing extends 6' above braden head, three holes have been eaten through 4 1/2" caseing.

We propose to fix holes with line pipe clamps, extend the surface pipe diameter up to ground level and cover 4 1/2" caseing with cement.
