**Jimmy Cooper #6 Closure Report
Duke Energy Field Services
Lea County, New Mexico**

JIMMY COOPER #6 (JC#6)

Re: Removal of Hydrocarbon-Impacted Soils from the JC #6 site
Township 20 South, Range 37 East, Section 8, Unit O

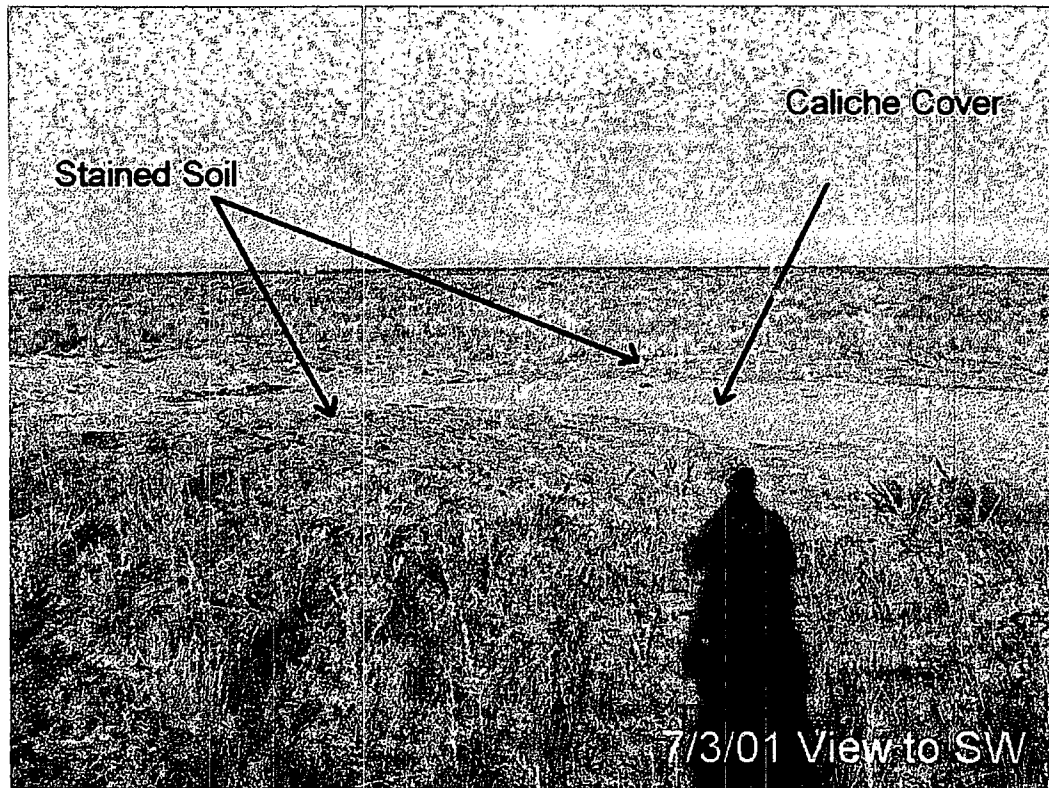
JC6-1

View of site just prior to excavation.

Visibly stained soil was observed on both sides (east and west) of the pipeline across an 800 square foot area. The surface soil immediately above the pipeline appeared to consist of a thin layer of caliche, possibly added after the line repairs were made (see Photo 1). Mr. Cooper said the surface soil above the pipeline was salt contaminated natural soil; this however, seems unlikely since any salt contaminated soil immediately above the pipeline would have been removed when the line was repaired.

Photo #1 Stain soil at the surface
on east & west side
of fresh caliche covering
the repaired pipeline

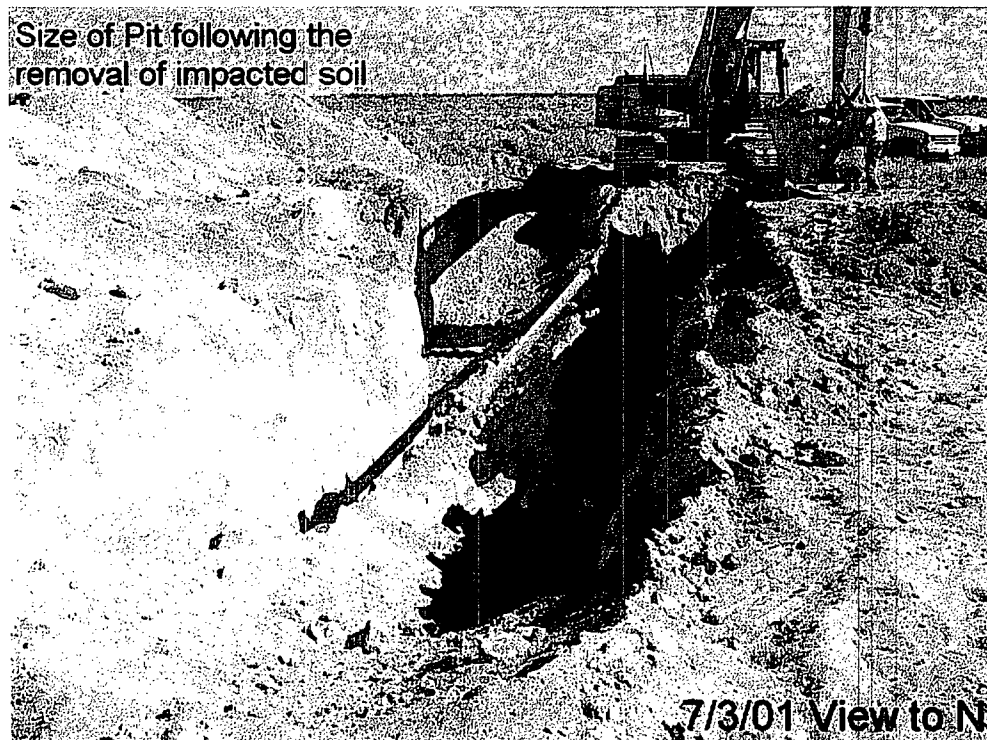
JC6-3 View facing north showing completed excavation.

The excavation was then widened and cleaned out until soil samples recovered from the bucket on all four sides contained <1-ppm VHC (Photo 3). A grab sample was recovered from the floor of the excavation for laboratory analysis of DRO and GRO. The removed soil to this point (assumed to be contaminated) was segregated to the west of the excavation (Stockpiles "B" and "C") and the walls of the excavation were ramped on all sides to prevent injury to livestock or area workers (Photo 4 and 5). Soil from the ramping operation was placed adjacent to the excavation (Stockpiles "A" and "D").

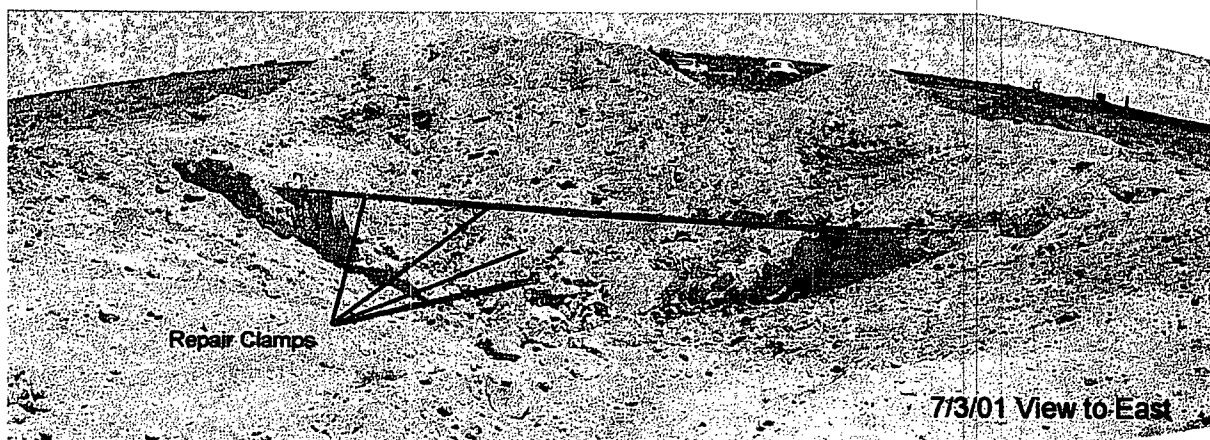
Historical condensate release caused by external corrosion of steel pipeline in subsurface. Steel pipeline had 5 clamps to repair historical leaks. Removal of impacted soil requested by landowner (Jimmy Cooper).

JC6-4 View facing east showing location of pipe clamps and completed excavation.

It should be noted that five (5) repair clamps were discovered along the exposed section of pipeline. The northern most was surrounded (within a few inches) with moist, hydrocarbon-impacted soil. Mr. Blackwood (Allstate) indicated that he would contact a local Duke employee to come check the line prior to back-filling the excavation.
