Merit Energy Denton SWD #1 Work Plan NW 1/4-NW 1/4 of Section 13 Township 15S, Range 37E Lea County, New Mexico

November 17, 2004

Merit Energy 13727 Noel Road, Suite 500 Dallas, Texas 75240

Safety & Environmental Solutions, Inc. 703 E. Clinton Suite 102 Hobbs, New Mexico 88240 (505) 397-0510

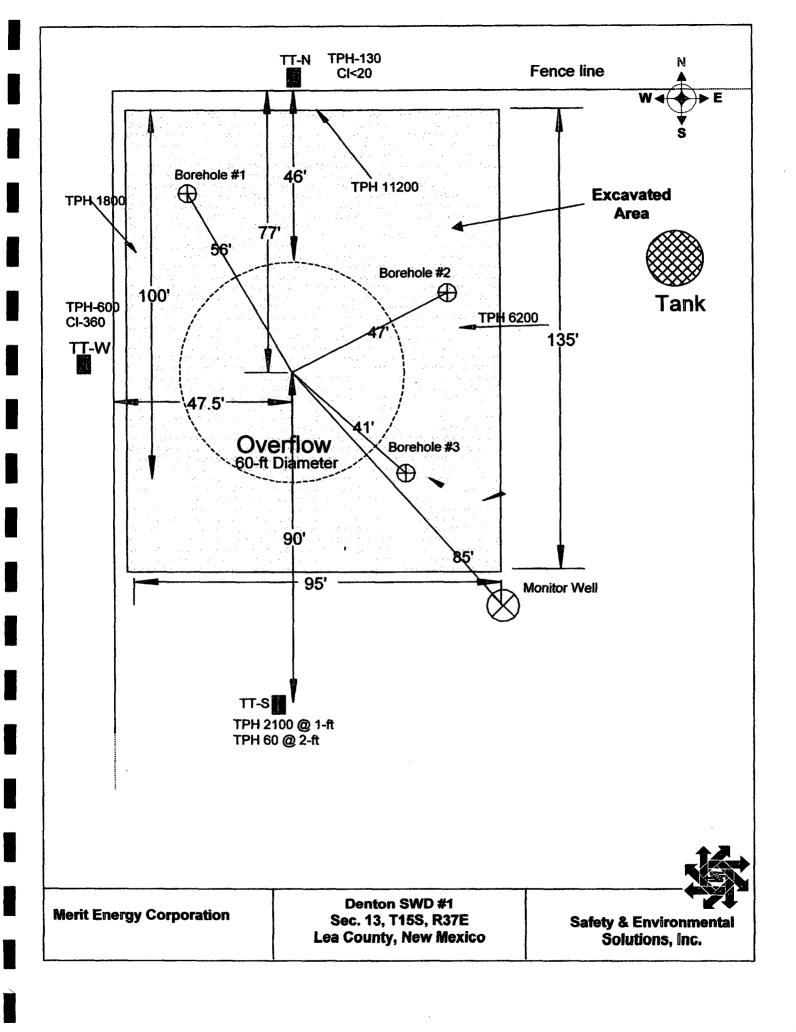
Figure 2 Site Plan

The pit area was excavated to an average depth of 5 feet. The existing excavation measures 135' X 95'. Approximately 2900 cubic yards of excavated soil were transported to Artesia Aeration for disposal. TABLES OF TEST RESULTS

SESI proposes to line the existing excavation with a 40-mil poly liner. The liner will be installed in a manner so that the bottom and sidewalls will be covered to encapsulate the backfill on all sides but the top.

After the liner installation the excavation will be backfilled with clean soil from off site. A berm will be constructed around the excavation to isolate the excavated pit area from the rest of the facility.
