## **REMEDIATION SUMMARY & CLOSURE REQUEST**

**REGENCY FIELD SERVICES LLC.  
R.R Sims 10" MA-3 Line  
Release Site  
Lea County, New Mexico  
Unit Letter "C", Section 3, Township 23 South, Range 37 East  
Latitude 32.33946, Longitude -103.15354**

December 2014  
Apex Project No. 7030714G099

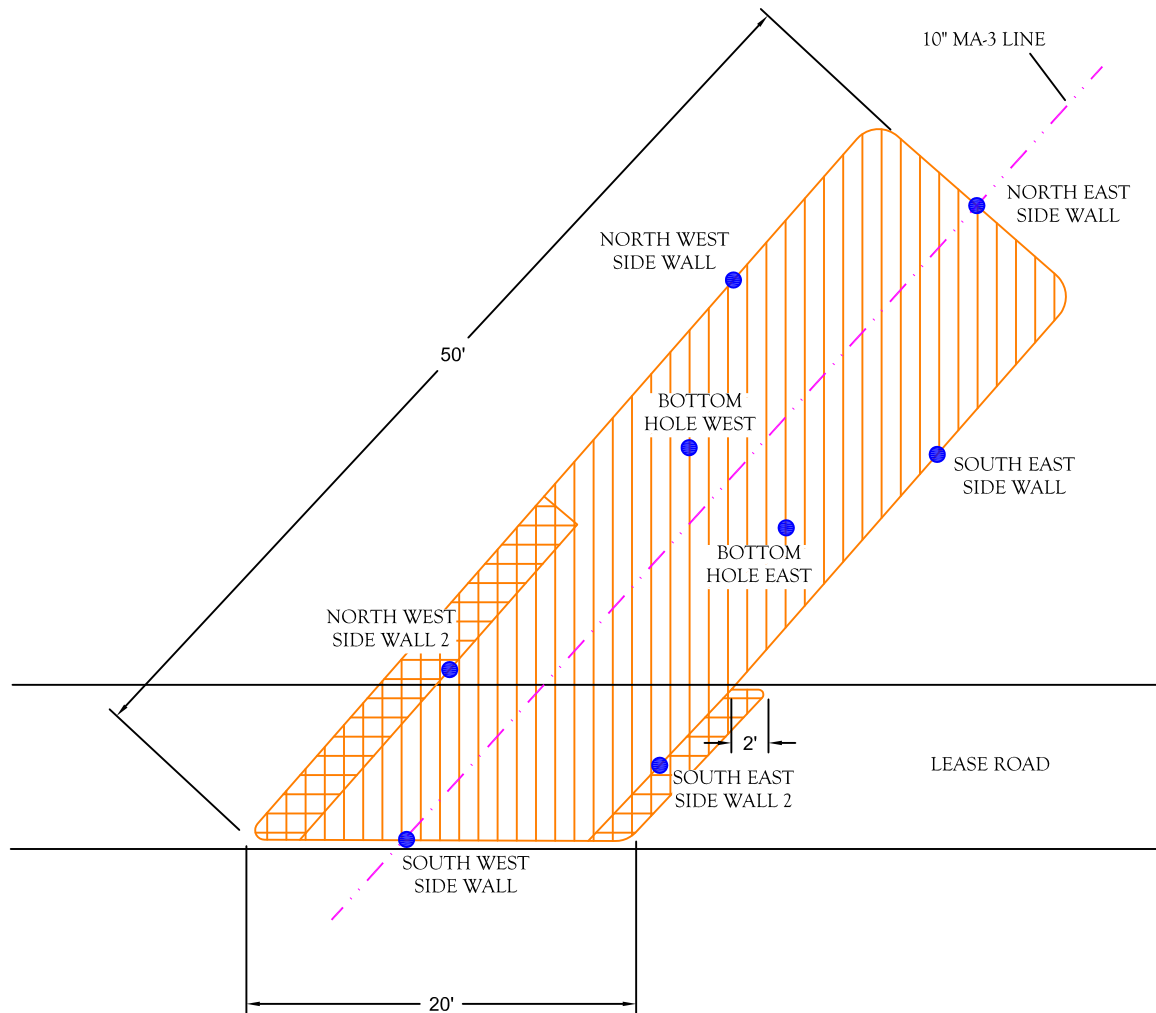
**FIGURE 3**  
**Site Map**

EXCAVATION 12' to 14' DEEP
-

BENCH EXCAVATION 4' DEEP

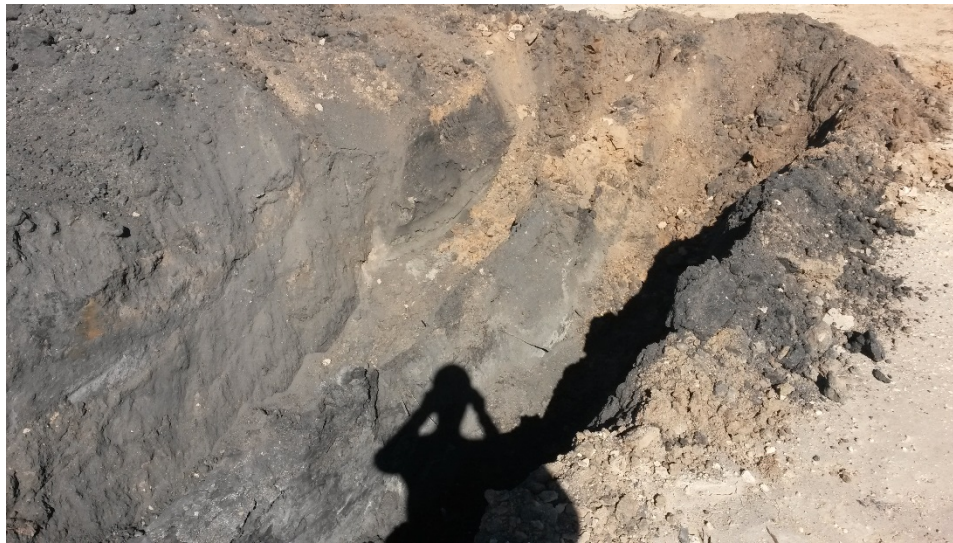
View North – Buried Line and Impacted Soil

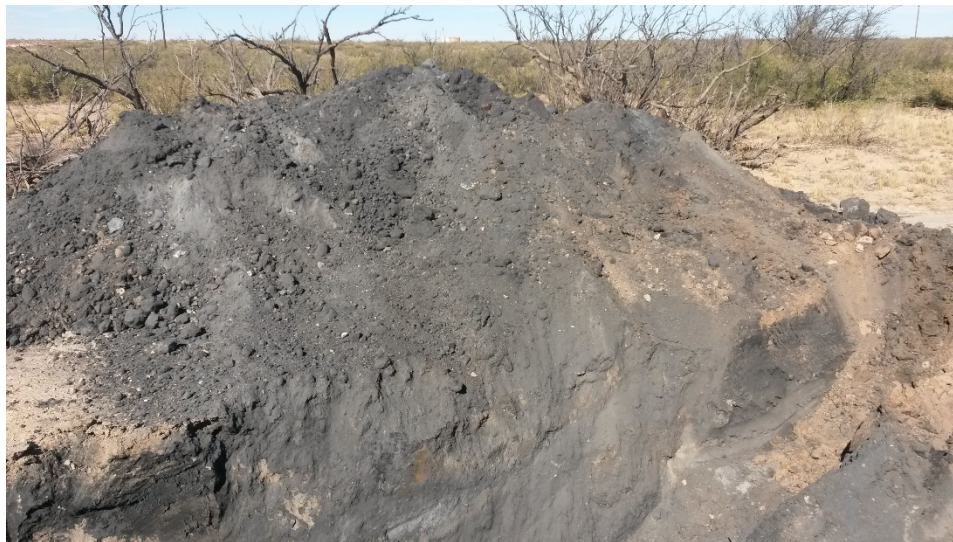
View North – Impacted Soil

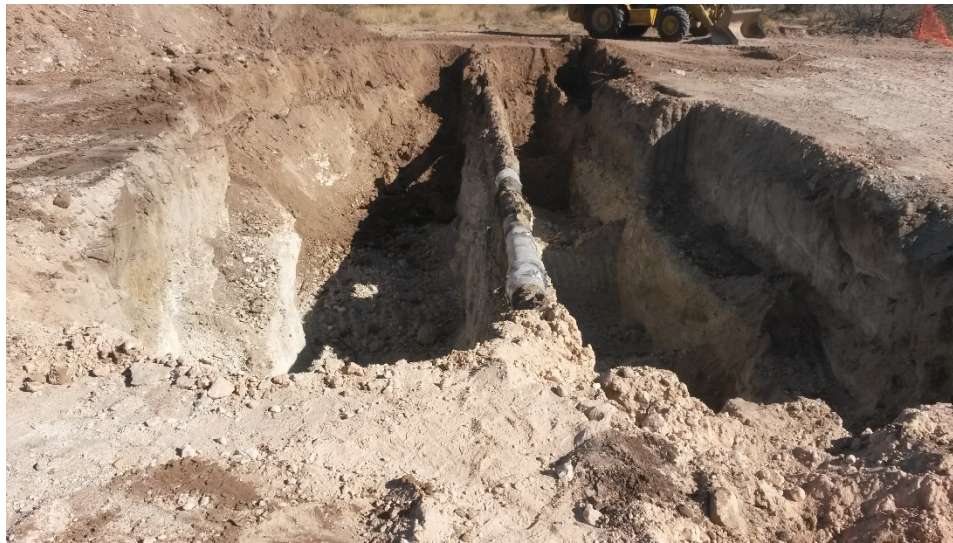
View Northeast – Area of NW and SE Side Walls

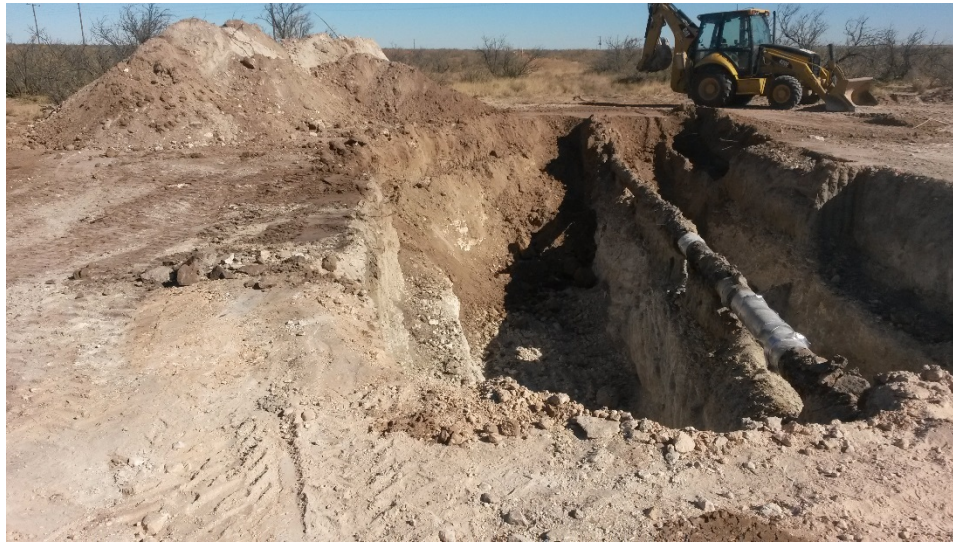
View Northeast – Area of NE Side Wall

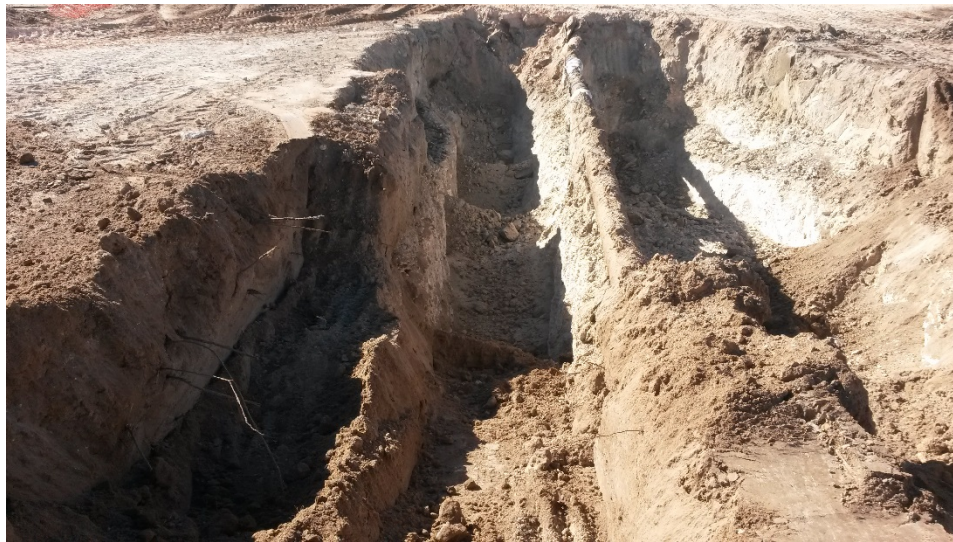
View Southwest – Area of NW and SE Side Walls

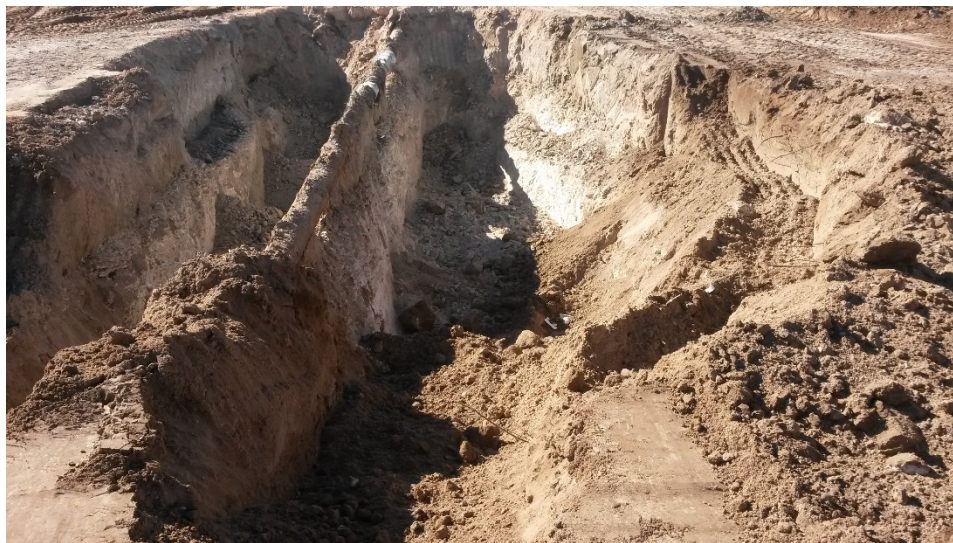
View Southwest – Area of SW Side Wall

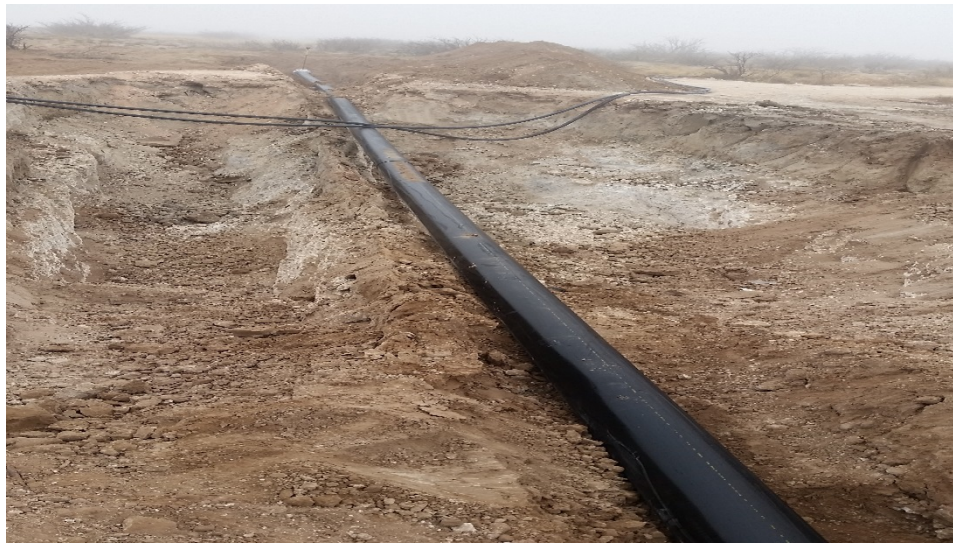
View Northeast – Replaced old line and backfill

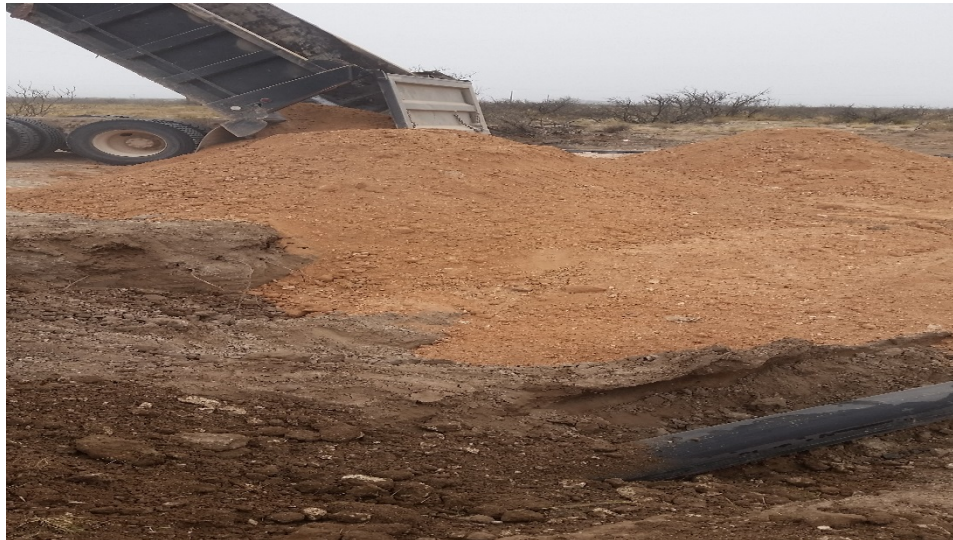
View Northwest – Backfill

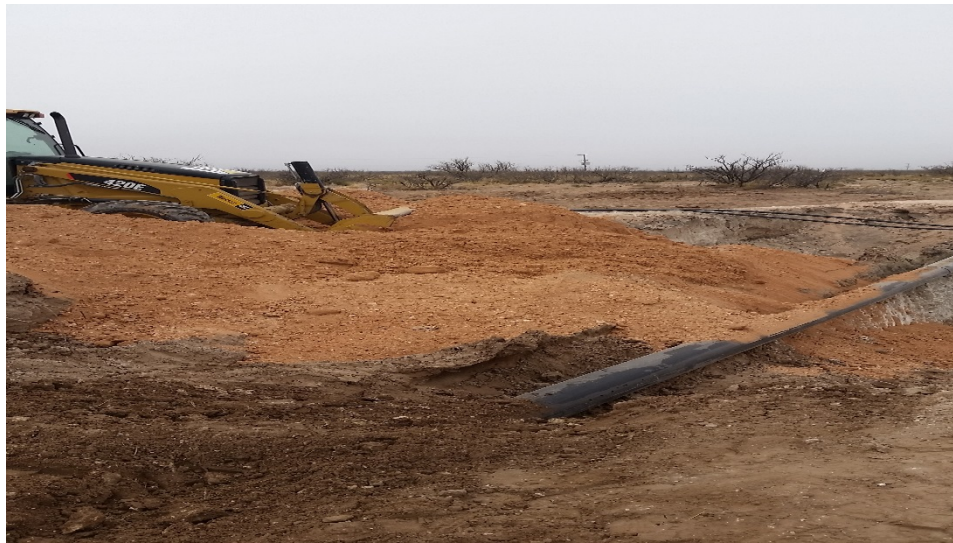
View North – Backfill

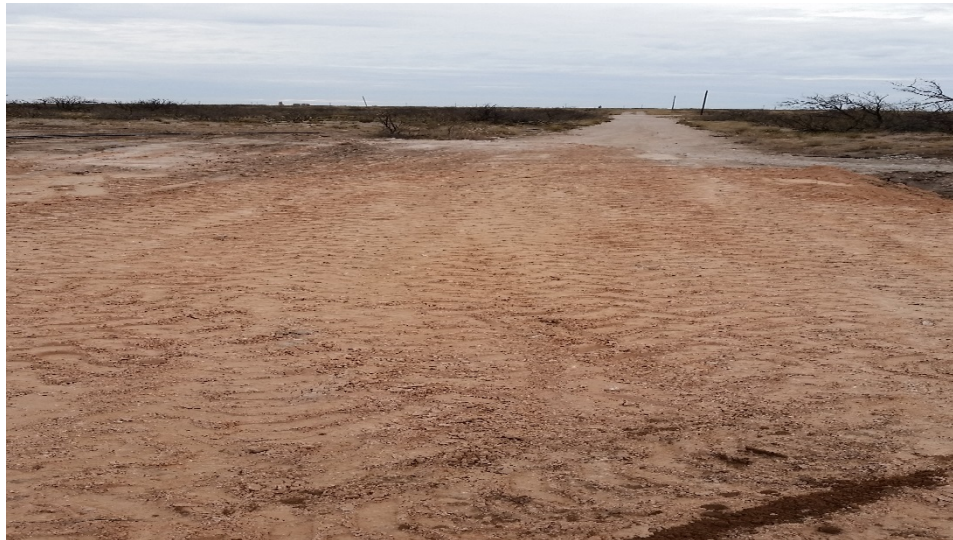
View West – Backfill
