## Release Notification and Corrective Action

OPERAT	TOR	⊠ Initi	al Report     Final Repo		
Name of Company: Devon Energy Production Co LP (6137)				Contact: Jeff Heath							
Address: PO Box 250 Artesia, NM 88211					,	Telephone N	No. 575-5	13-2274			
Facility Nar	me:	Ragin Caju	n 13 Fed	1H		Facility Typ	e: Well I	Location	7 (10)		
Surface Ow	ner: Fed	eral		Mineral (	Owner:	er: Federal API No. 30-025-41259					
				LOCA	ATION	OF REI	LEASE				
Unit Letter N	Section 13	Township 26S	Range 34E	Feet from the 330		South Line	Feet from the 1345	East/West Line West	County Lea		
			Latitud	le: 32.03698296	632102	Longit	ude: <u>103.42782</u>	<u>3760271</u>			
Type of Rele	ase· p	roduced Wate	71°	NAT	TURE	OF RELI		37.1	1.00111		
				. 70			Release: 20 bbl		Recovered: 20 bbls		
Source of Re		ater Treatmer	it Tank				our of Occurrence /15, 10:00 PM		Hour of Discovery 20/15, 10:00 PM		
Was Immedia	ate Notice		Yes 🗌	No Not Re	equired	If YES, To Whom?

Summary of Repairs on the West Tank Location:

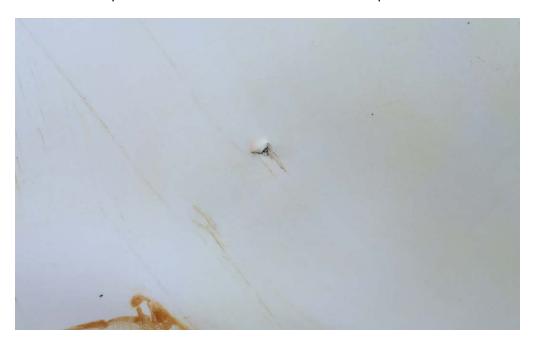
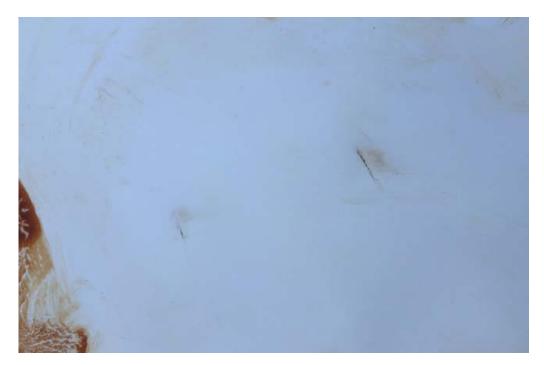
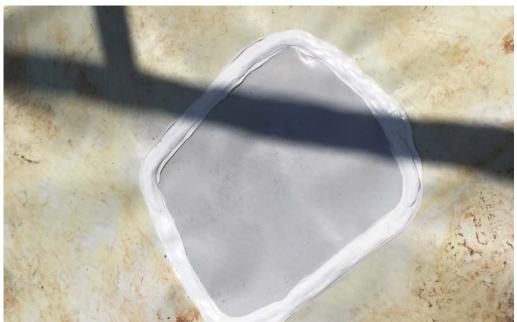
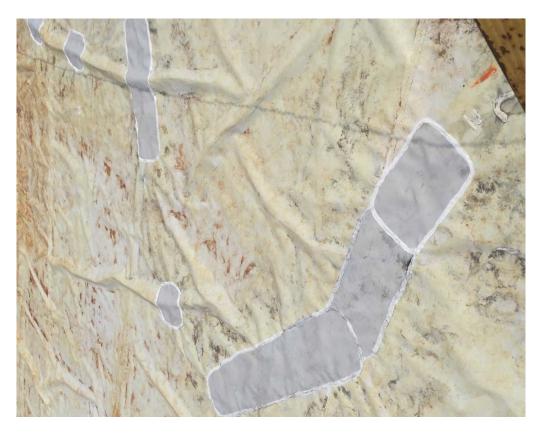
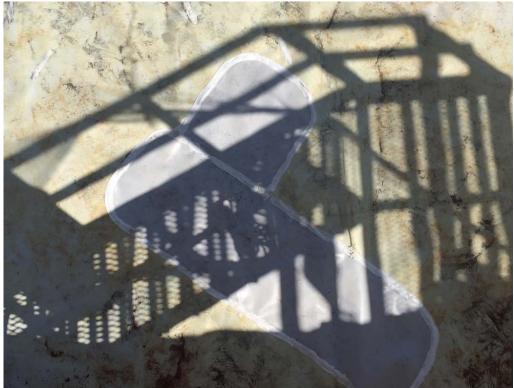
Between frac jobs we observed the west tank located on the Ragin Cajun Fed 13 1 H Pad developed a leak in the first and second liner inside the tank as produced water was exiting into the ground containment area outside the tank.

Once the tank was emptied we observed a couple small cuts in the liner due to the suction manifold shifting and causing the cuts. We repaired the two (2) areas and put the tank under hydro test for 24 hours. During the hydro test we noticed the tank continued to leak. We dropped the tank level down and scrubbed the entire area to make sure all possible areas the manifold could have reached was inspected.

Once the area was scrubbed we found and repair a total of seven cuts due to the manifold. The cuts were very small which were patch and then a larger patch was put over the entire area of the smaller patch to provide double protection over the repaired cut. The manifold is being properly installed above the liner to prevent this from reoccurring.
