Release Notification and Corrective Action

Name of Company Matador Production Company	Contact Catherine Green	
Address 500 N Main St Ste One	Telephone No. 575-623-6601	
Facility Name Chevron 12 Fed # 5	Facility Type Oil Well	
Surface Owner	Mineral Owner	API No. 30-025-30682

Chevron 12 Fed #5 Final Report

Dec. 7, 2015

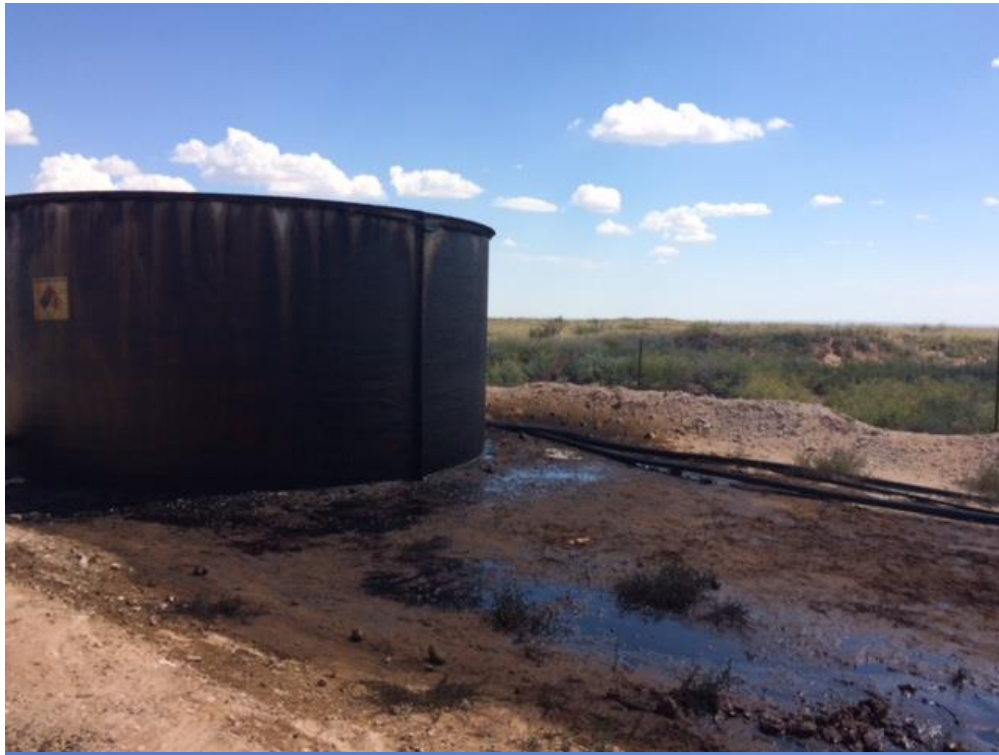
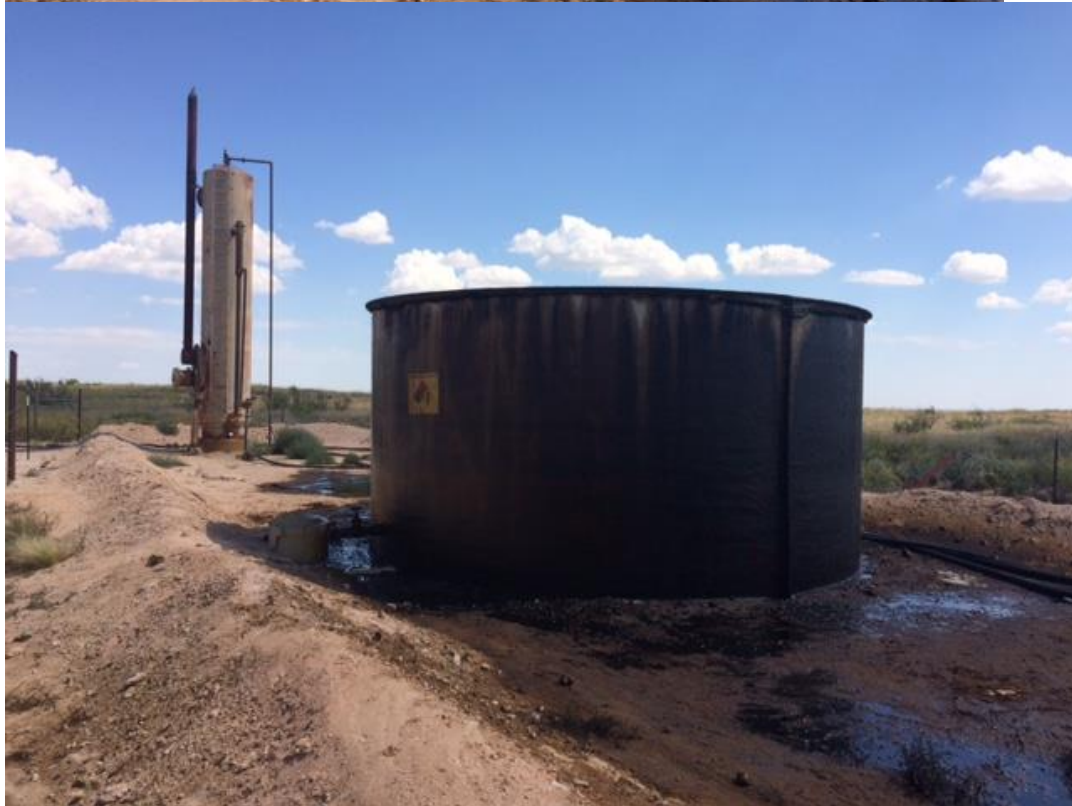
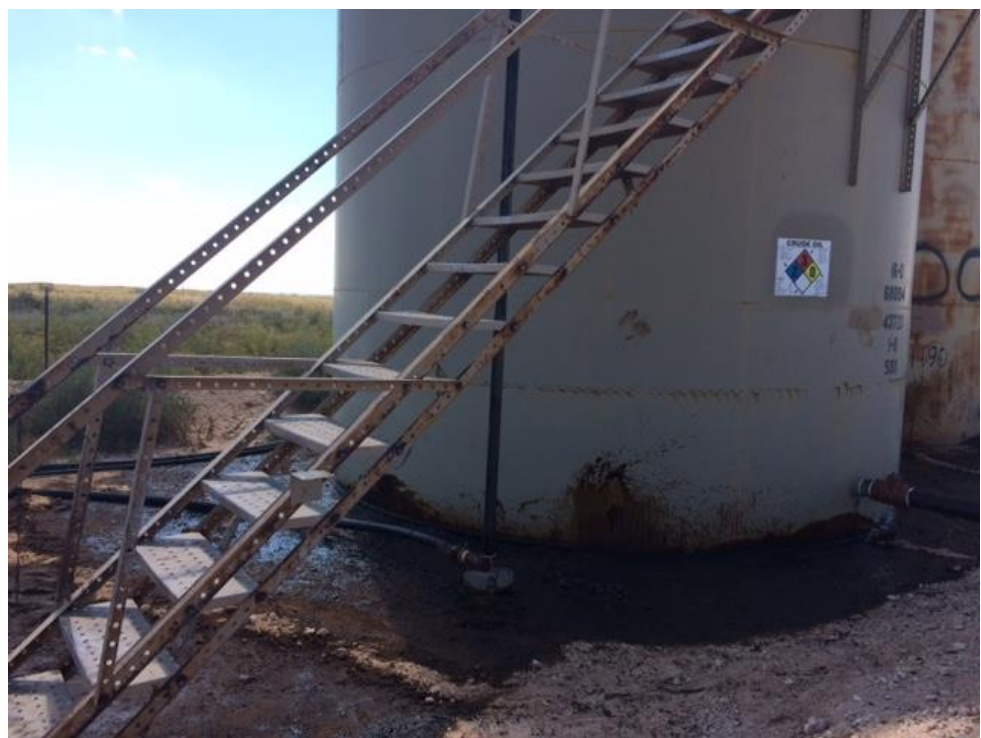
Matador Resources Production Foreman encountered a broken coupling on a transfer pump on Sept. 16, 2015 at 10:00am. It was estimated that 35 barrels of fluid had spilled into the earthen dike. See attached photos. The foreman turned the well off, telephoned to report the spill, telephoned for a vacuum truck to vacuum up as much fluid as possible, and ordered a new pump. 25 barrels of fluid were recovered.

Pictures of spill, September 16, 2015

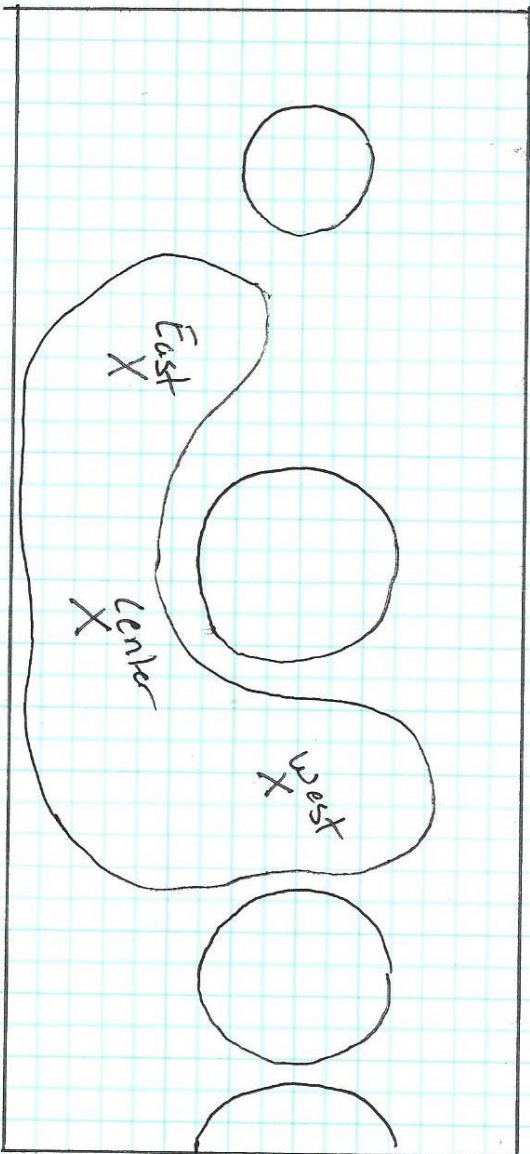
Diamondback Location Plat

Diamondback Disposal Service collected soil samples at the indicated locations. See attached location plat diagram. Soil samples were sent to Cardinal Labs. Original soil samples from the surface indicated benzene, toluene, and total BTEX to be above reporting limits. Contaminated soil was removed from the spill area and taken to R360 environmental. A second set of soil samples were collected at a depth of 18 inches below surface. Cardinal Labs analyzed them. See attached. Results are below reporting limits. Clean soil was brought in, and the location was returned to normal operations.

Approx 18 in deep
