Re: East half Clean-up on Sunray State Tank Battery spill, API # 30-005-21036
1980' FNL and 1650' FWL of Section 16, T-8-S, R-31-E, Chaves County, New Mexico

East half clean-up plan
Sunray State Tank Battery
API# 30-005-21036
Page 2

Sampling Map
Sunray-State Tank Battery
Sec-16, T-8S, R-31E
Chaves, NM

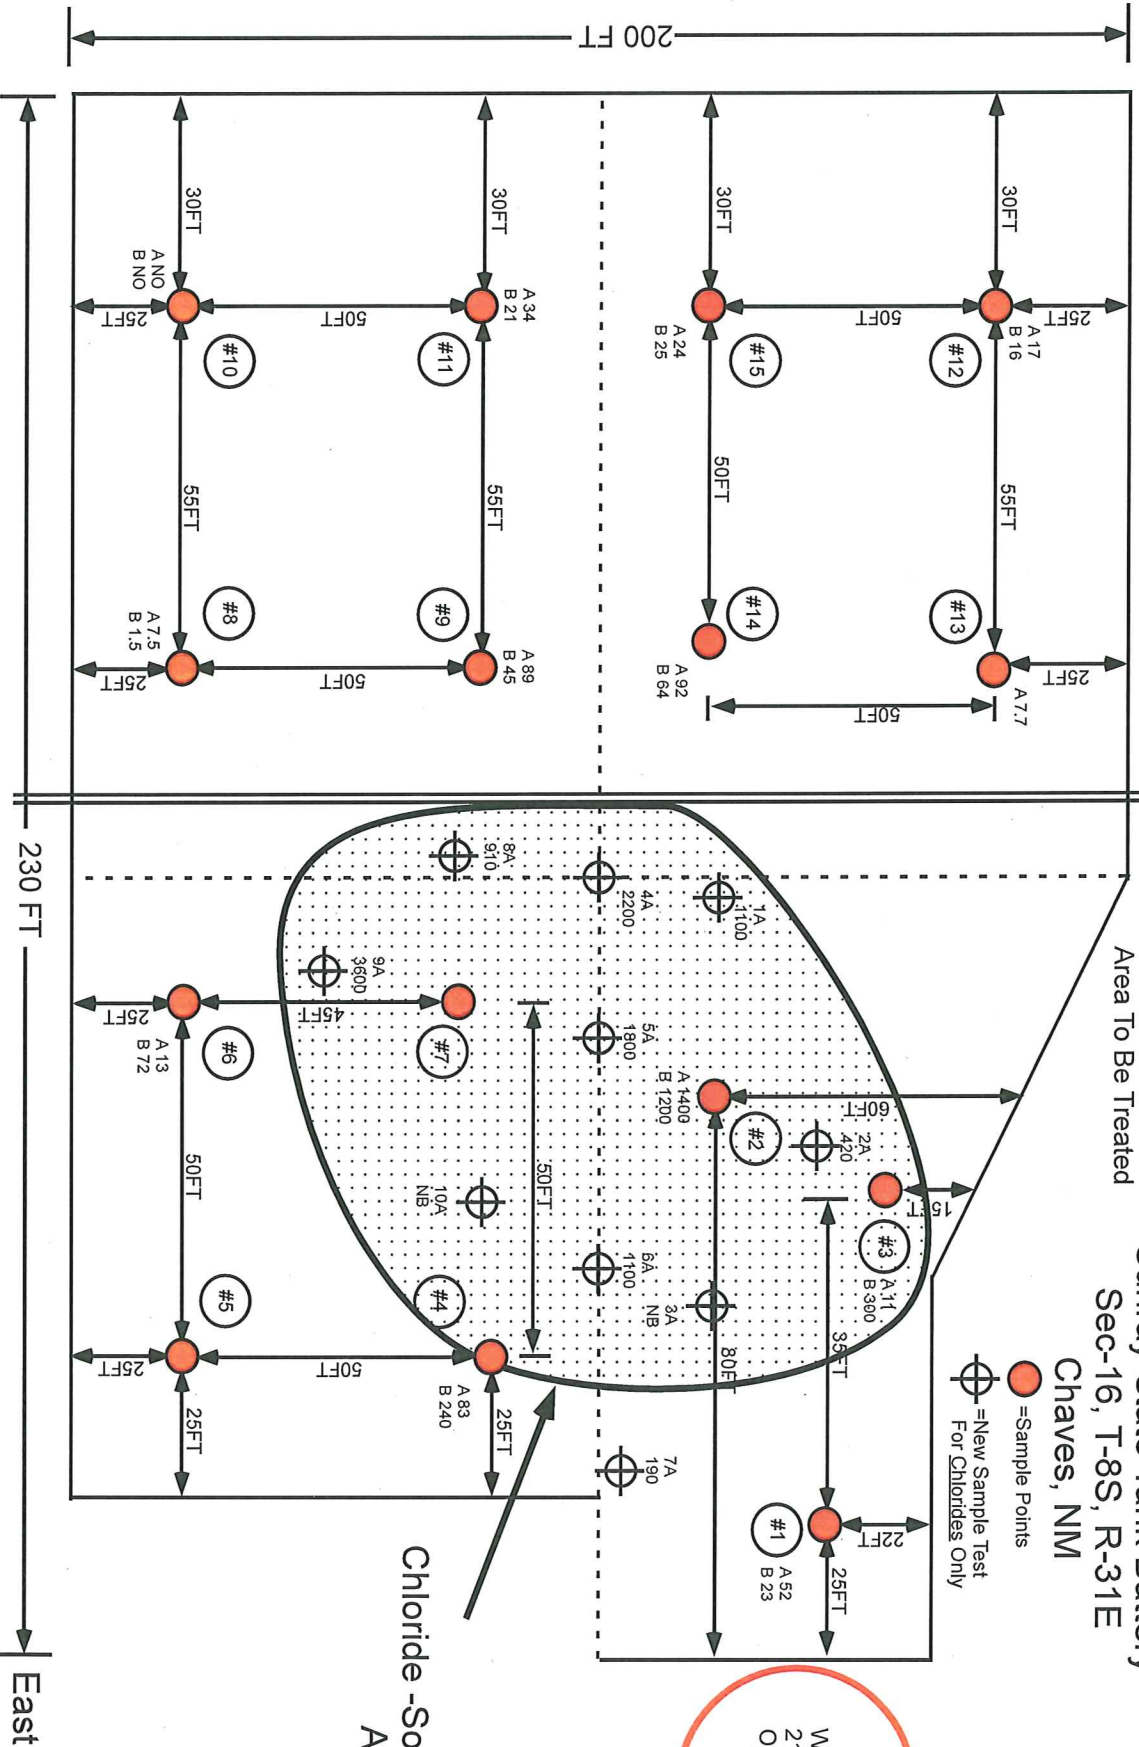
Cross Border Resources, Inc. ("Cross Border") has delineated the elevated chloride levels on the East half of the spill area (see attachment #1). Cross Border now proposes to complete the east half (see attachment #1) of Sunray State site by removing the top six to twelve inches of asphaltene hardpan that exists on the east half of the Sunray site. In order to remove the asphaltene hardpan, the water tank will have to be moved to a new location between the oil tanks and the heater treater inside the original tank battery. The flow line will also have to be moved so that the hardpan can be removed and staged on the original caliche location prior to be loaded onto dump trucks. It is imperative that the asphaltene hardpan be removed from underneath the water tank. The material will then be taken to the Gandy Marley Inc. Land Farm located in Roswell New Mexico. Once the hardpan is removed, it is planned to re-sample the east side of Sunray State site for chlorides and hydrocarbons utilizing Hall Environmental as the testing laboratory. It is Cross Border intent to delineate the chloride exposure in a vertical sense of the east side of the spill area. Hydrocarbons will be delineated in the vertical section if the re-sampling suggests there is an issue with TPH in excess of 5000 ppm. Cross Border understands that the horizontal extent has been identified, but vertical delineation value of 250ppm chlorides has to be determined before any remediation work can be started.

Cross Border intends to vertically delineate the Chlorides only in the chloride-soil remediation area (attachment #1). Depending on hydrocarbon levels after the asphaltene hardpan is removed, Microblaze will be utilized in a 3% solution with fresh water and tilled into the soil. Initial estimates suggest the site contains between 500 and 750 cubic yards of soil requiring remediation. This will require 75 gallons of Microblaze and 60 bbls of fresh water. Cross Border has a farming tractor on site. Cross Border plans to apply the Microblaze and till the soil with our own equipment. Surface remediation of the chlorides will be brought down to 1000 ppm or less.

1. Chloride delineation has not occurred. At this time there are several sample points that are above the delineation value of 250 ppm.
2. Provide a sampling plan to indicate how often the areas applied with Microblaze will be sampled or inspected.
3. Ensure SLO approval/concurrence.
