**Release Notification and Corrective Action**

Name of Company: Jay Management Company	Contact: Jim Foster
Address: 2425 W Loop South, Ste. 810, Houston, Texas 77027	Telephone No.: 979-324-2139
Facility Name: Dolly No. 1	Facility Type: Tank Battery

1RP-4705

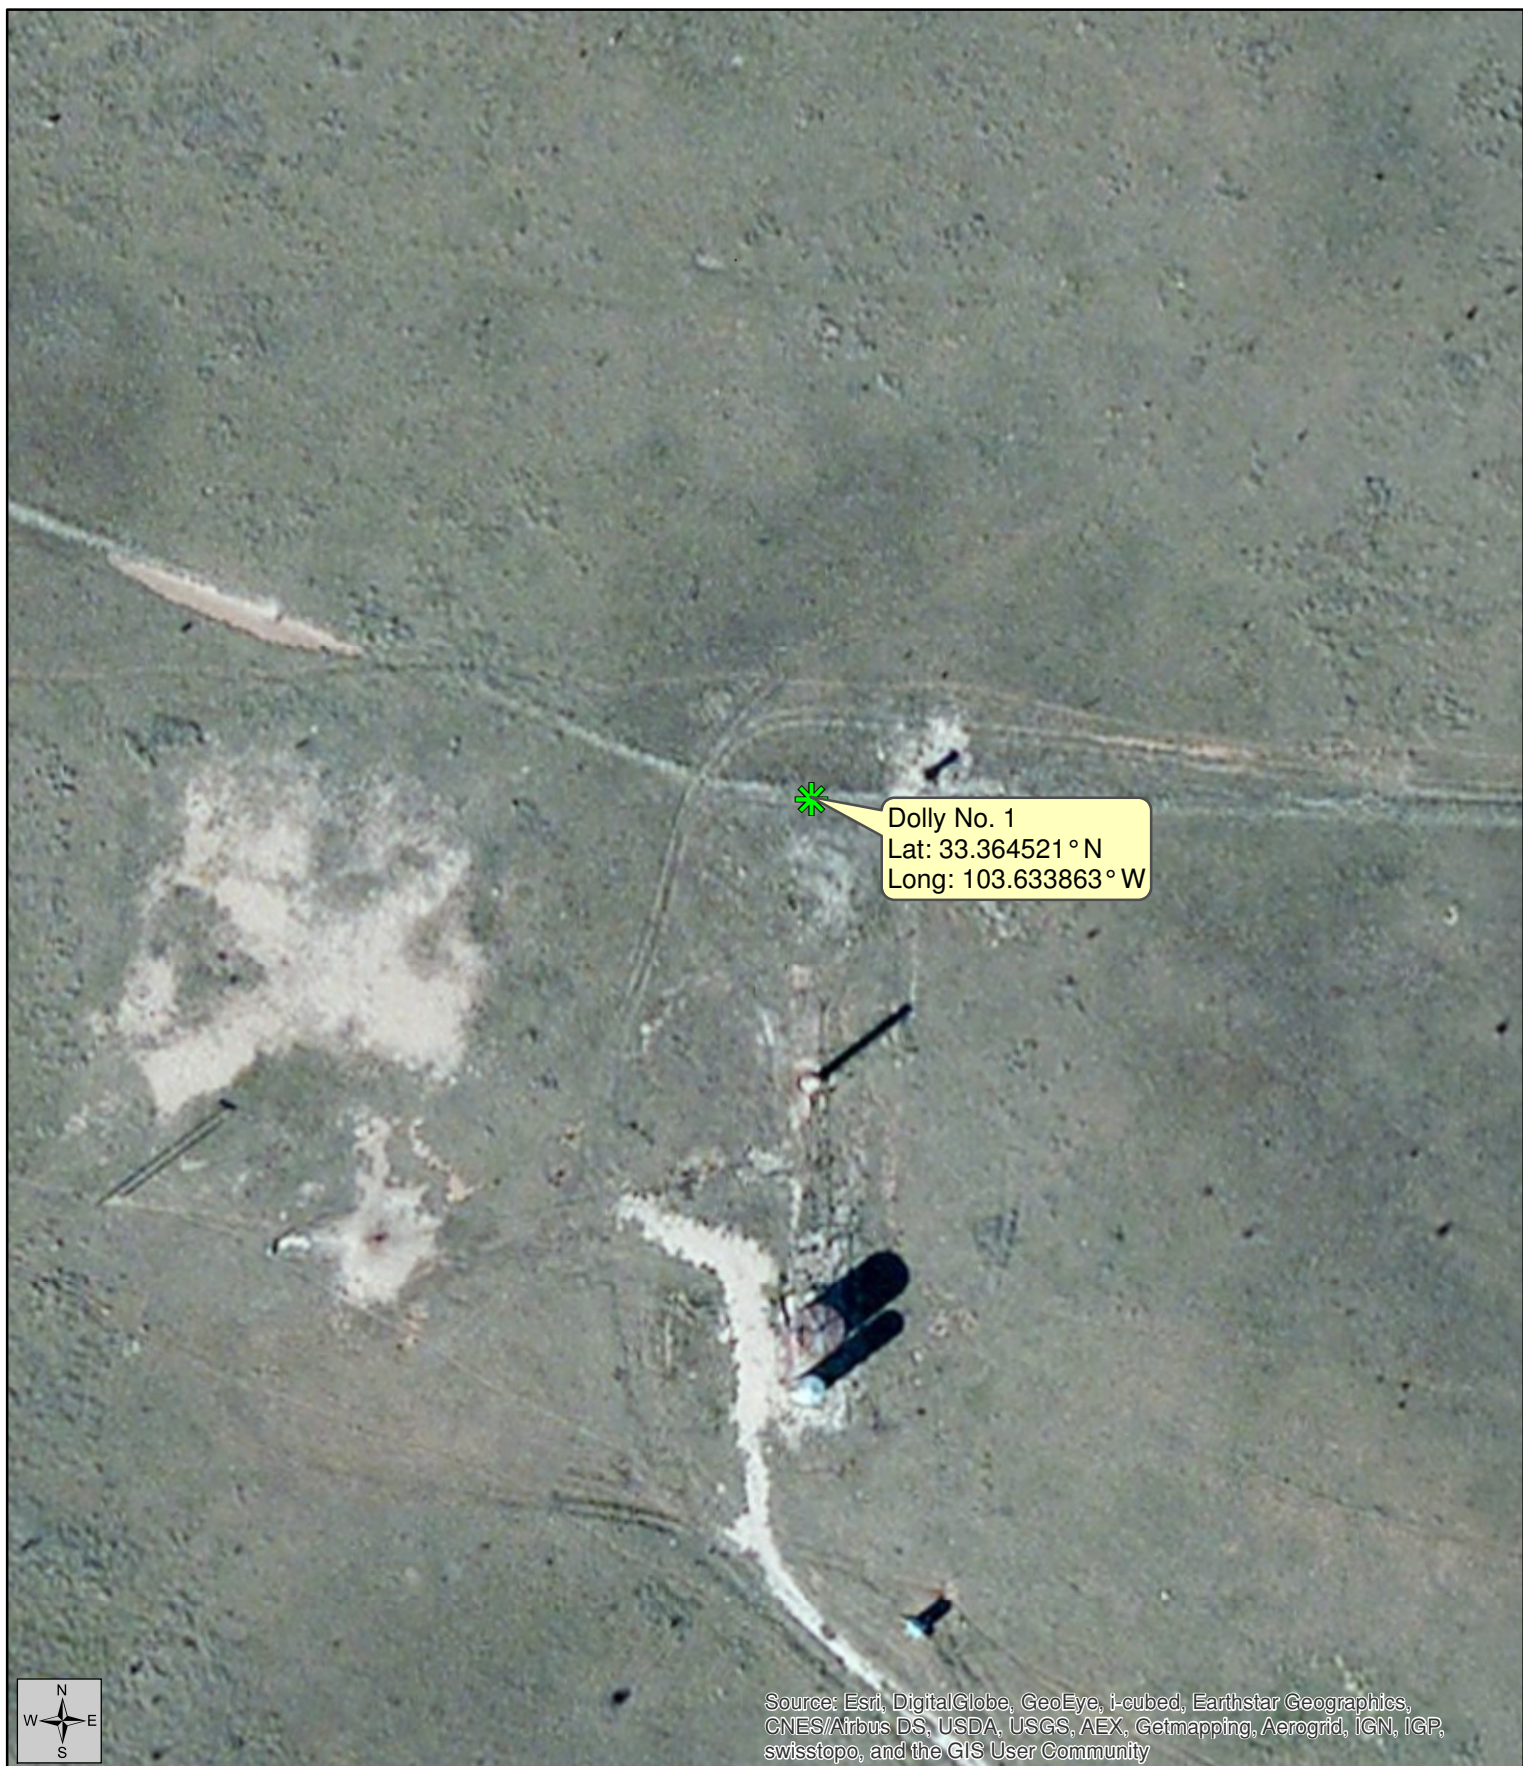
**Figure 3**  
 Spill Location Map

Type of Release: Produced Water	Volume of Release: 30-50 bbls	Volume Recovered: Recovery In Progress
Source of Release: Dolly No. 1 produced water flowline, at the junction of the trunkline.	Date and Hour of Occurrence: 05/19/17, exact time unknown	Date and Hour of Discovery: 05/19/17, 10:00 am
Was Immediate Notice Given? X Yes No <input type="checkbox"/> Not Required	If YES, To Whom? Olivia Yu, NMOCD Environmental Specialist	
By Whom? Mr. Amir Sanker, Operations Manager	Date and Hour: 5/19/17 at 3:00 pm CST	
Was a Watercourse Reached? <input type="checkbox"/> Yes <input checked="" type="checkbox"/> No	If YES, Volume Impacting the Watercourse.

Vandalism suspected at the connection of the oil flowline and trunkline. This section of pipeline has been repaired.

Release occurred approximately 120 feet north of the heater treater. Remediation efforts began immediately upon discovery of the release; approximately 30 bbls of produced water was recovered by vacuum.

Impacted soils will be excavated and replaced with clean soil.
