Re: Work Plan for Site Characterization  
Enfield No. 1 Facility Storage Tank Release  
Bagley North Oil Field, Lea County, New Mexico  
NE1/4 NE1/4, Sec. 16, T11S, R33E

**Photographic Documentation**  
**Enfield No. 1 Release**  
**Jay Management Company, Lea County, New Mexico**

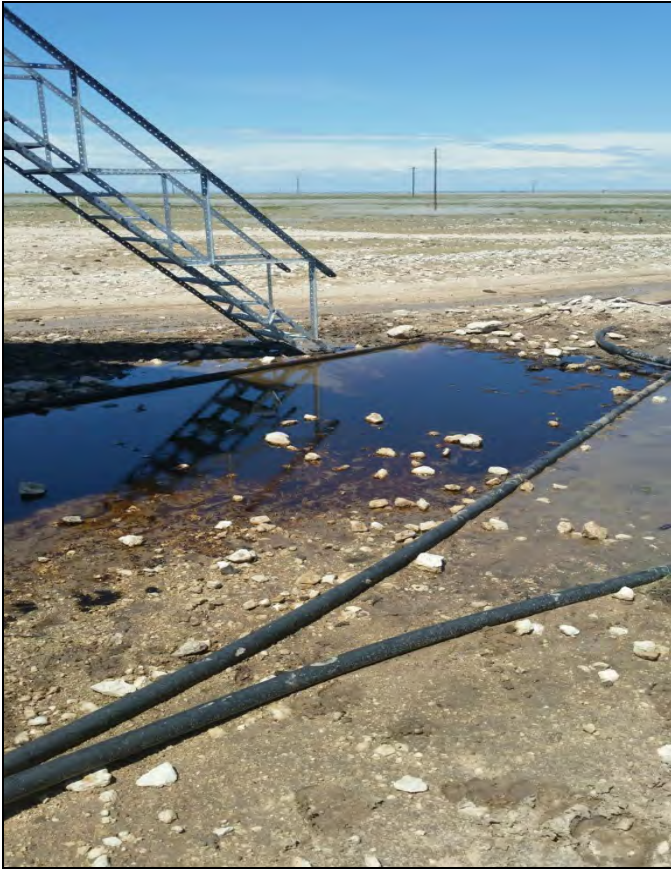
**Photograph 1** - A view looking at the released fluids within tank battery secondary containment.

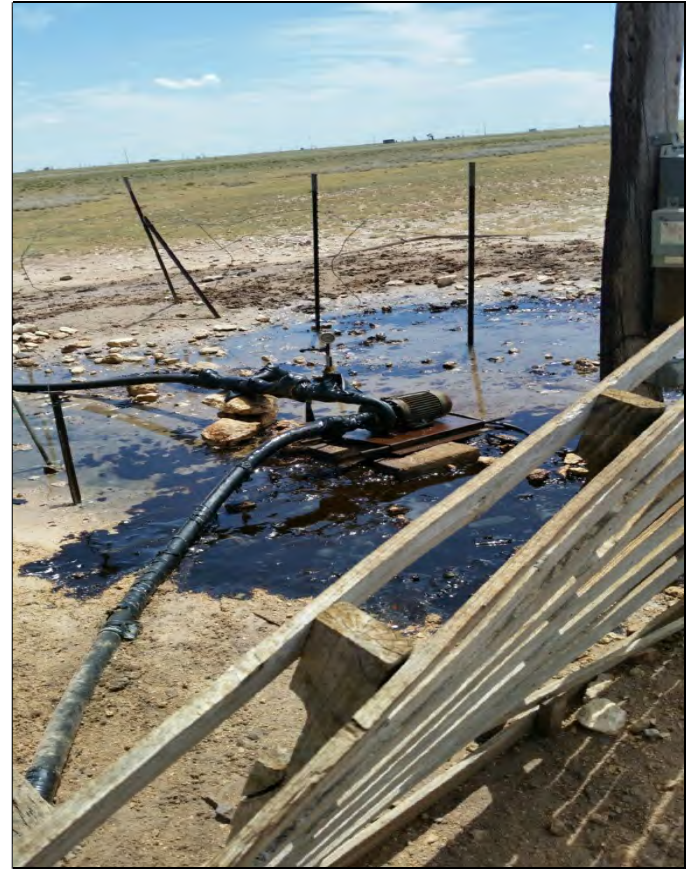
**Photograph 2** - A second view looking at the released fluids within tank battery secondary containment.

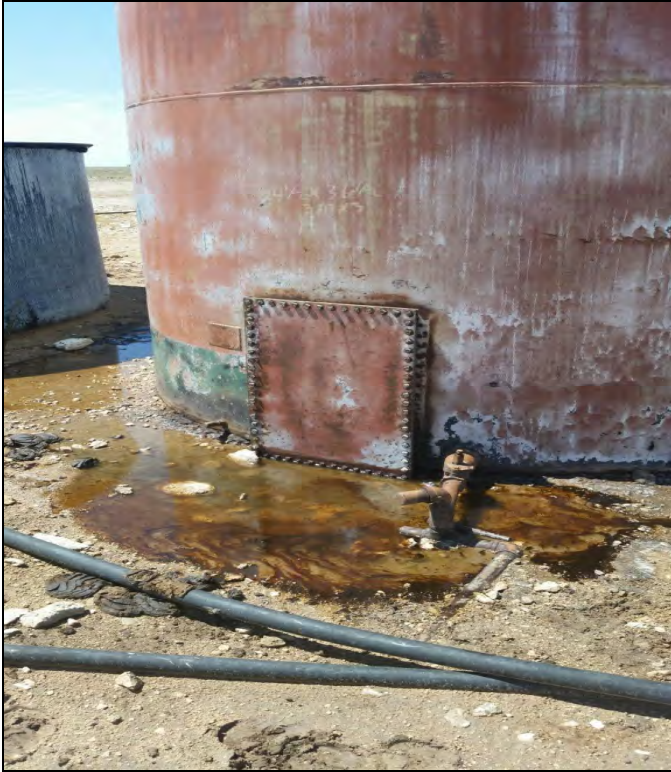
**Photograph 3** - A third view looking at the released fluids within tank battery secondary containment.

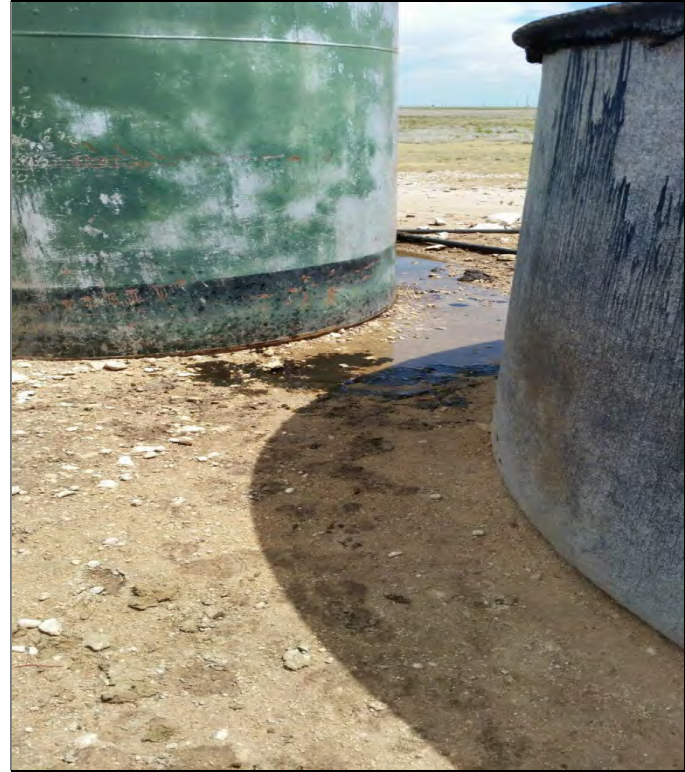
**Photograph 4** - A fourth view looking at the released fluids within tank battery secondary containment.
