**1RP-4721**

**DELINEATION PLAN**

**EMSU Well #410 Produced Water Spill**

LAI Project No. 17-0182-01

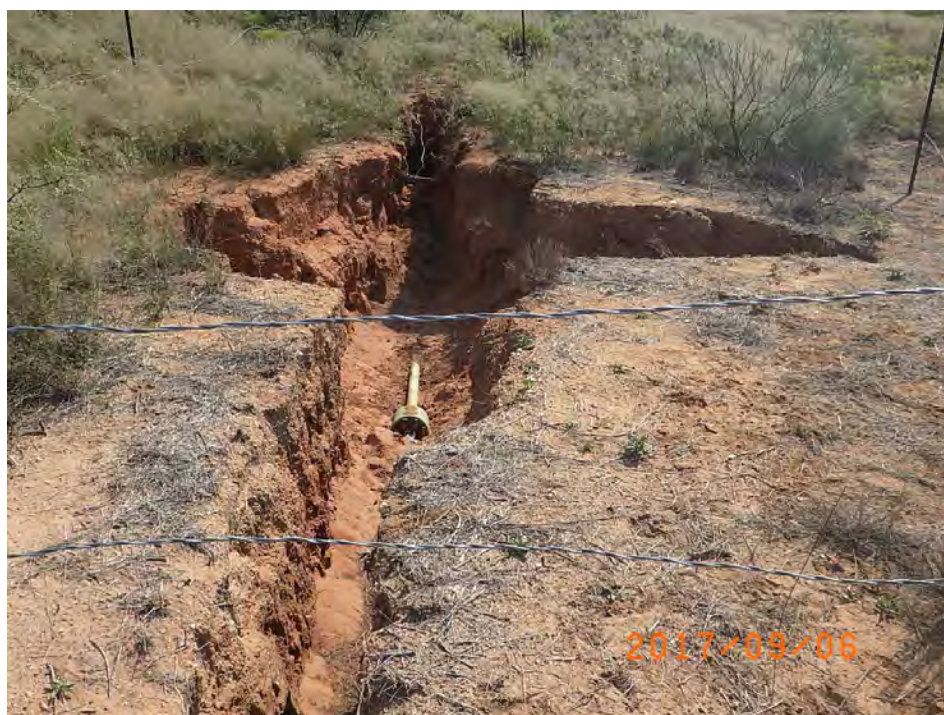
Excavation Prior to Remediation Viewing East

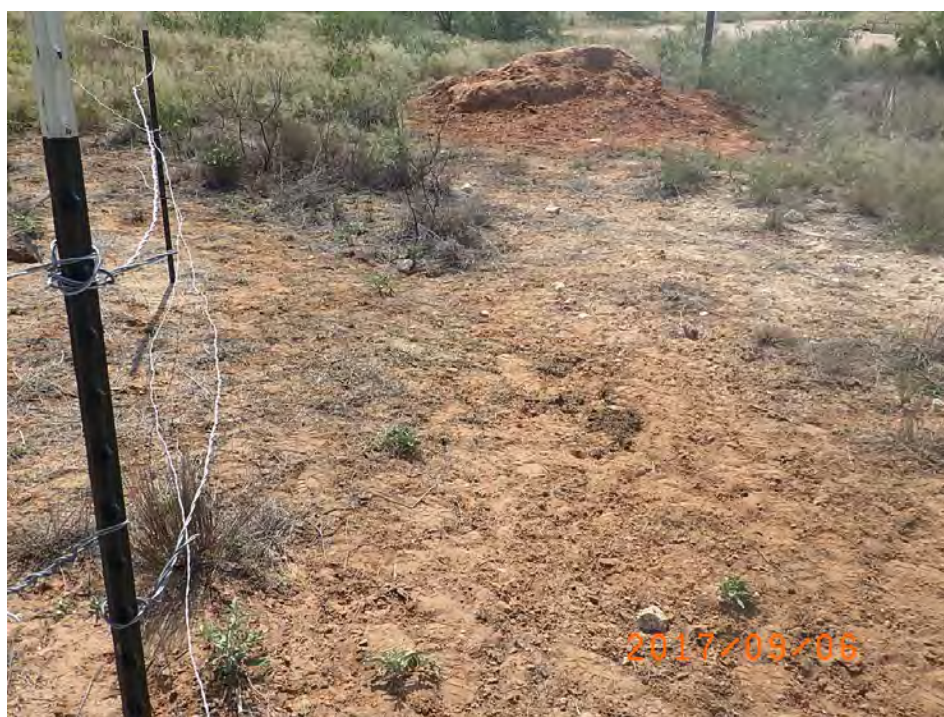
Excavated Soil Viewing East

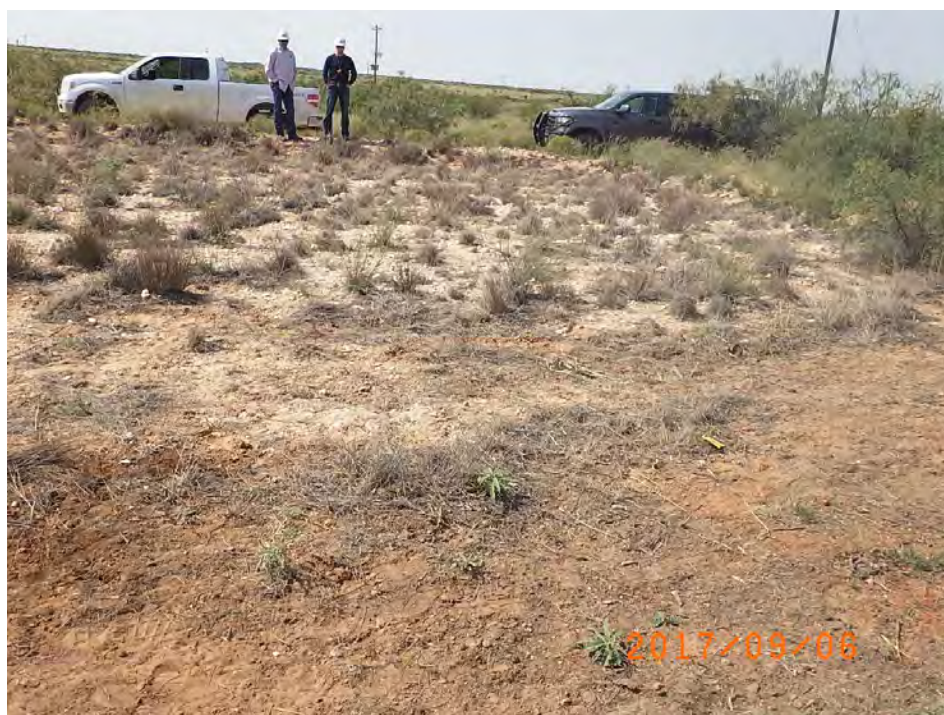
Site Prior to Remediation Viewing South

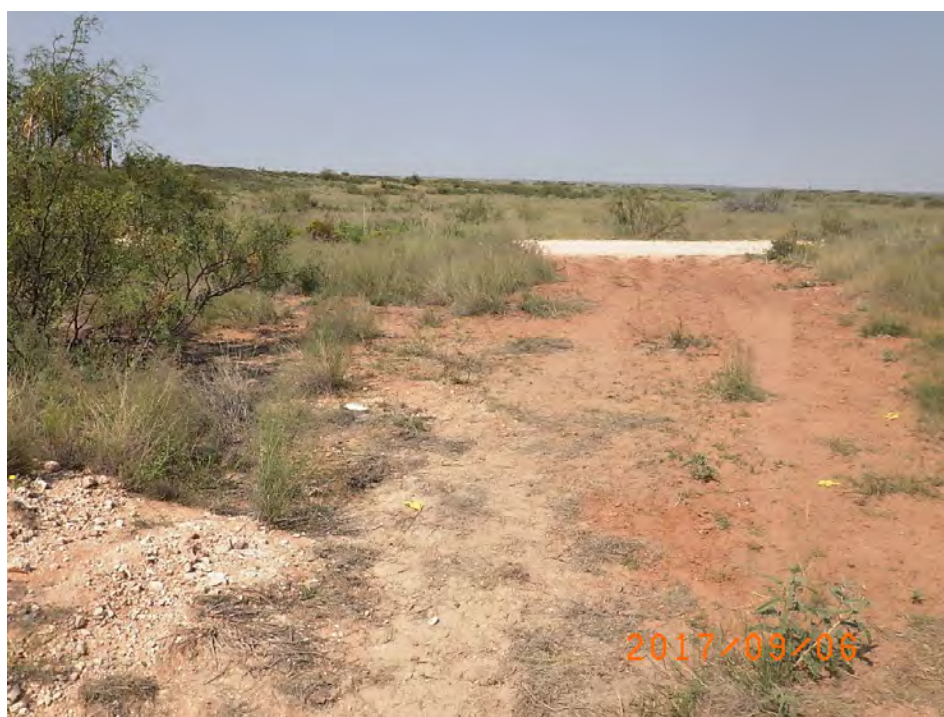
Site Prior to Remediation Viewing West

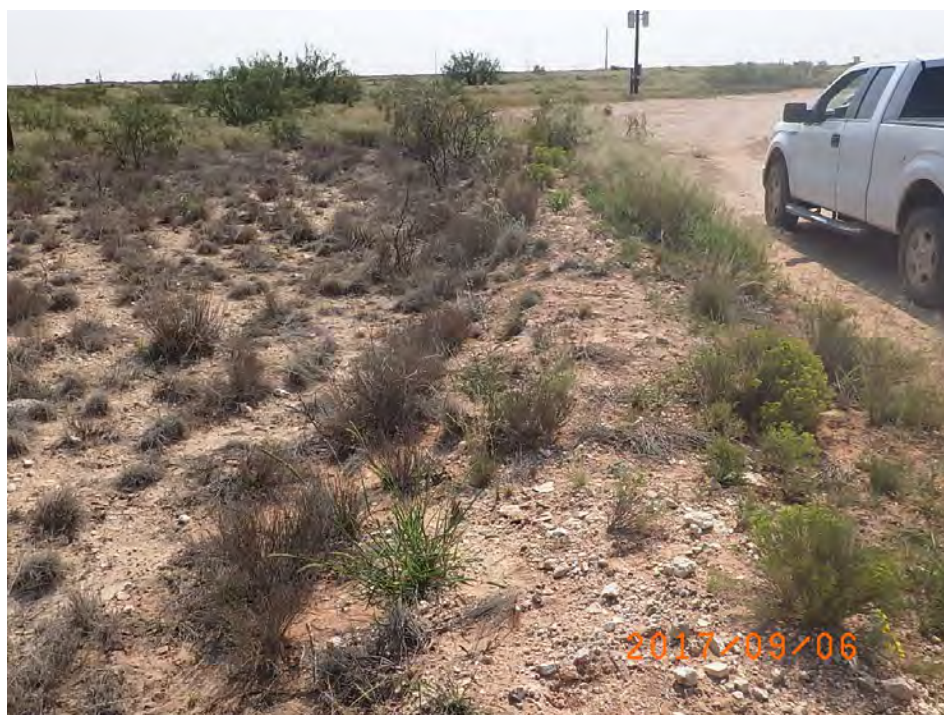
Site Prior to Remediation Viewing East

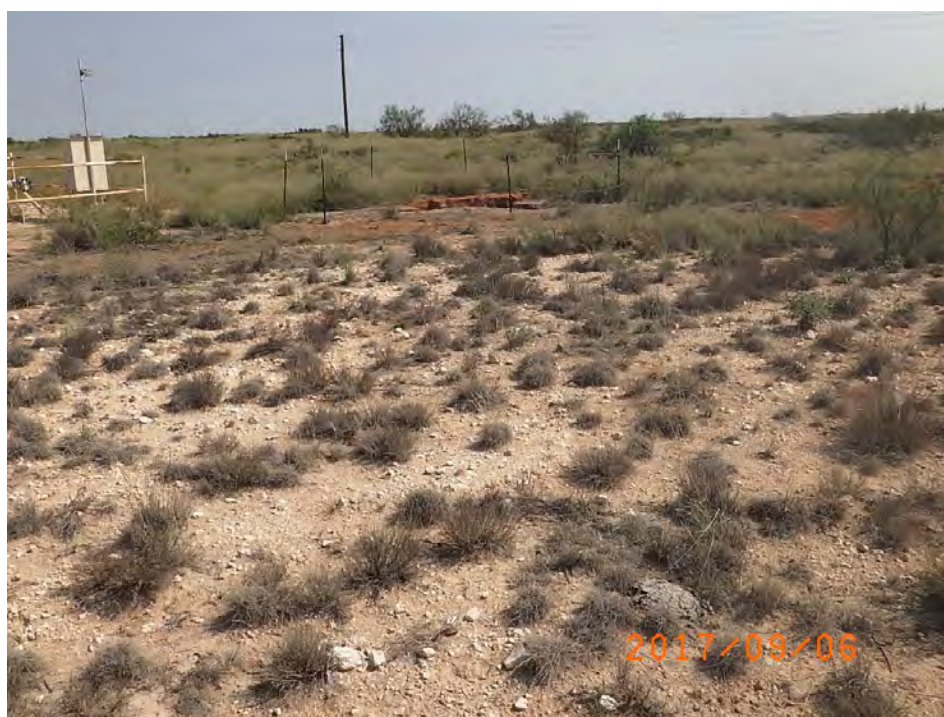
Site Prior to Remediation Viewing North
