**1RP-4818
DELINEATION PLAN
SALADO DRAW RWCS 1RC-11
PRODUCED WATER SPILL
Lea County, New Mexico**

LAI Project No. 17-0186-01

September 27, 2017

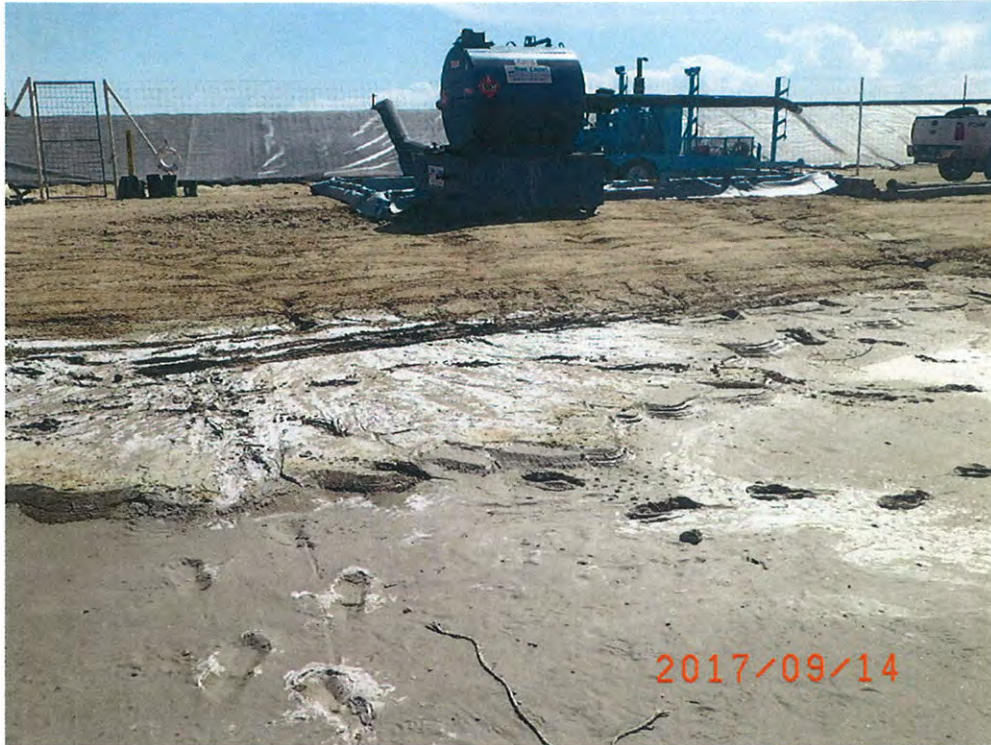
The spill occurred on September 13, 2017. The spill was caused by a leak in a hose on the recirculation system. This leak released approximately 1,105 barrels of treated produced water. The source of the flow was isolated and approximately 500 barrels of treated produced water was recovered by vacuum truck. The spill occurred between the North and South treated water pits. The spill flowed from the north side of the South pit to the low area between the South pit and the North pit. The spill then flowed east and west for a distance of about 600 feet and covered an area approximately 20,711 square feet or about 0.47 acres. On September 13, 2017, Chevron verbally notified the New Mexico Oil Conservation Division (OCD) District 1 and the Bureau of Land Management, as surface and mineral owner. The OCD assigned the spill remediation permit number 1RP-4818. Attachment A presents the initial C-141. Attachment B presents photographs.

Source of Spill Viewing South

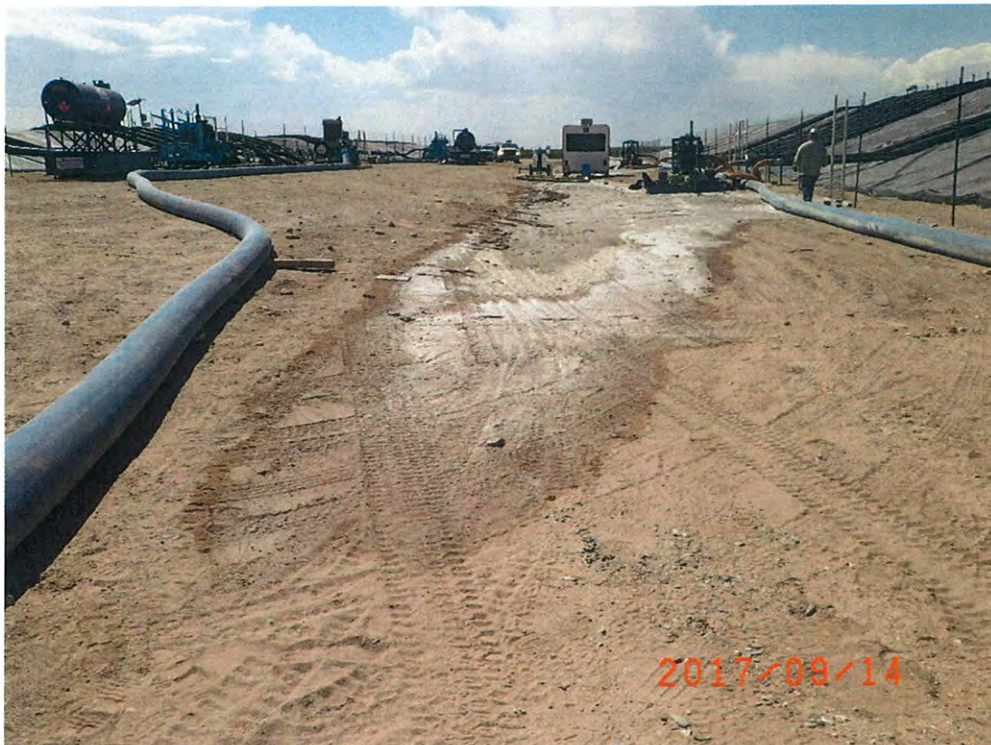
East End of Spill Viewing West

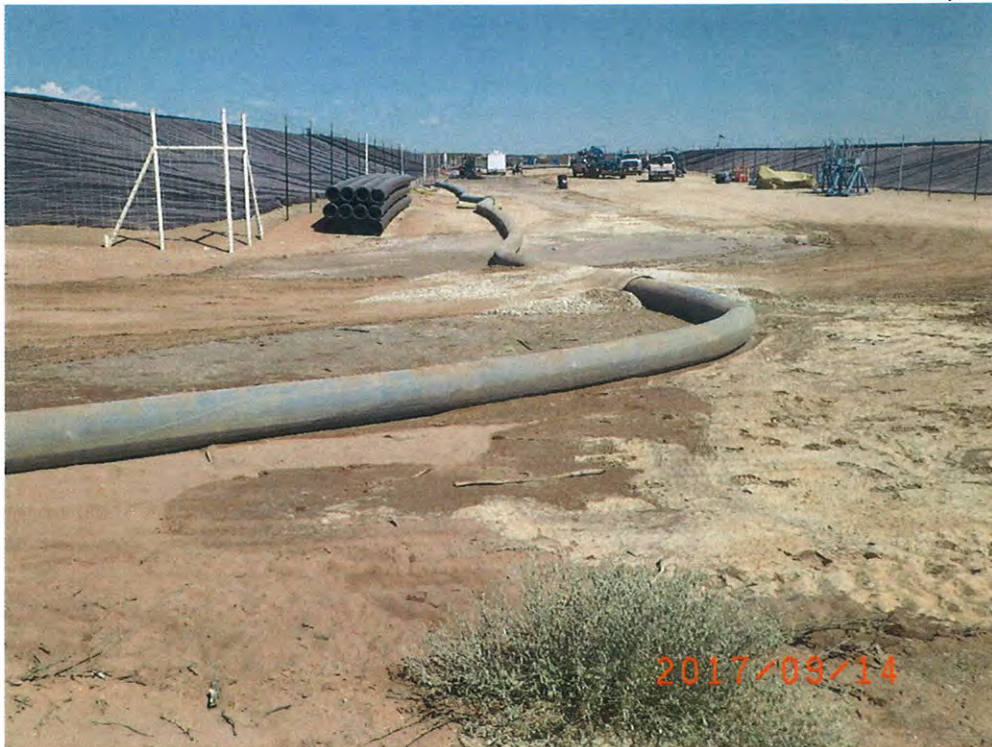
West End of Spill Viewing East

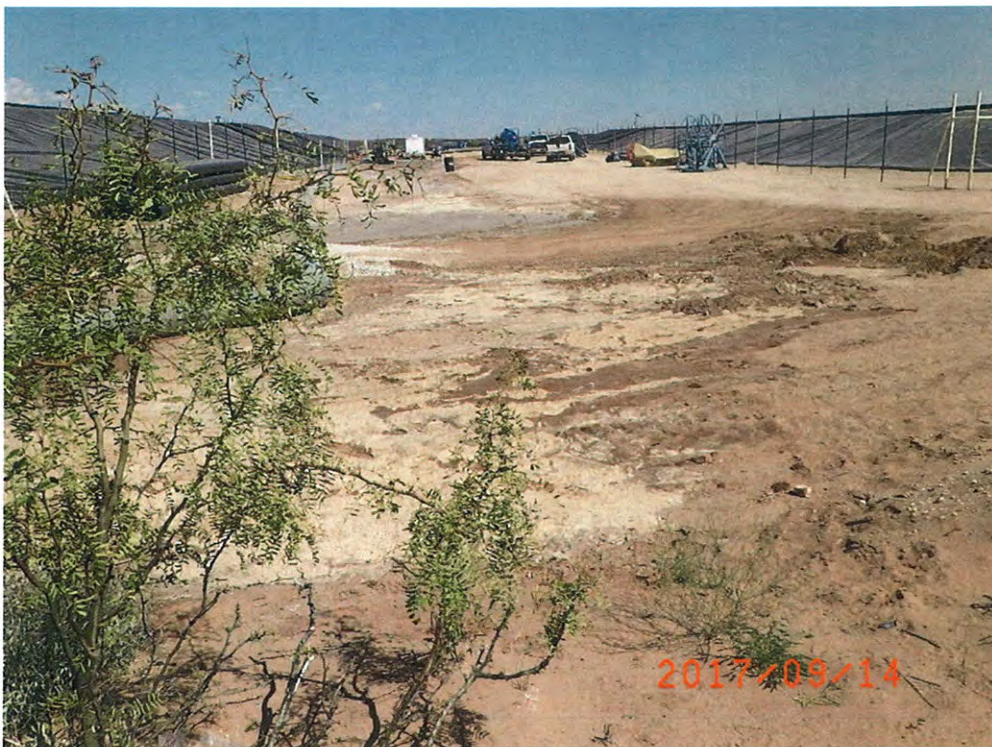
West End of Spill Viewing East
