1RP-4654 **DELINEATION PLAN** Lea Unit Central Battery **Crude Oil Spill** Lea County, New Mexico

LAI Project No. 17-0175-33

January 8, 2018

1RP-4654 Delineation Plan Lea Unit Central Battery Crude Oil Spill January 8, 2018

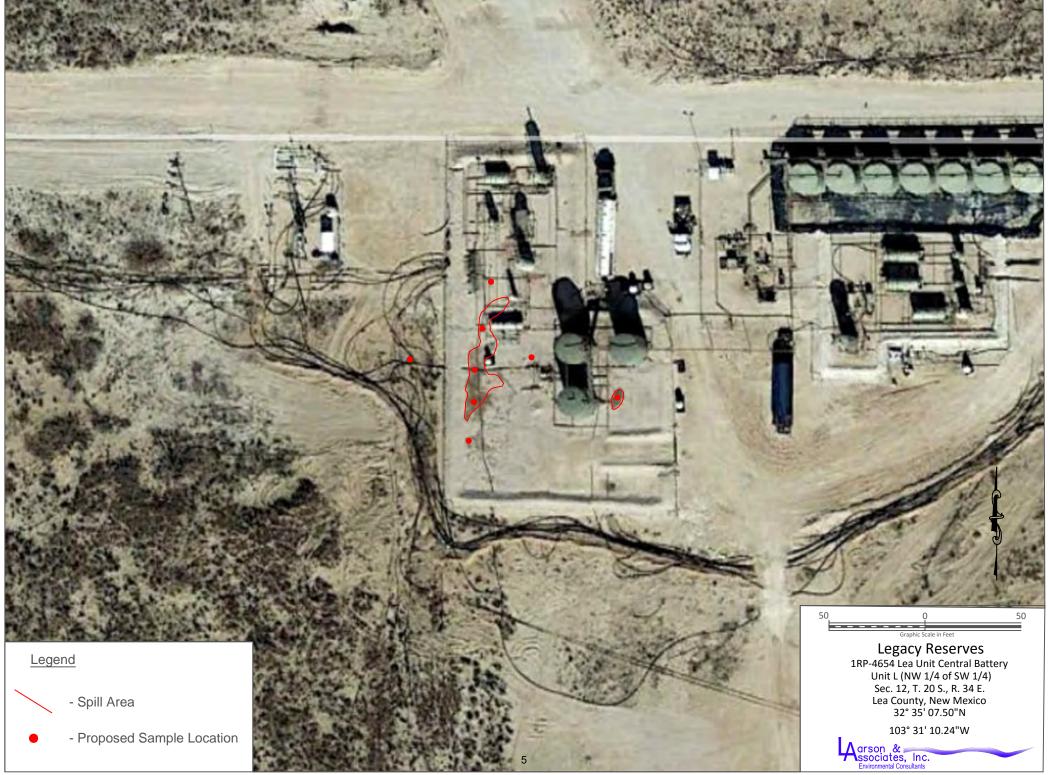
Figure 2 - Aerial Map

LAI proposes to collect soil samples at four (4) locations within the containment. The samples will be collected at 1 foot intervals to approximately 4 feet bgs and 2 foot intervals to approximately 12 feet bgs using direct push technology (DPT) depending on subsurface conditions. Additional samples will be collected in each cardinal direction (north, south, east and west) of the spill area at the same depth intervals for horizontal delineation. The soil samples will be delivered under chain of custody and preservation to Permian Basin Environmental Lab (PBEL) in Midland, Texas. The upper samples (1.e., 0 to 1 foot) will be analyzed for benzene, toluene, ethylbenzene and xylenes (BTEX), total potential hydrocarbons (TPH), including gasoline range organics (GRO), diesel range organics (DRO) and oil range organics (ORO) by EPA SW0846 Methods 8021B, 8015M, with additional samples analyzed as needed for delineation. All samples will be analyzed for chloride by EPA Method 300. Pending laboratory results, further delineation may be required to reach cleanup level standards. Figure 3 presents a site map showing proposed soil sample locations.

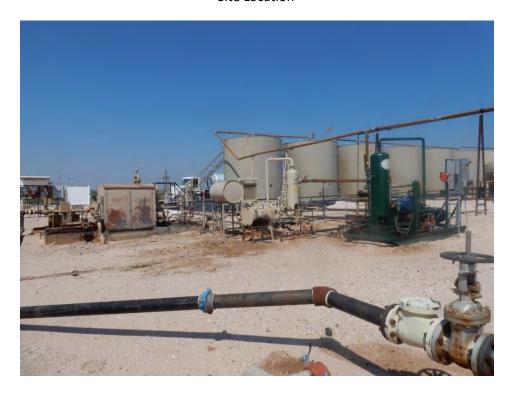
Site Prior to Remediation Viewing Northeast, September 8, 2017

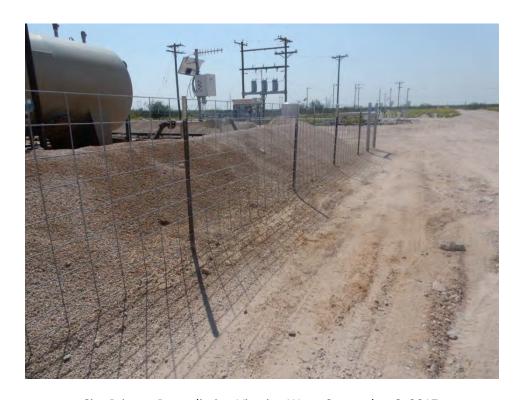
Site Prior to Remediation Viewing West, September 8, 2017

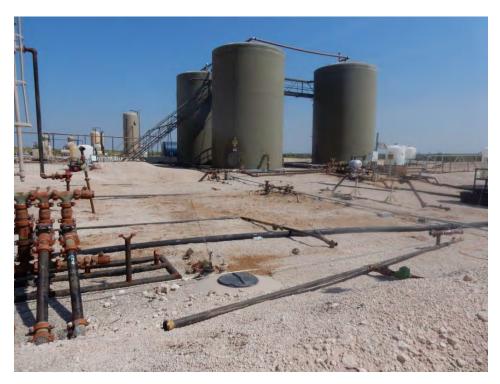
Site Prior to Remediation Viewing Southeast, September 8, 2017

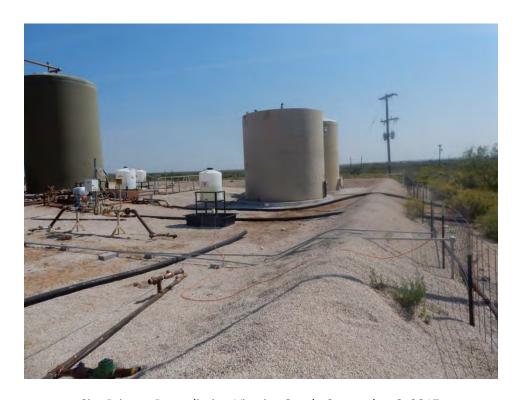
Site Prior to Remediation Viewing South, September 8, 2017

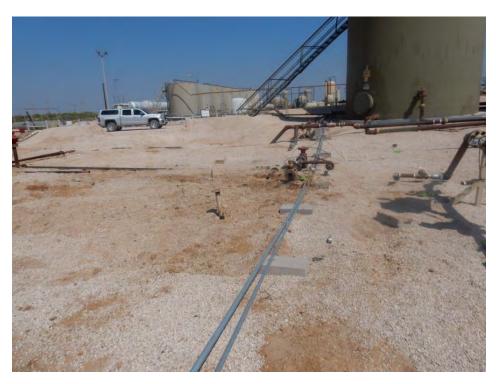
Site Prior to Remediation Viewing East, September 8, 2017
