July 26, 2017

Re: Proposed Closure Strategy – West Boiler Sump
Energy Transfer Company's Jal #3 Gas Plant
Section 33, Township 24 South, Range 37 East
Lea County, New Mexico

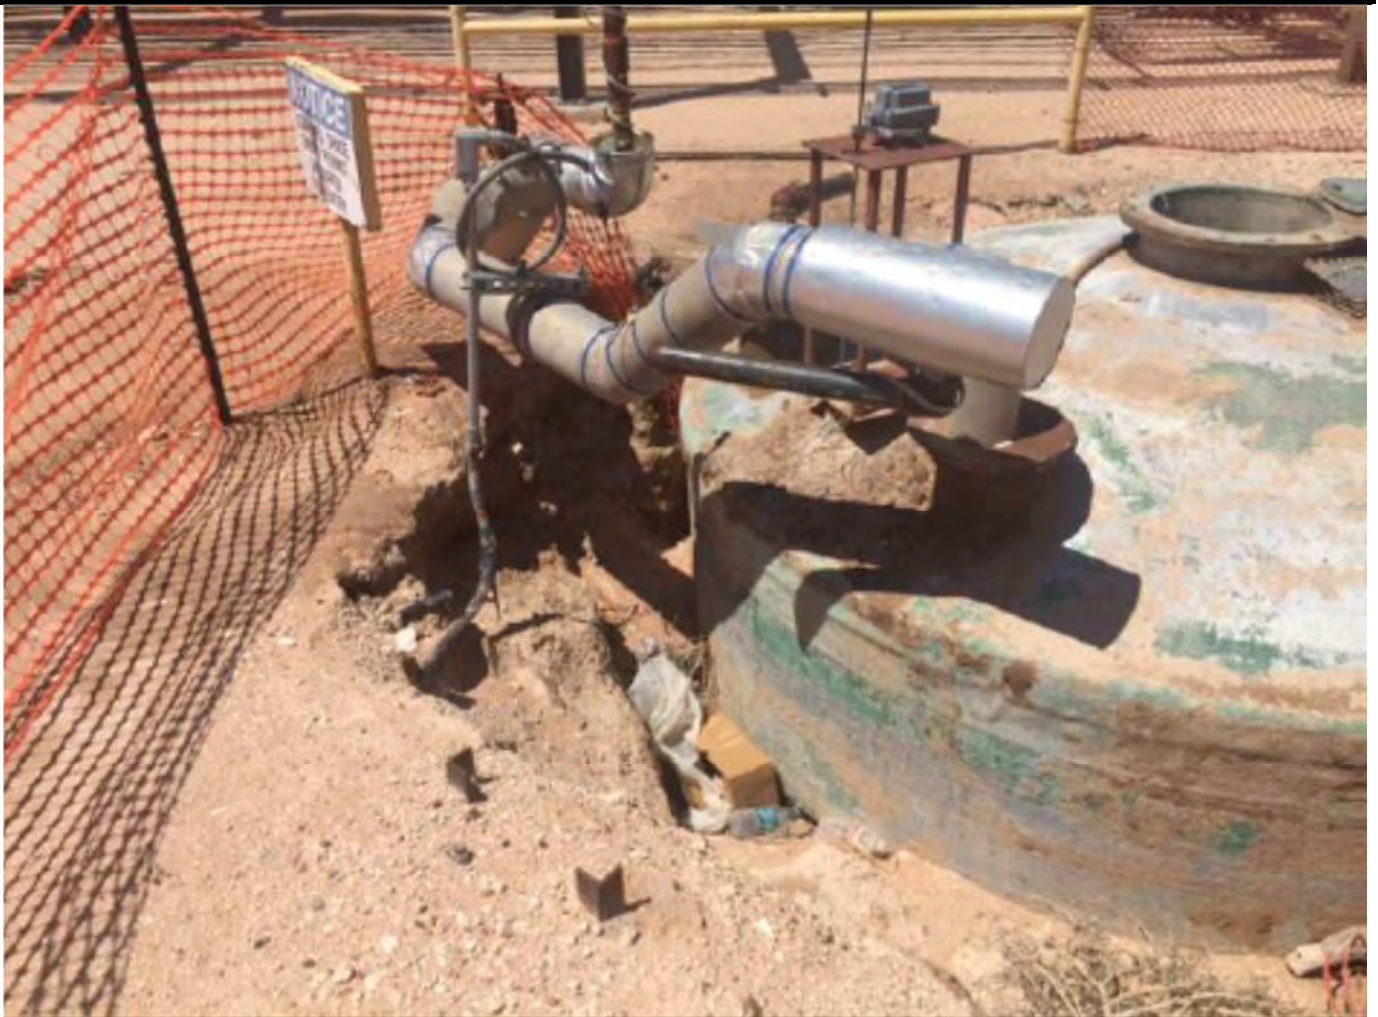
Photo 1: View of the West Boiler Sump prior to cutting the top off, facing north.

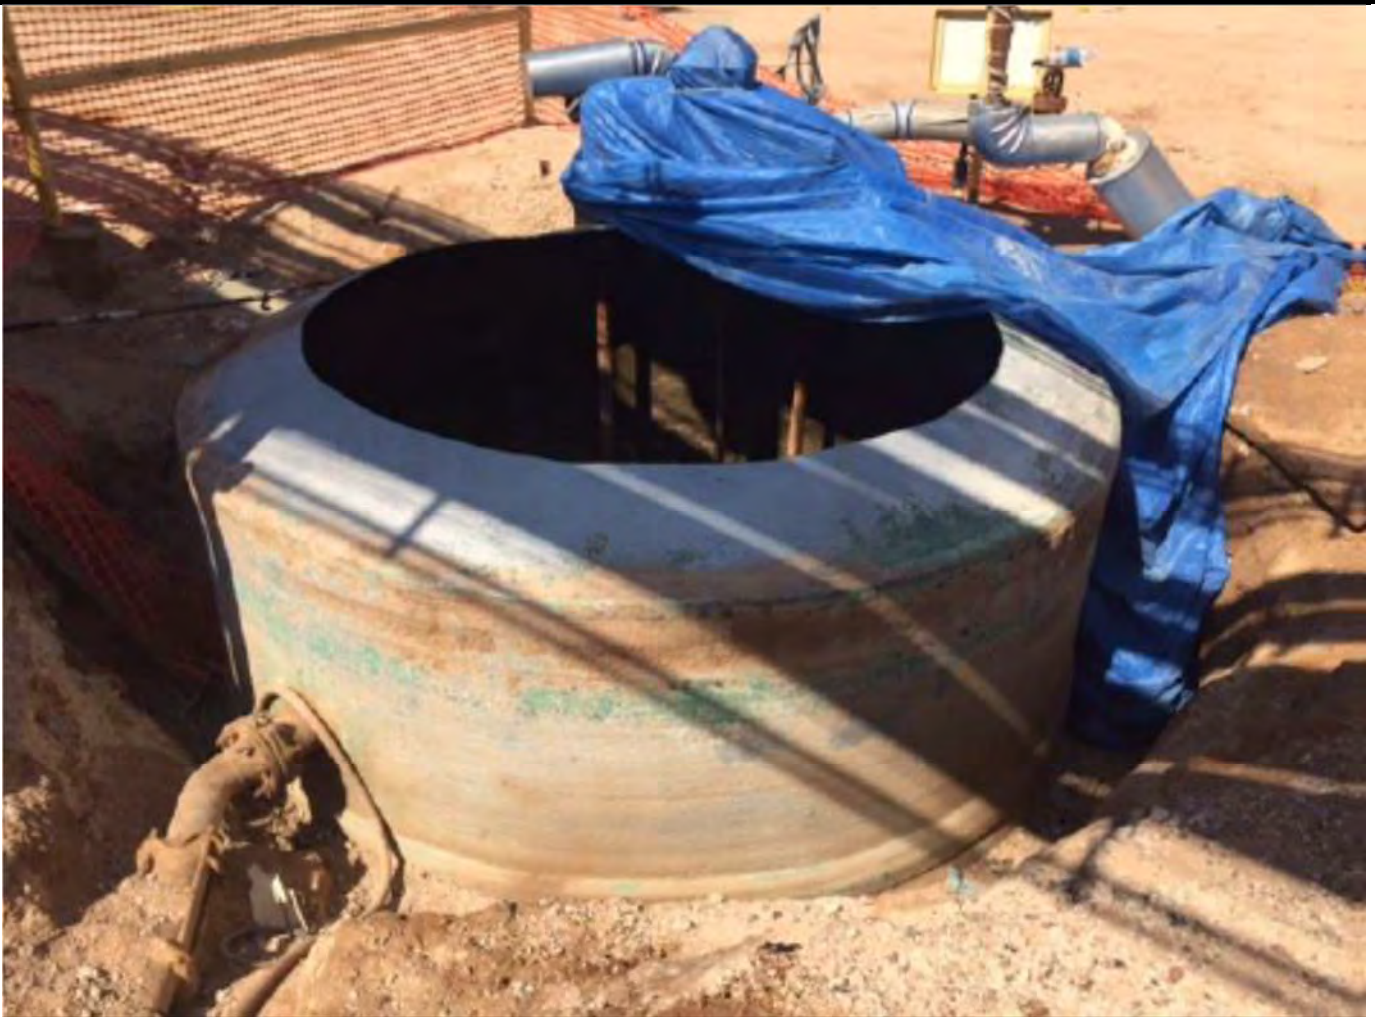
Photo 2: View of the West Boiler Sump after cutting top off, facing southwest.

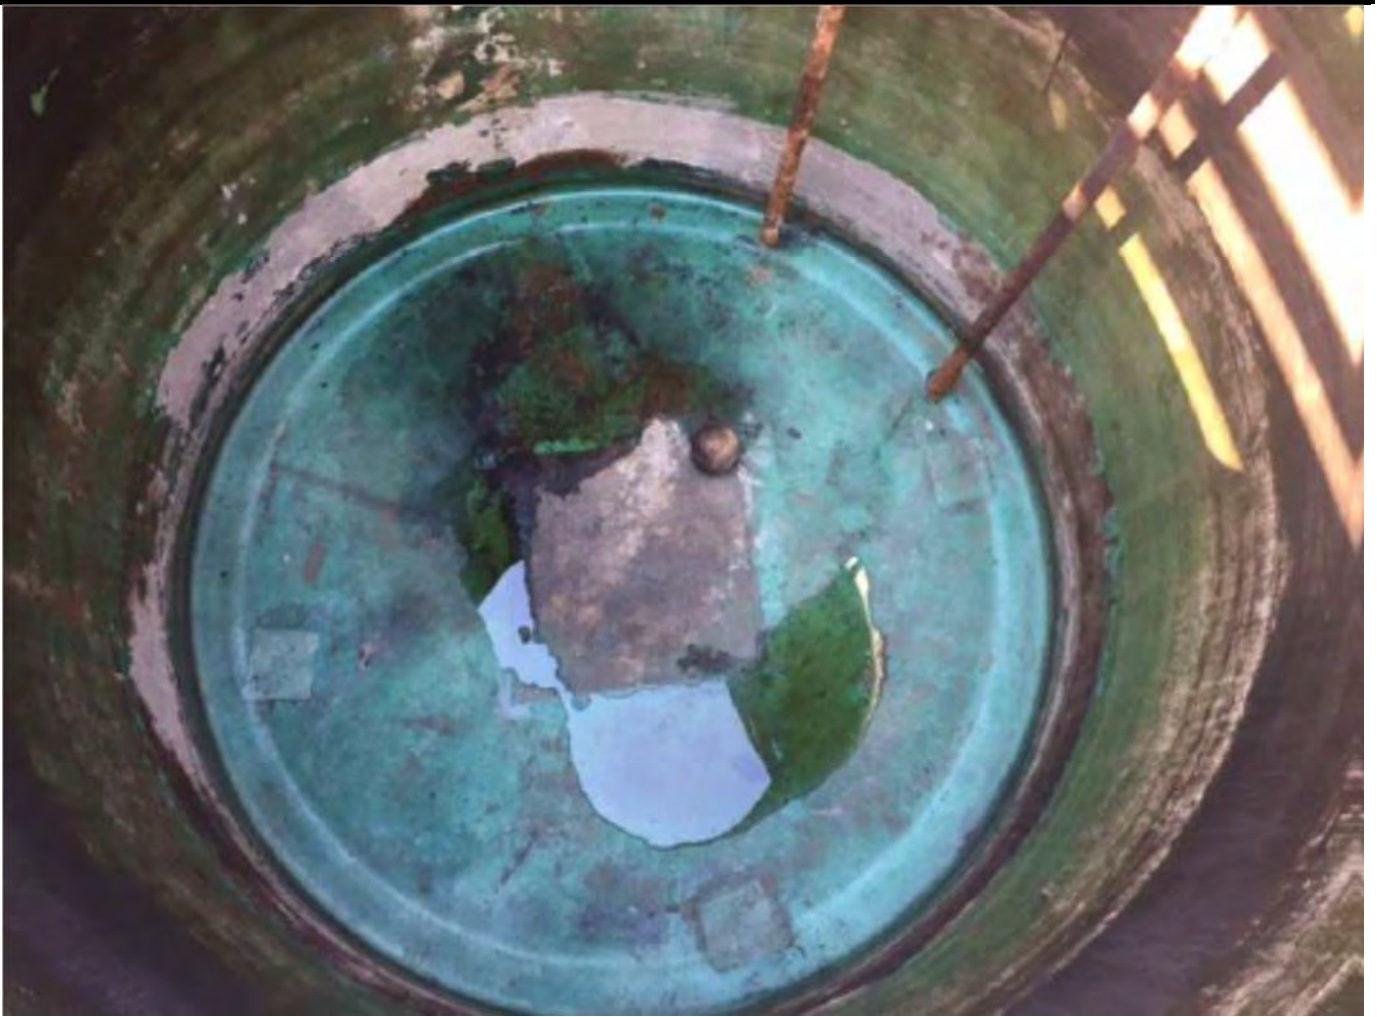
Photo 3: View of the interior of the West Boiler Sump after limited cleaning activities.

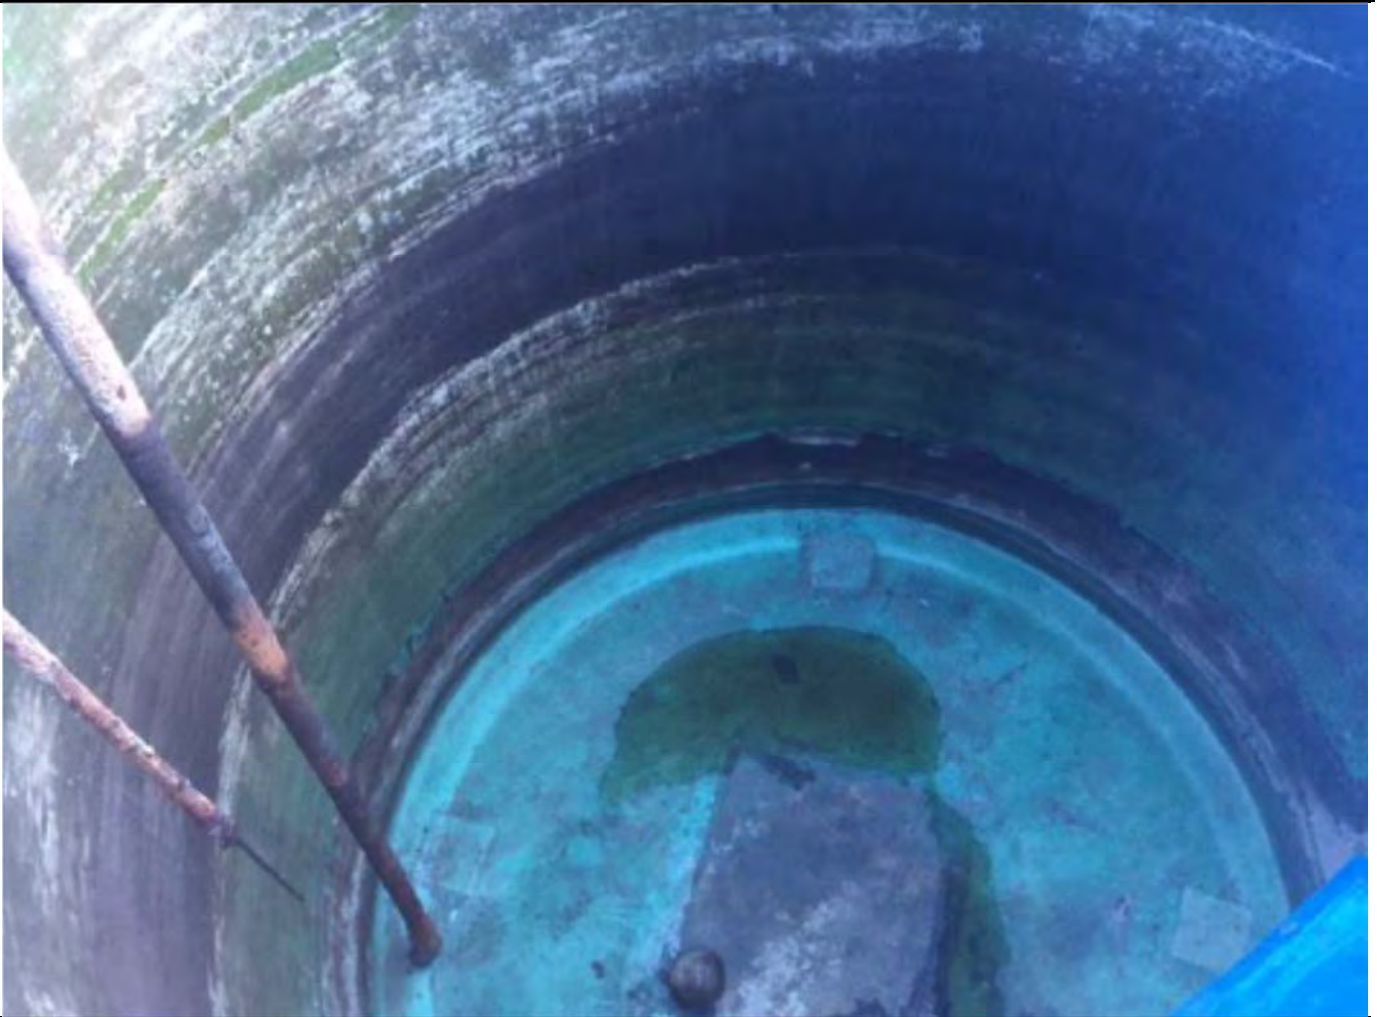
Photo 4: View of the interior of the West Boiler Sump after limited cleaning activities.

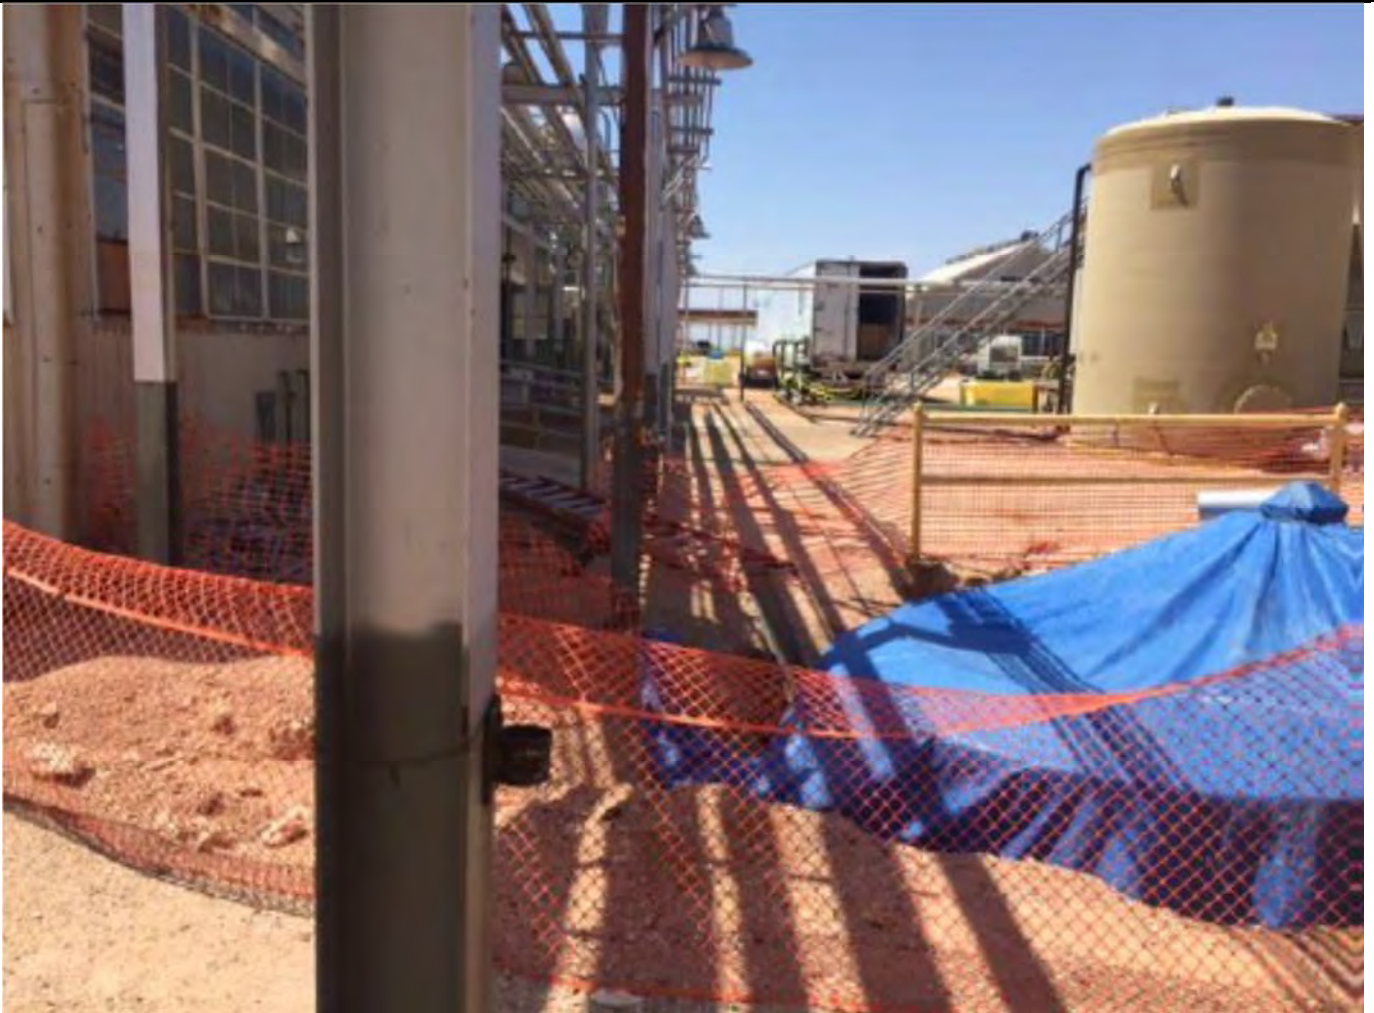
ETC maintains removing the West Boiler Sump from its current location poses a risk to human health and safety due to its proximity to the mechanical building and multiple above and below ground utilities, particularly the plant's main high pressure steam line, which is located on an adjacent pipe rack. A preliminary visual inspection of the floor and side of the tank from the surface and accounts from ETC personnel who have entered the BGT to conduct tank cleaning activities suggest the fiberglass BGT's integrity has not been compromised. A hydrostatic test, detailed inspection and/or the collection of soil samples would be necessary to confirm these.

Photo 5: View of the West Boiler Sump and affected utilities and proximity to pipe rack, facing south.

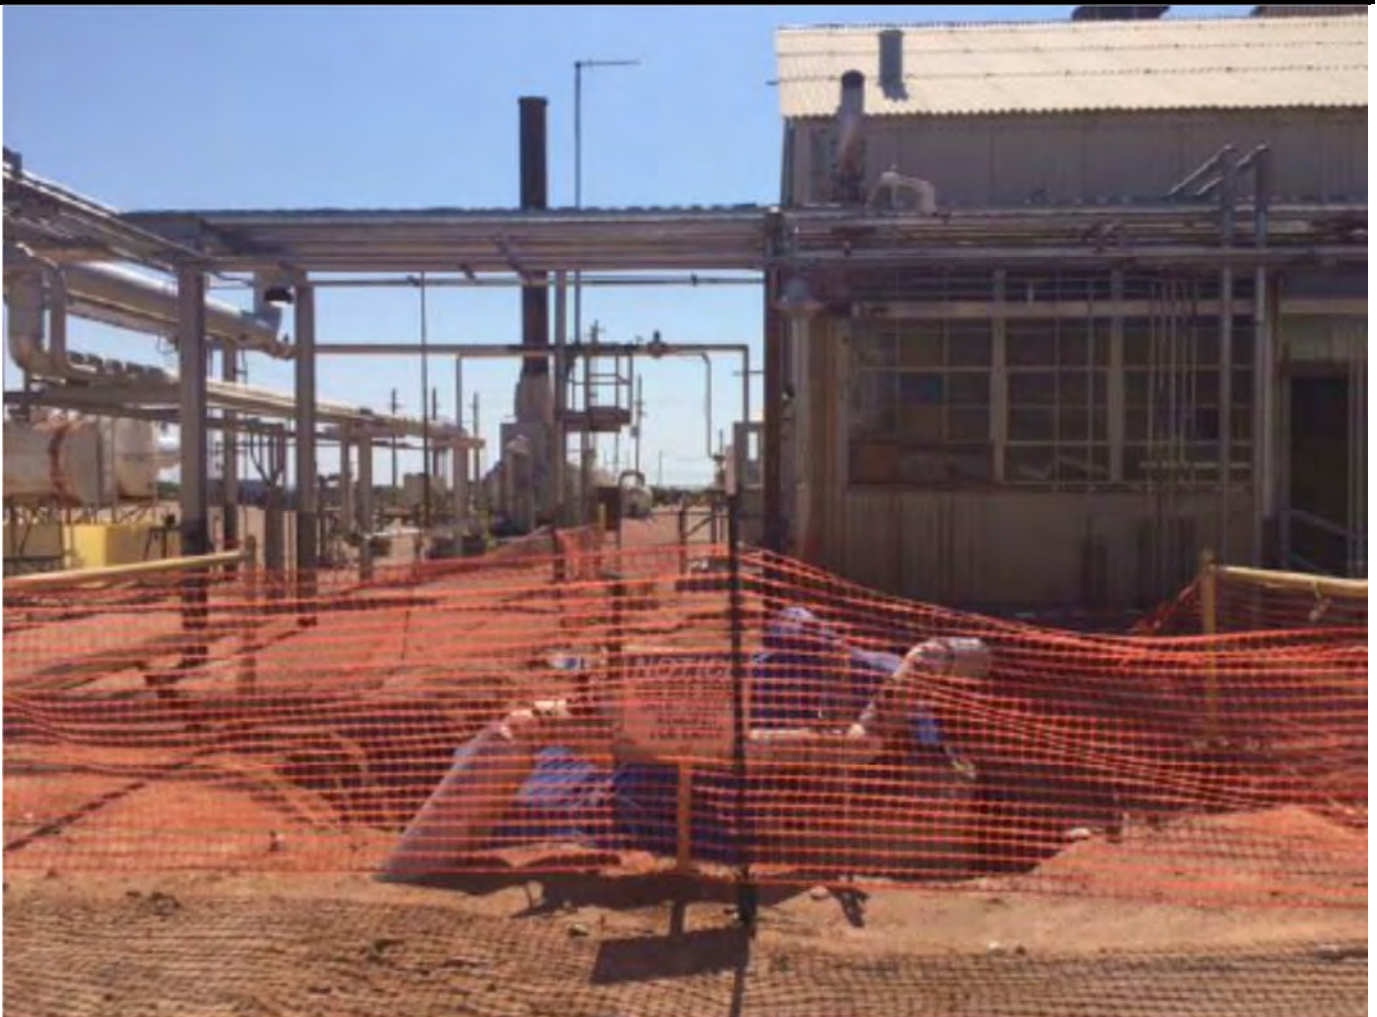
Photo 6: View of the West Boiler Sump, affected utilities, proximity to pipe rack and mechanical building, facing east.

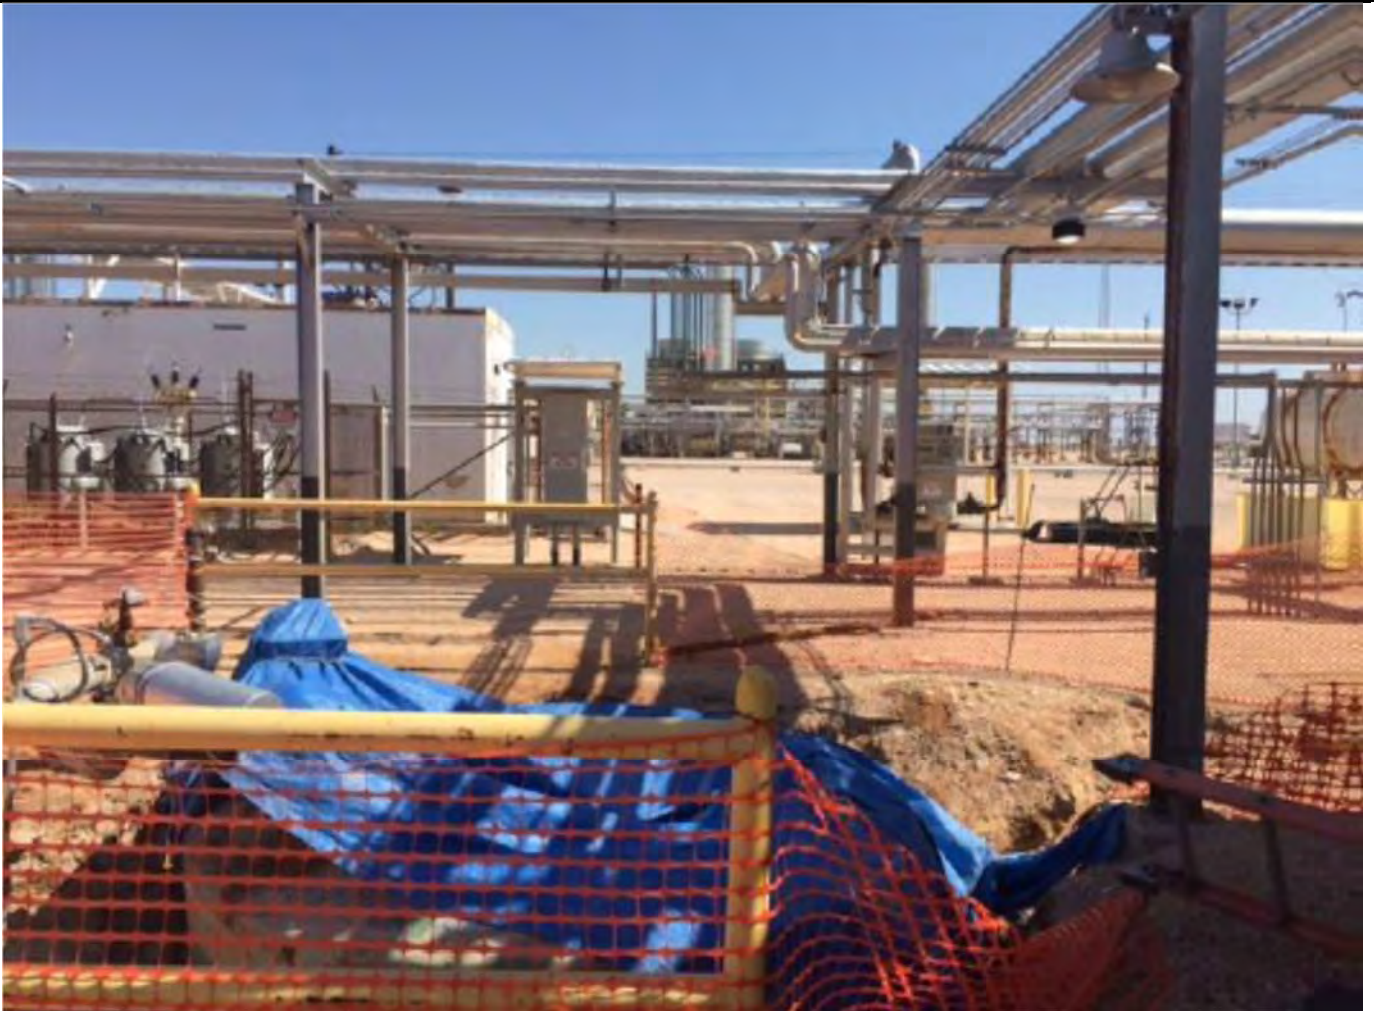
Photo 7: View of the West Boiler Sump and affected utilities and proximity to pipe rack support (east side), facing north.

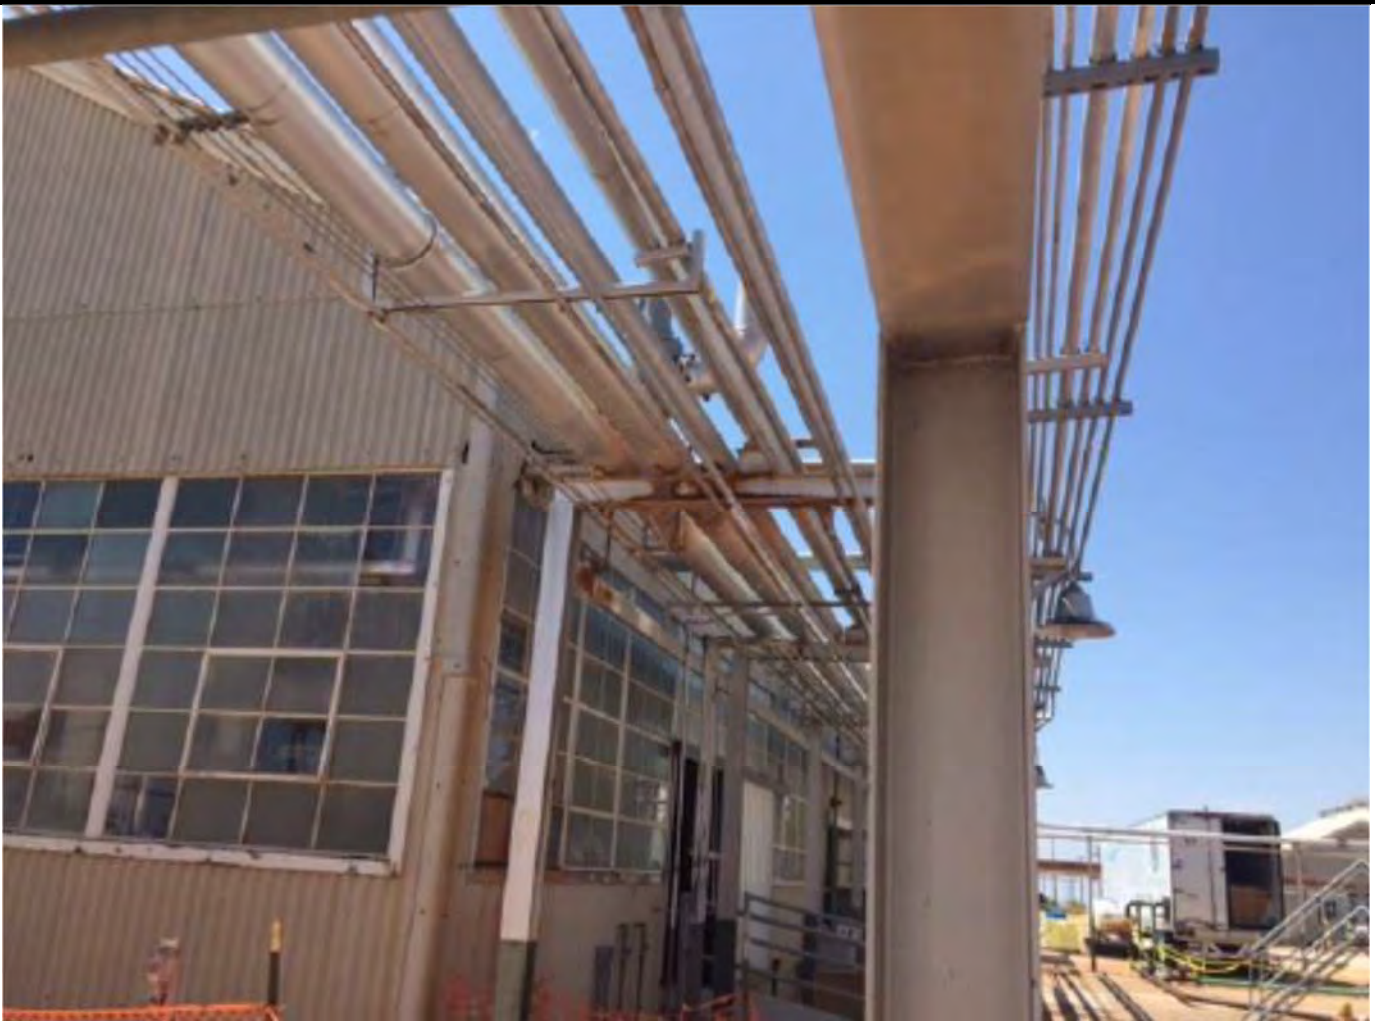
Photo 8: View of affected pipe rack support and associated utilities, included the high pressure steam line, facing south.
