HUNGRY HORSE, LLC

To: Katherine Boyer, HollyFrontier Transportation Reference: Remediation Work Plan Amendment 2 Operator: HollyFrontier Transportation Location: Hobbs Truck Station #529 Address: 413 W Arco Road, Hobbs, New Mexico 88240 GPS: 32.6527 -103.1395 Legals: NW1/4 Sec, 22,T19S, R3BE NMOCD approves of the proposed remediation plan for 1RP-4926 and grants backfill approval. See email correspondence for clarifications.

To: Katherine Boyer, HollyFrontier Transportation **Reference: Remediation Work Plan Operator: HollyFrontier Transportation** Location: Hobbs Truck Station #529 Address: 413 W. Arco Road, Hobbs, New Mexico 88240 GPS: 32.6527 -103.1395 Legals: NW1/4 Sec. 22, T19S, R38E

This remediation Work Plan is submitted in response to the unplanned release of crude oil from two above ground tanks into an unlined bermed containment area. All released fluids remained inside the berms except for approximately 2-4 gallons underneath the LACT unit.

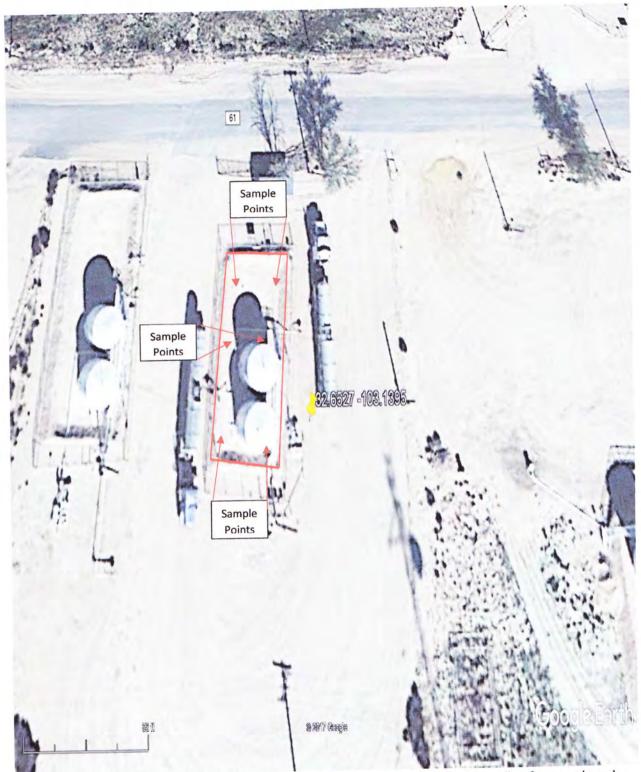
HollyFrontier Transportation Hobbs Truck Station # 529 Proposed Sample Points

As proposed in the work plan, 6 sample points from the floor, 2 from each side wall, 1 from each end will be selected as noted above. Confirmation samples below each floor sample will be obtained and analyzed for the same contaminants. GPS points will be obtained at the time of sampling and provided with lab analysis.

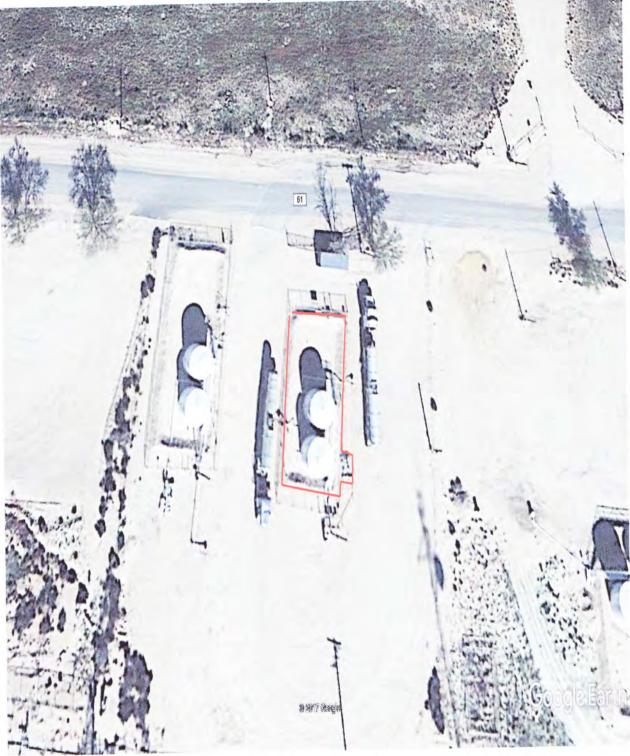
HollyFronter Transportation Truck Station # 529 413 W Arco Road Hobbs, New Mexico 88240

Impacted area is outlined in RED and is approximately 36' x 71'.
