**1RP-4258
DELINEATION PLAN
LR Chamberlain Tank Battery
Crude Oil & Produced Water Spill
Lea County, New Mexico**

LAI Project No. 17-0175-24

February 20, 2018

Prepared for:
Legacy Reserves Operating, LP
303 West Wall Street, Suite 1300
Midland, Texas 79701

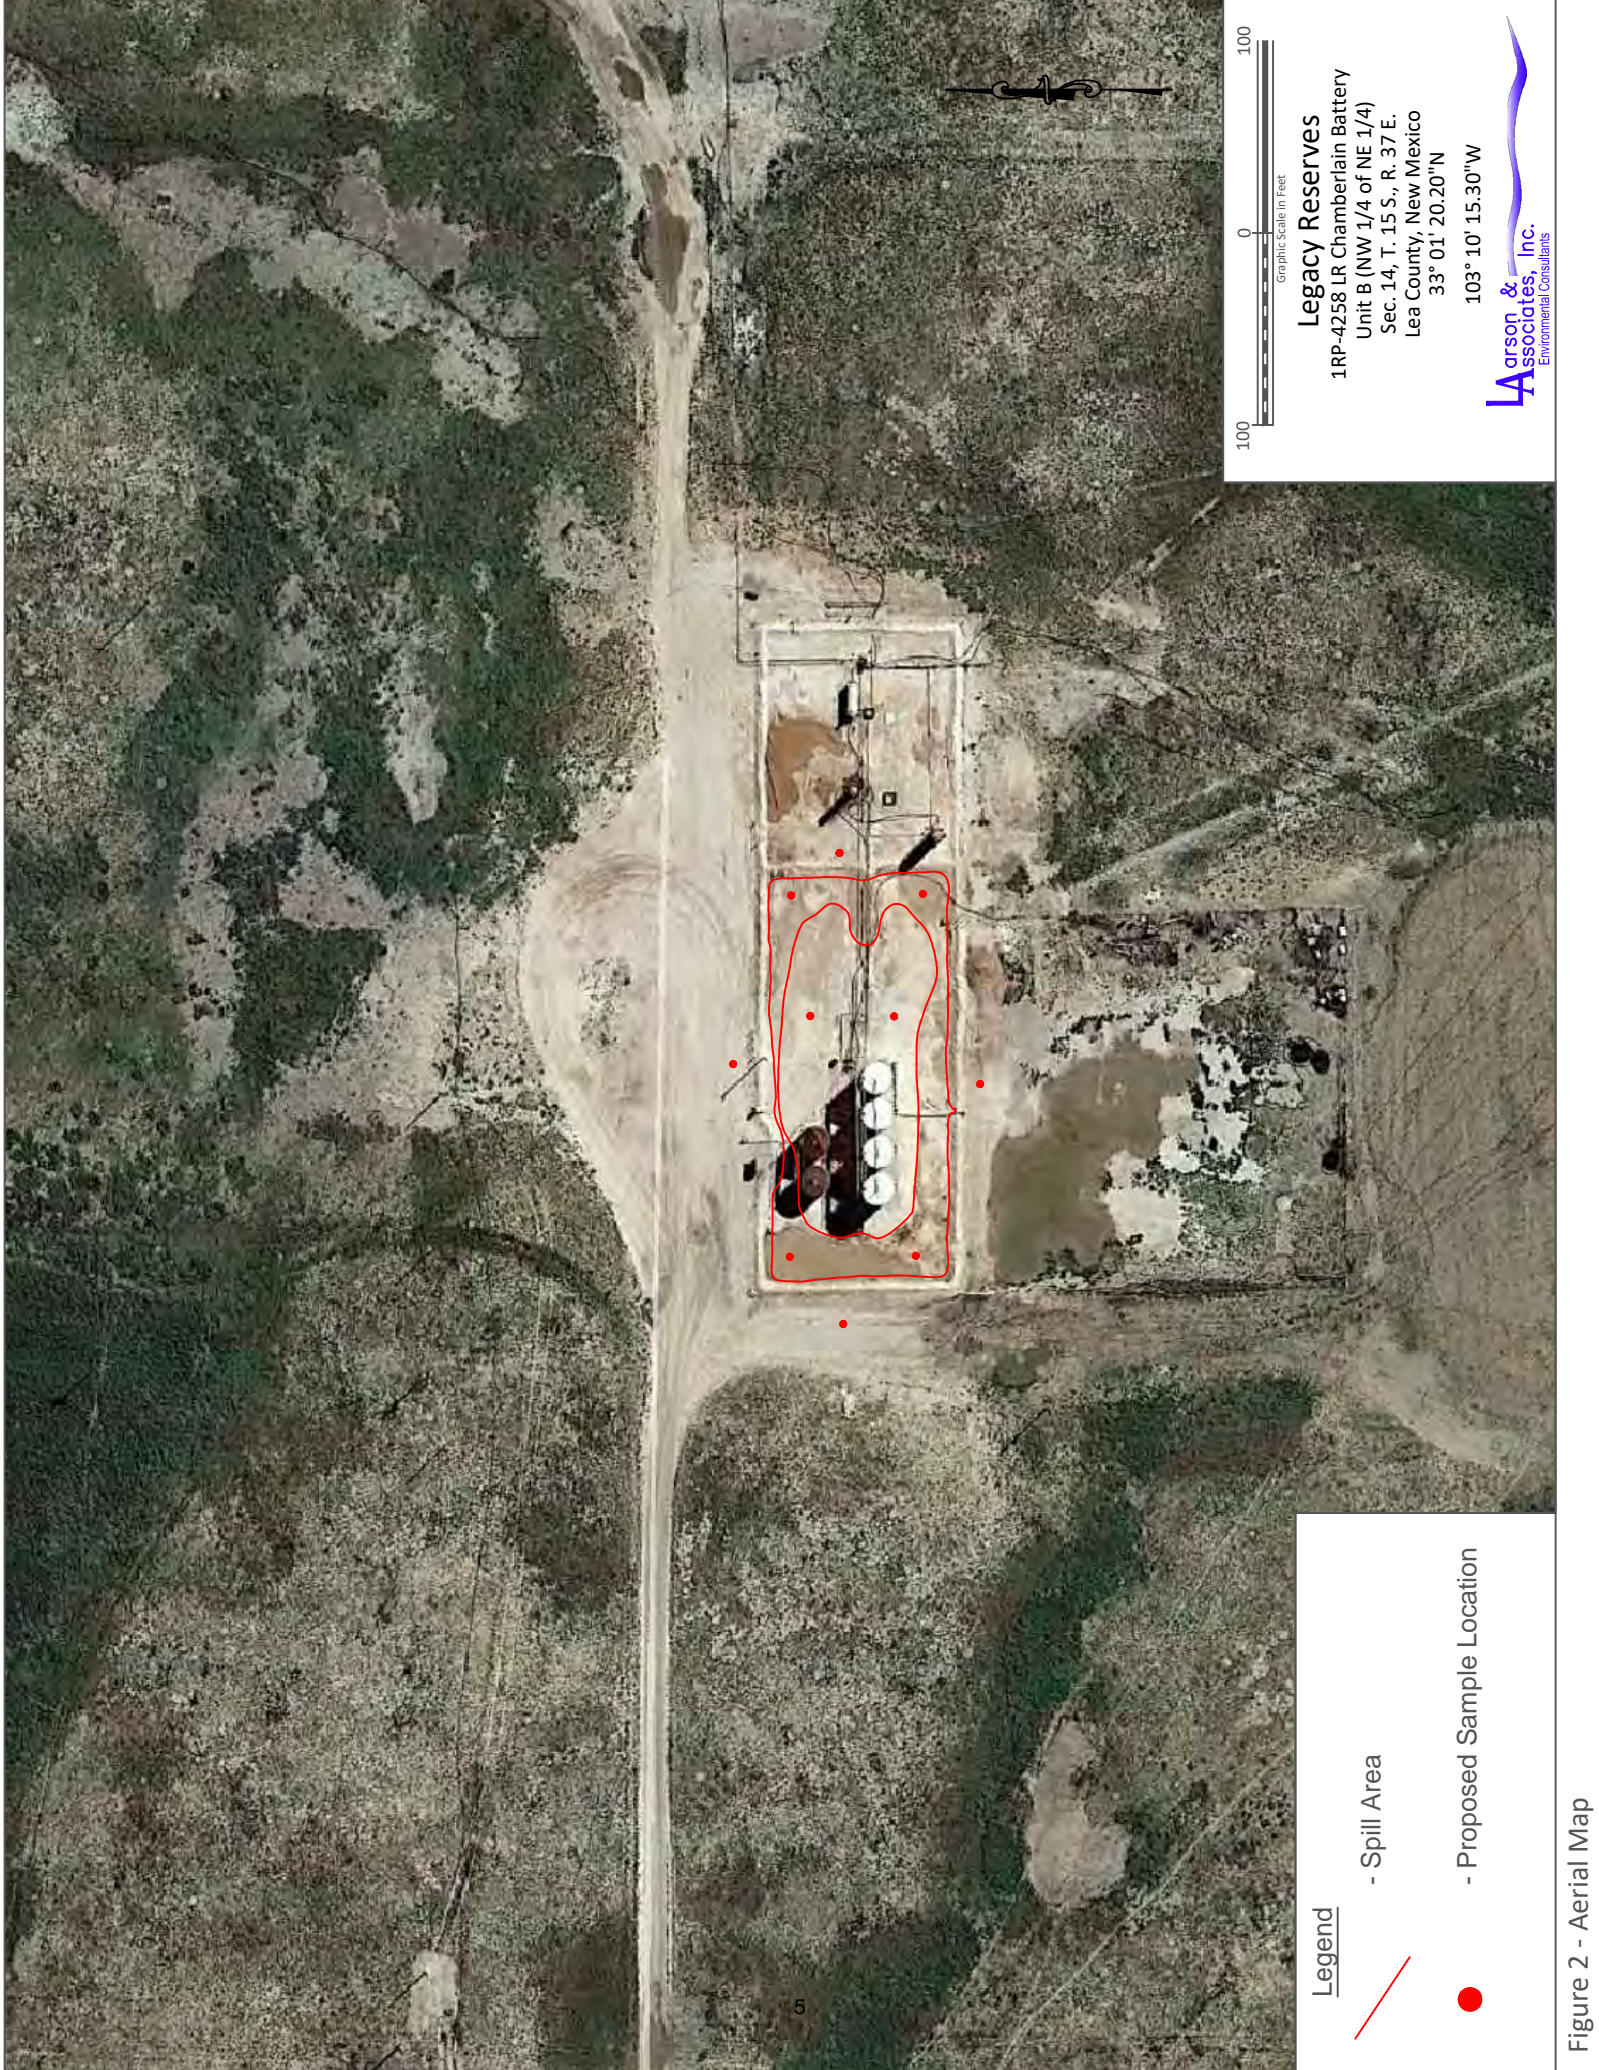
Figure 2 - Aerial Map

LAI proposes to collect soil samples at six (6) locations within the contaminated area inside the secondary containment. The samples will be collected at 1 foot intervals to approximately 4 feet bgs and 2 foot intervals to approximately 12 feet bgs using direct push technology (DPT) depending on subsurface conditions. Additional samples will be collected in each cardinal direction (north, south, east and west) of the spill at the same depth intervals for horizontal delineation. The soil samples will be delivered under chain of custody and preservation to Xenco Laboratories (Xenco) in Midland, Texas, and analyzed for BTEX, total petroleum hydrocarbons (TPH), including gasoline range organics (GRO), diesel range organics (DRO) and oil range organics (ORO) and chloride by EPA SW-846 Method 8021B, 8015M and 300 respectively. Pending laboratory results, further delineation may be required to reach cleanup level standards. Figure 2 presents a site map showing proposed soil sample locations. Appendix C presents photographs.

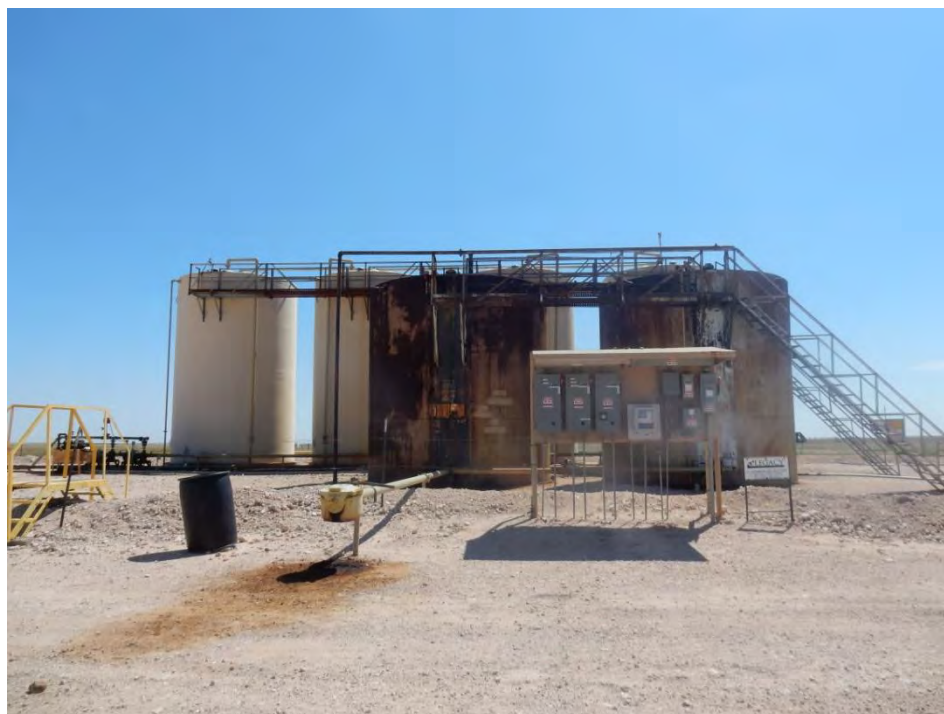
Site Prior to Remediation Viewing South, September 14, 2017

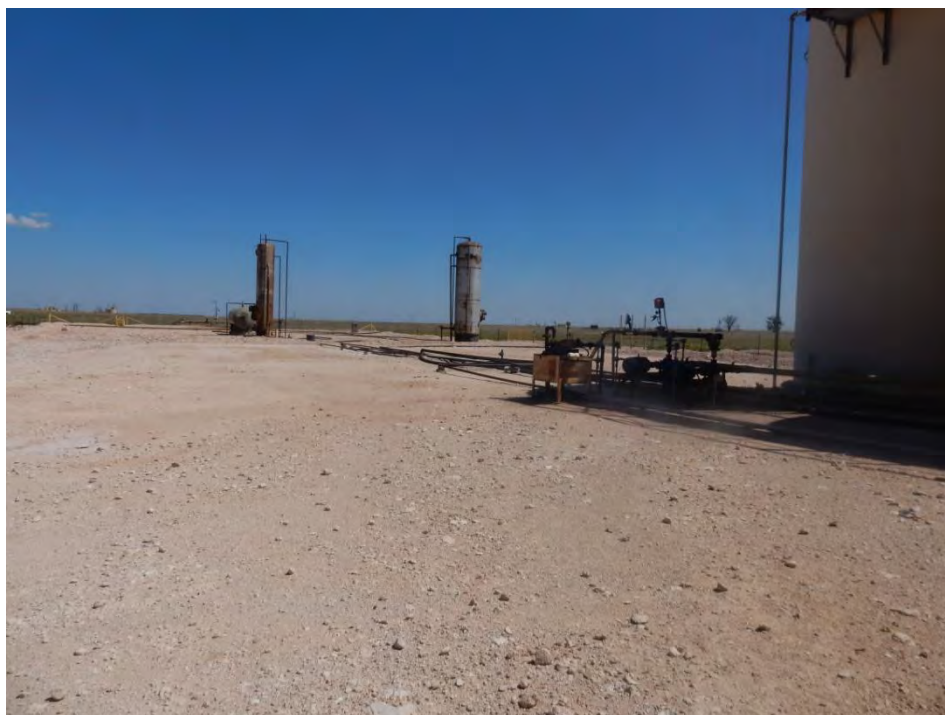
Site Prior to Remediation Viewing East, September 14, 2017

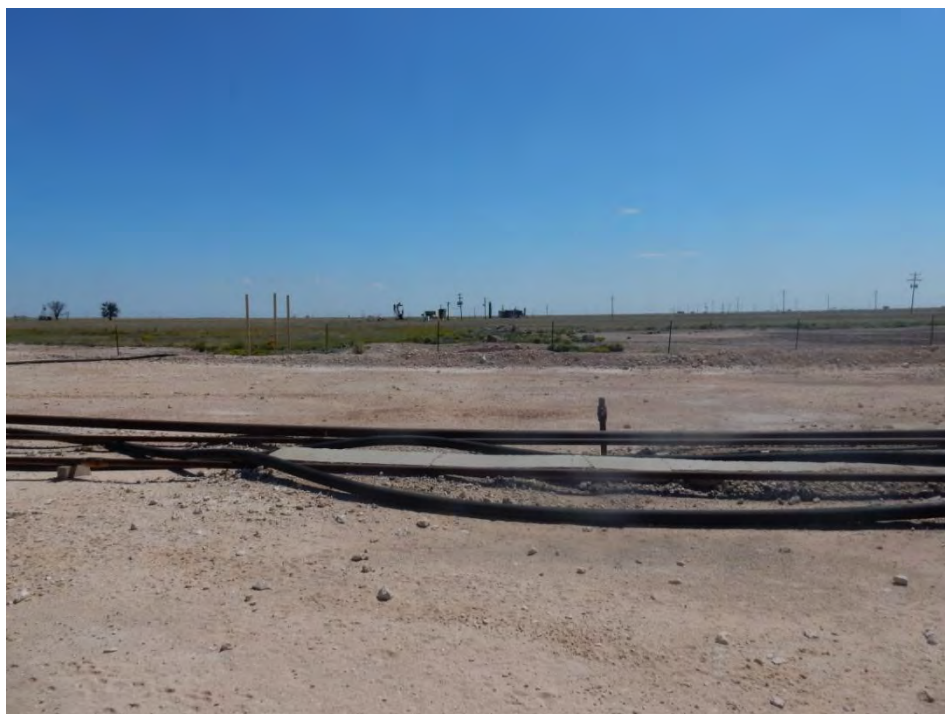
Site Prior to Remediation Viewing South, September 14, 2017

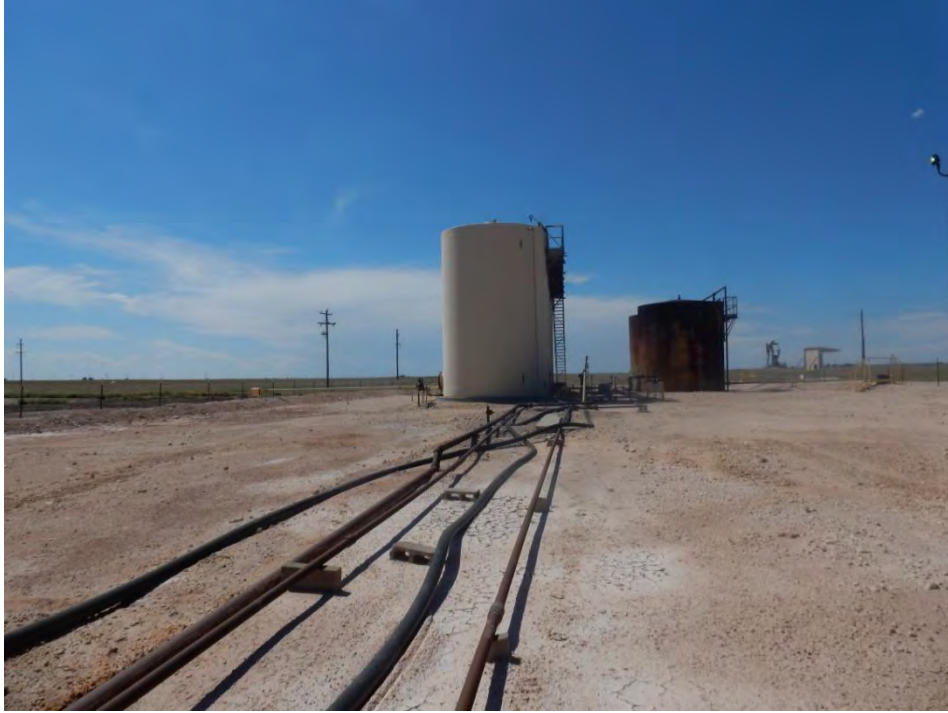
Site Prior to Remediation Viewing West, September 14, 2017
