Penroc Oil Corporation
Langlie Jal Unit #039
Injector Well - Flowline Failure

Preliminary Delineation Report
Case Number: 1R-4616

Section 04, T25S, R37E
Detailed coordinates in report.

Date of Incident
02/12/2017

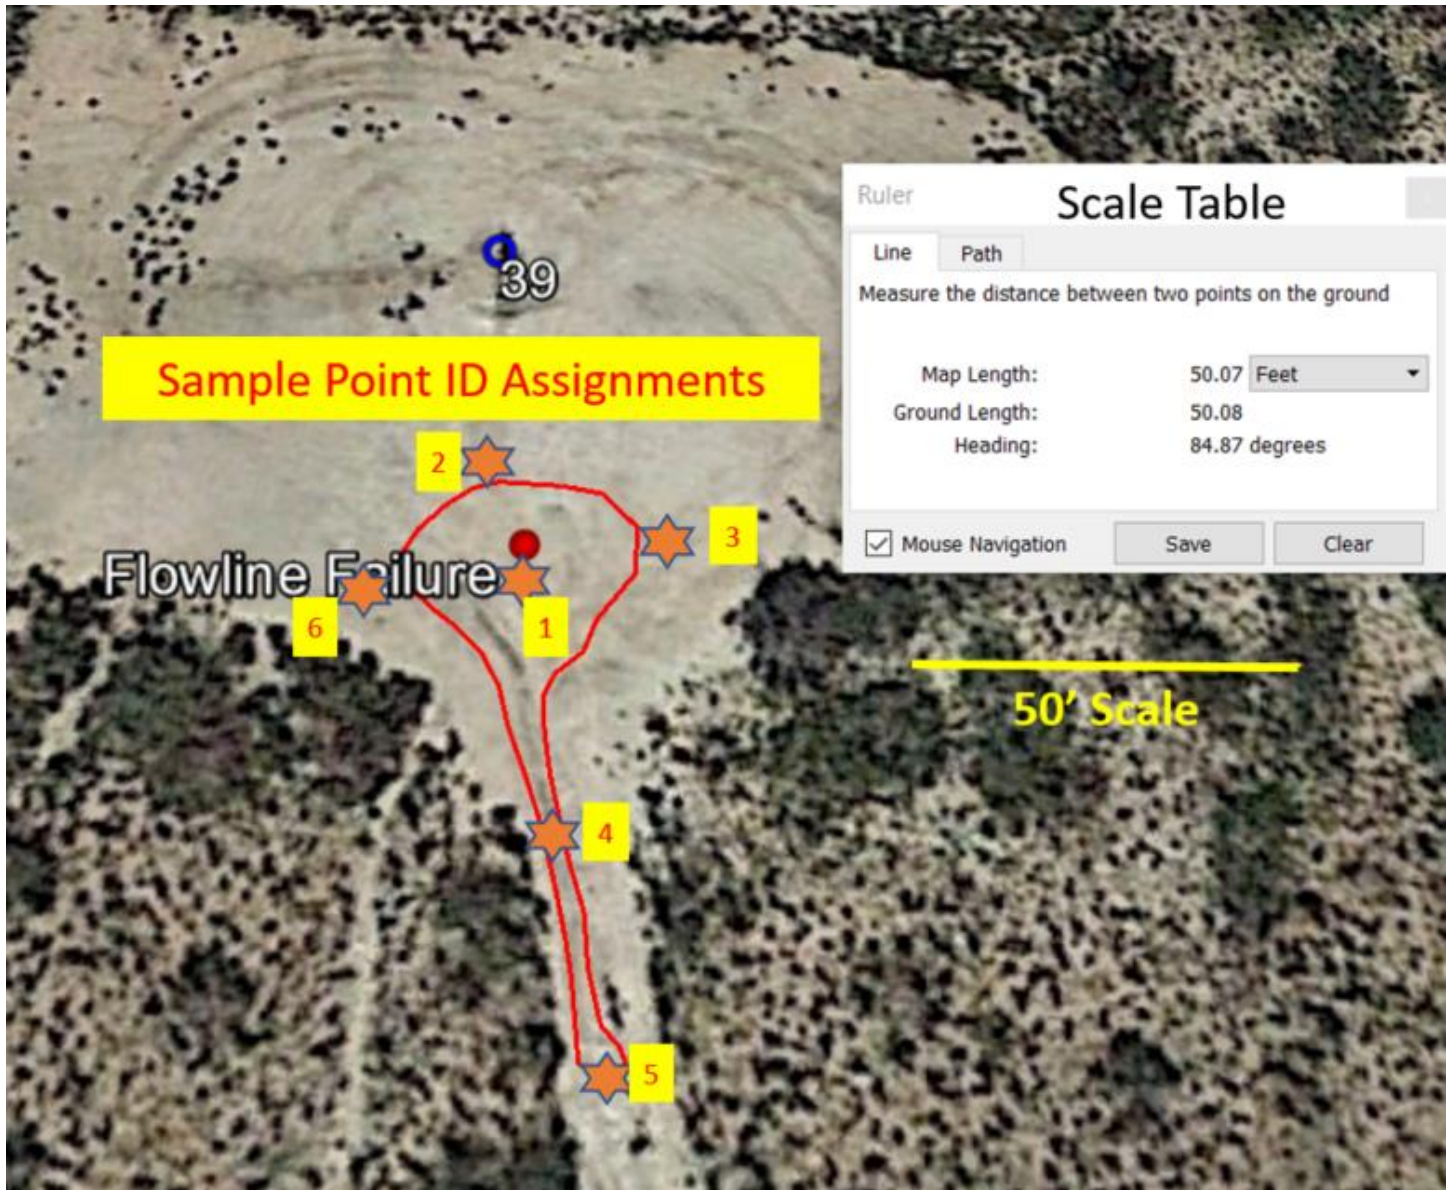
Location of Flowline Failure:

Latitude: 32.165570

Longitude: -103.173116

Flowline Failure

Red: Spill Outline
Red Dot: Flowline Failure Point
Orange: 83 Feet
Blue: 33 Feet
Green: 5 Feet

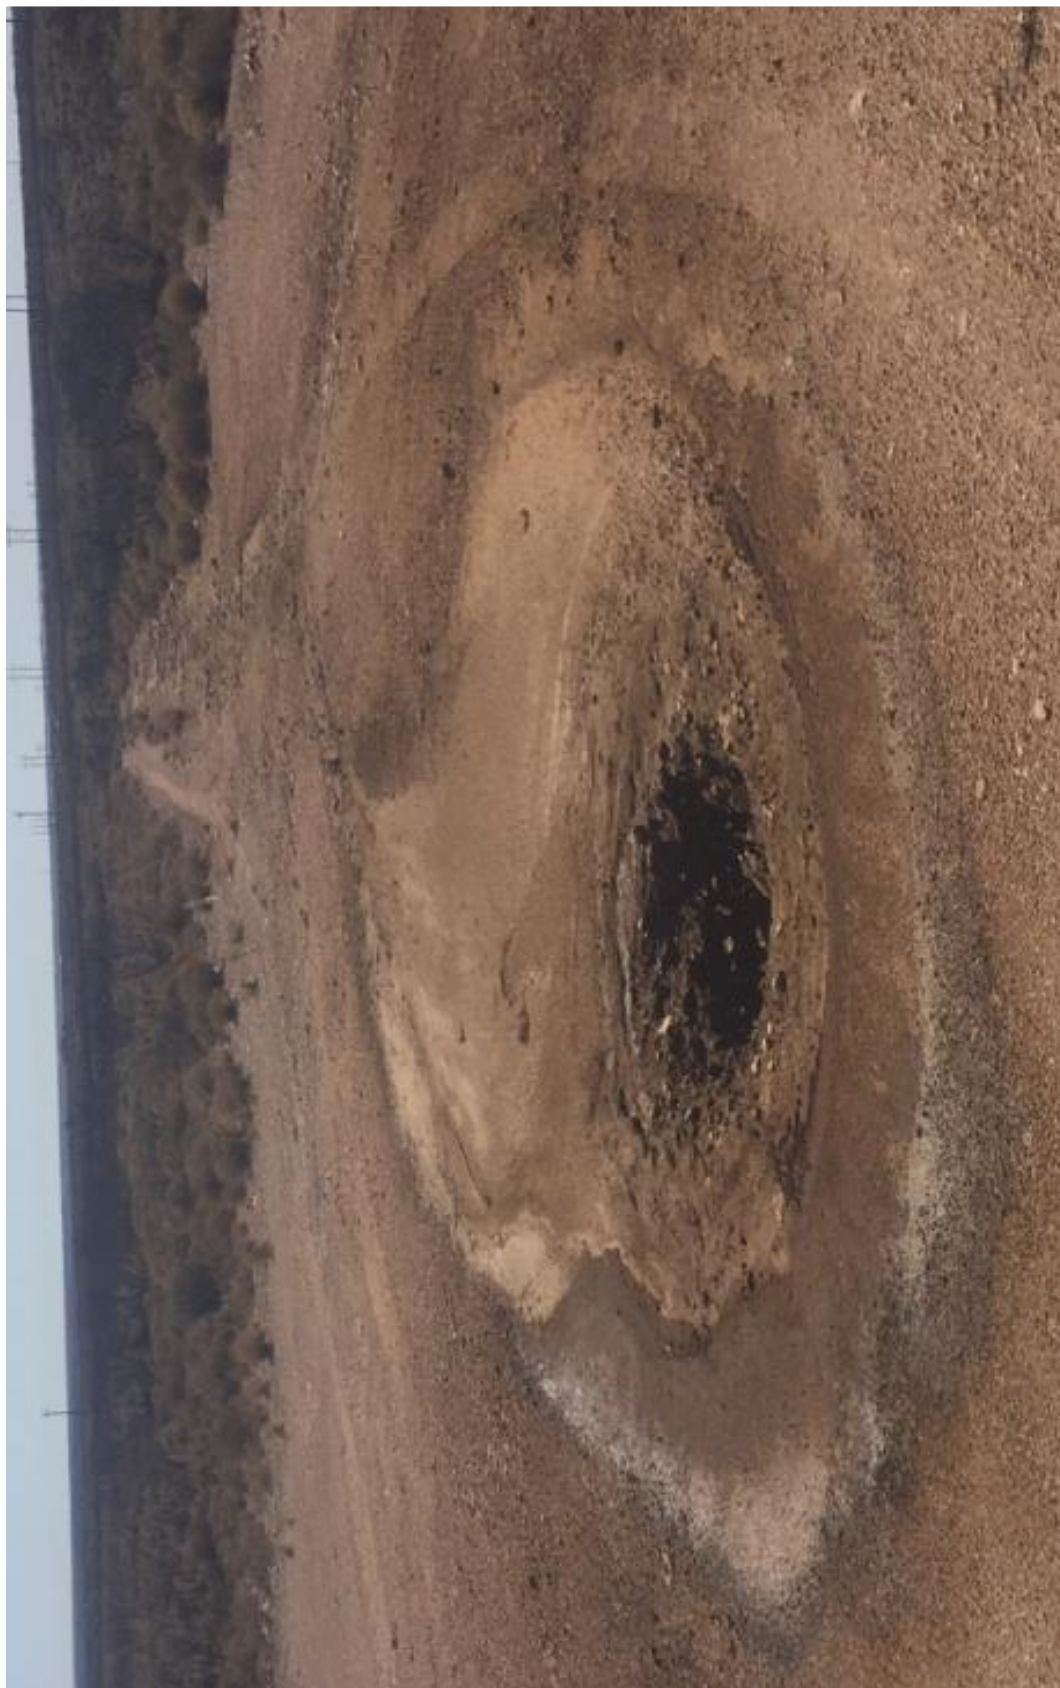
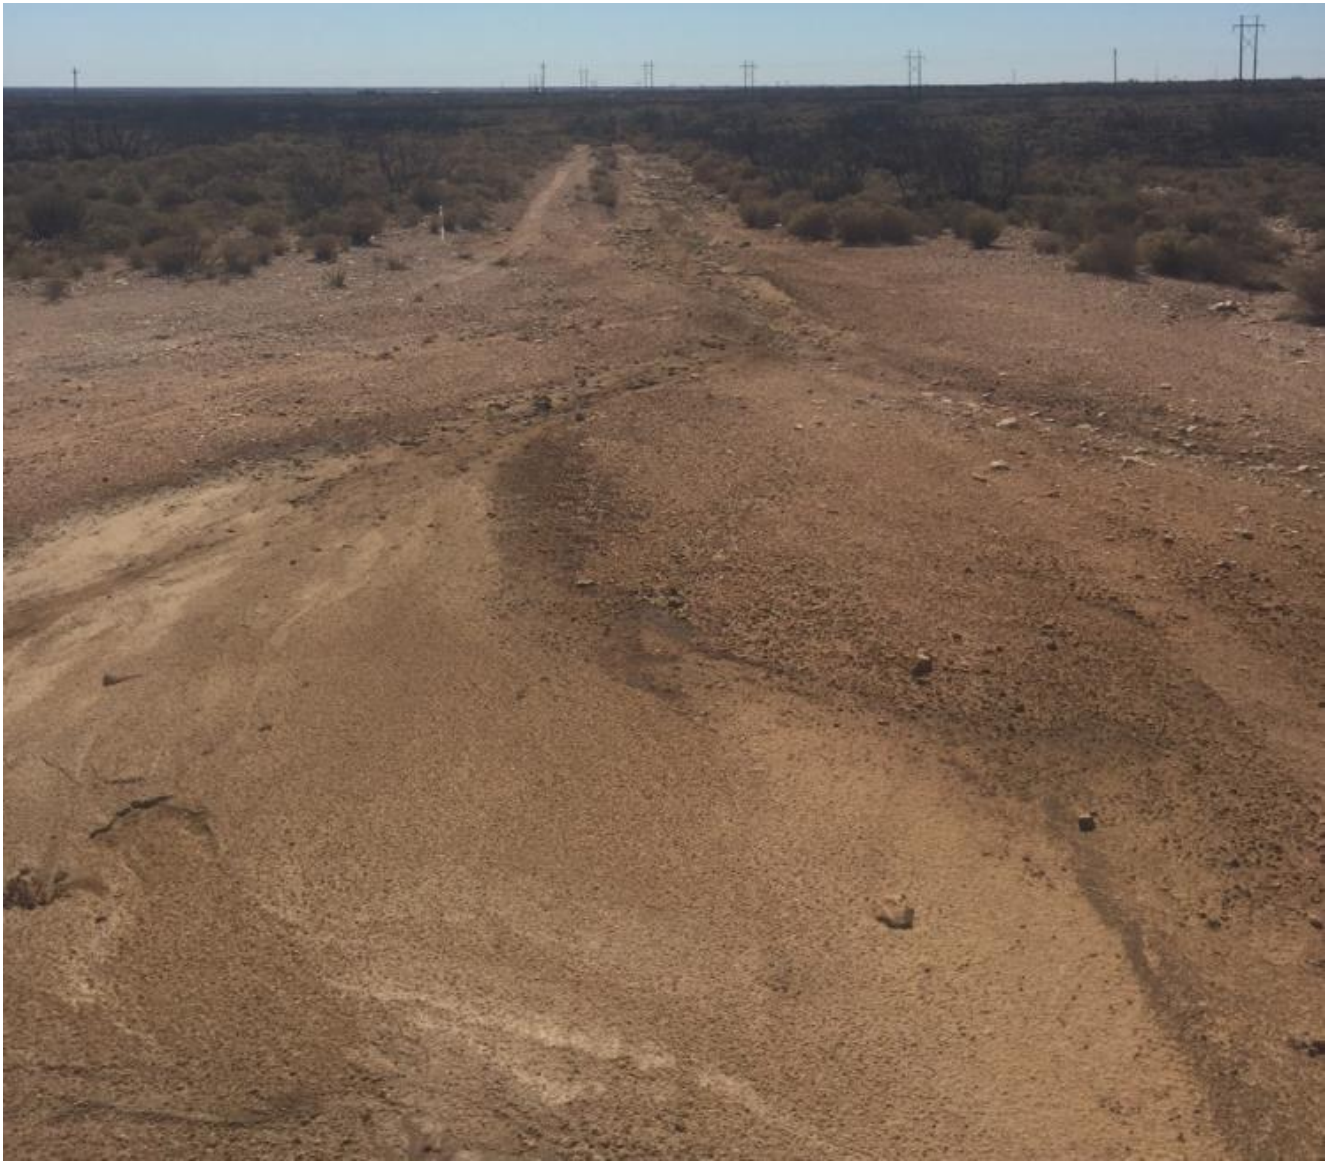
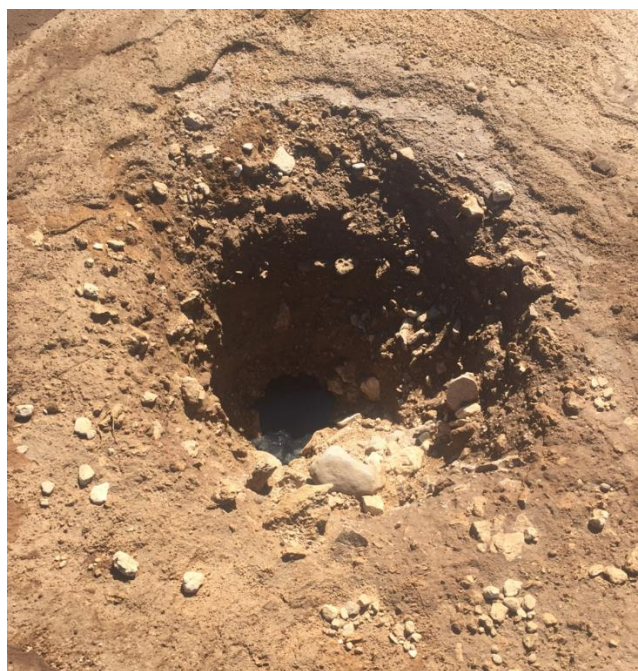
- Langlie Jal Unit #039 has a steel flowline that is buried from the edge of the well pad to the wellhead where it resurfaces. Approximately thirty feet from the well head, a buried portion of this flowline ruptured causing a release of produced water. The produced water from this release created a typical crater seen with other buried flowline failures and fluid began to spread across the immediate area of the rupture until discovery and isolation occurred. There were no signs of valve-position misplacement along the flow path, so it appears the flowline was weathered from long-term use, resulting in this failure. To remediate future failures of this nature, field personnel will be continually urged to inspect the condition of flowlines visible on the surface and routinely pressure test lines that appear overly weathered or aged in anyway. The well will remain shut in to prevent any further releases until the needed repairs are completed, contaminated soil is removed and trucked to disposal site (Sundance), soil tested per NMOCD requirements, and clean soil is brought in to replace.

- The area affected was the caliche well-pad and the caliche road due south of the well pad. The produced water ran down the caliche road until it settled at the entrance of the caliche road. Clean up actions that need to be taken are to remove the contaminated caliche on the well pad where the crater occurred. The remaining appears to be hard-rock surface staining and can be properly remediated with backhoe scraping. All contaminated caliche will be taken to an approved disposal site (Sundance). After clean up, clean caliche will replace what has been removed at the well-pad.

The following are photos taken immediately after the unauthorized release occurred and the wells in the area were shut in to prevent any further release of produced water.
