DELINEATION PLAN

**New Mexico State S Tank Battery
Lea County, New Mexico**

LAI Project No. 18-0153-01

August 8, 2018

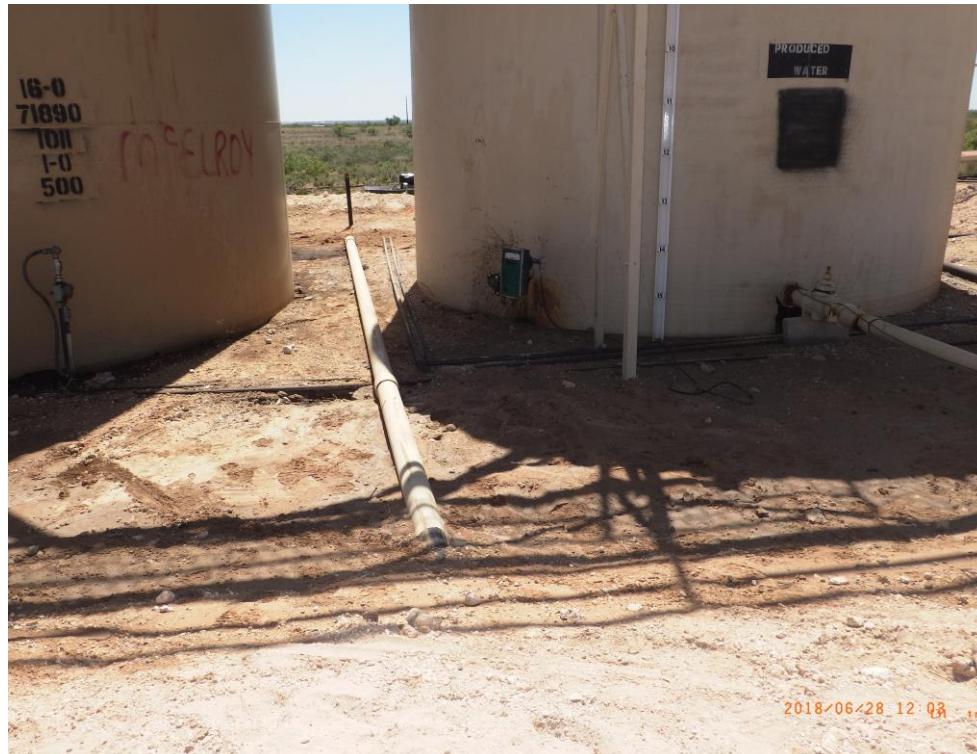
Spill Area Viewing East, June 28, 2018

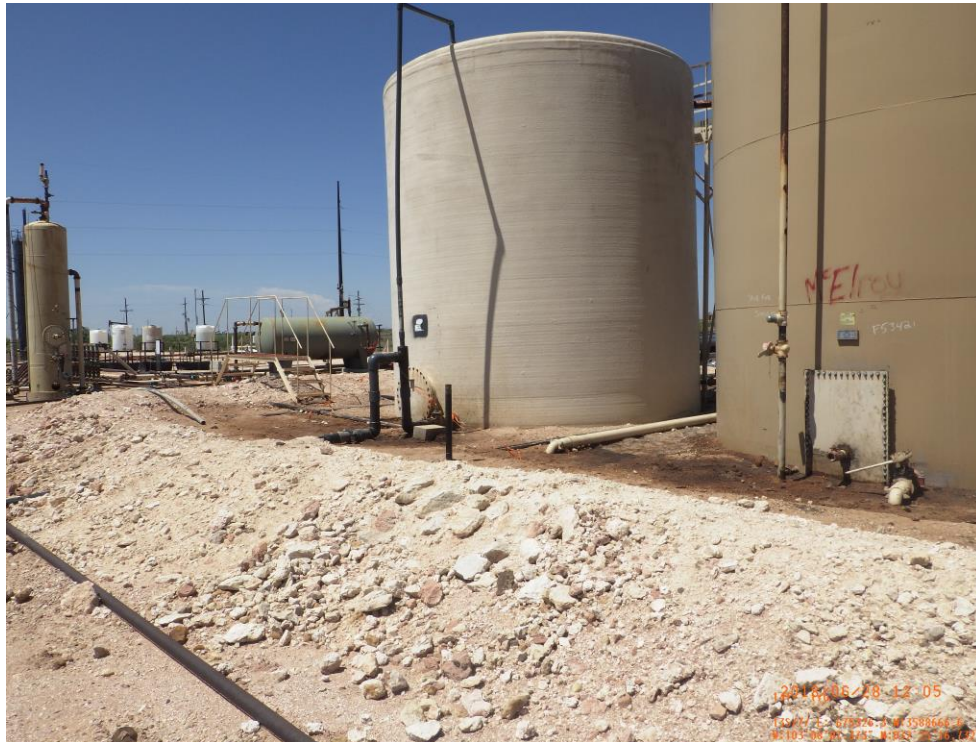
Spill Area Viewing Southwest, June 28, 2018

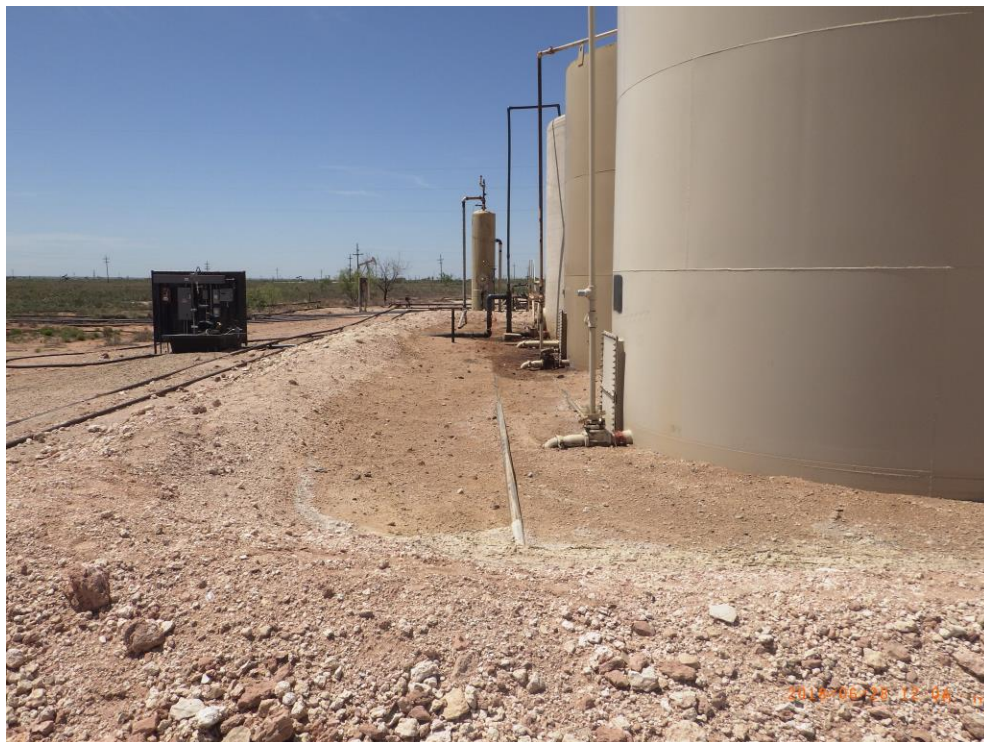
Spill Area Viewing South, June 28, 2018

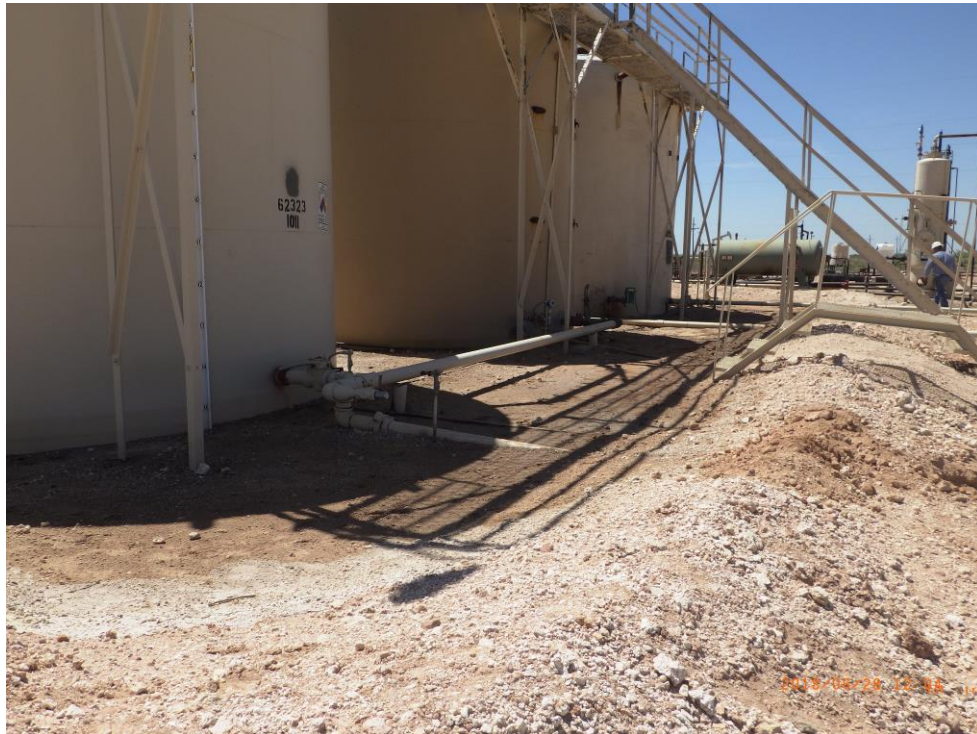
Spill Area Viewing Southeast, June 28, 2018
