**1RP-5068
DELINEATION PLAN
Jal Cooper Unit #238
Produced Water Spill
Lea County, New Mexico**

LAI Project No. 18-0138-01

August 31, 2018

Prepared for:
Legacy Reserves Operating, LP
303 West Wall Street, Suite 1300
Midland, Texas 79701

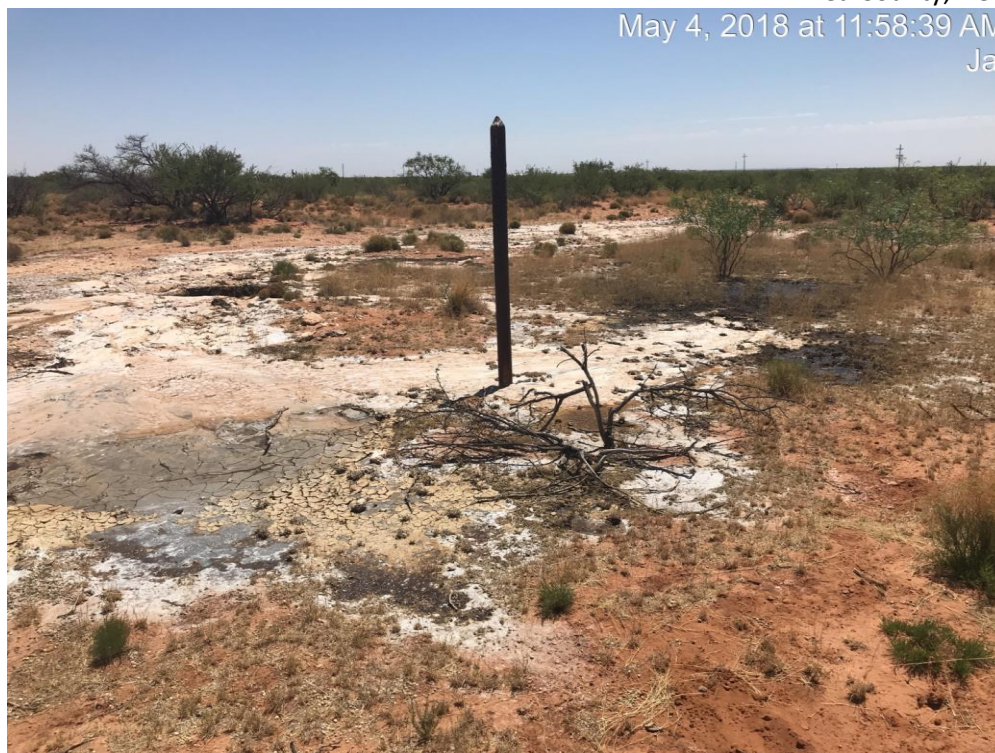
Spill Origin East of Cooper Jal Unit #222 (P/A) Viewing East, May 4, 2018

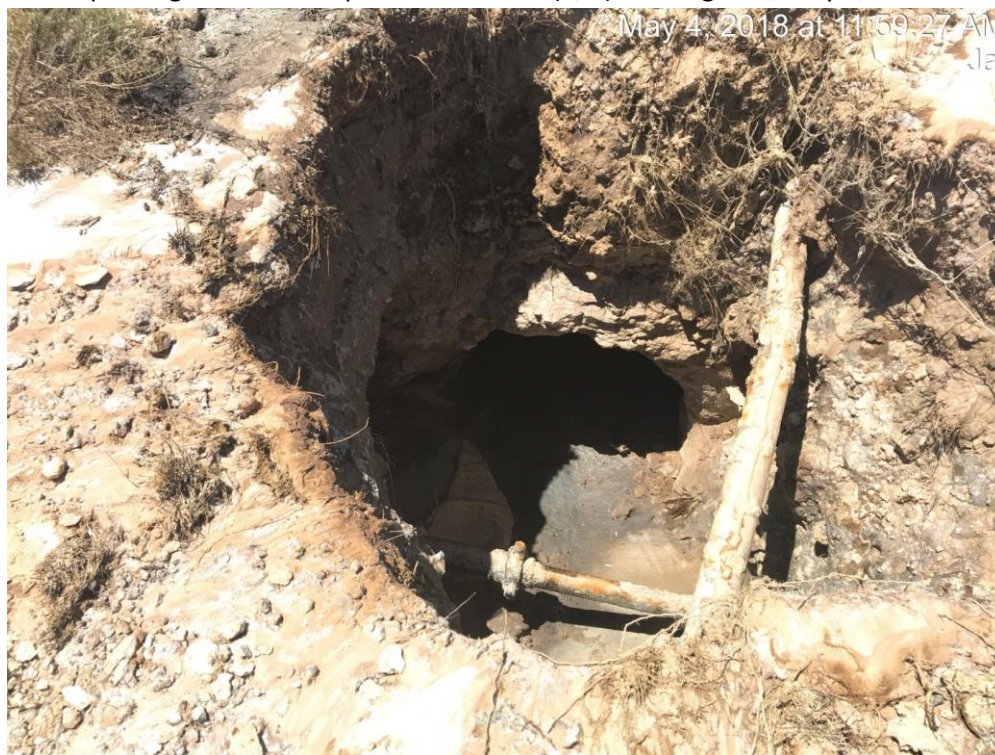
Washout from Injection Line Rupture East of Cooper Jal Unit #222 (P/A), May 4, 2018

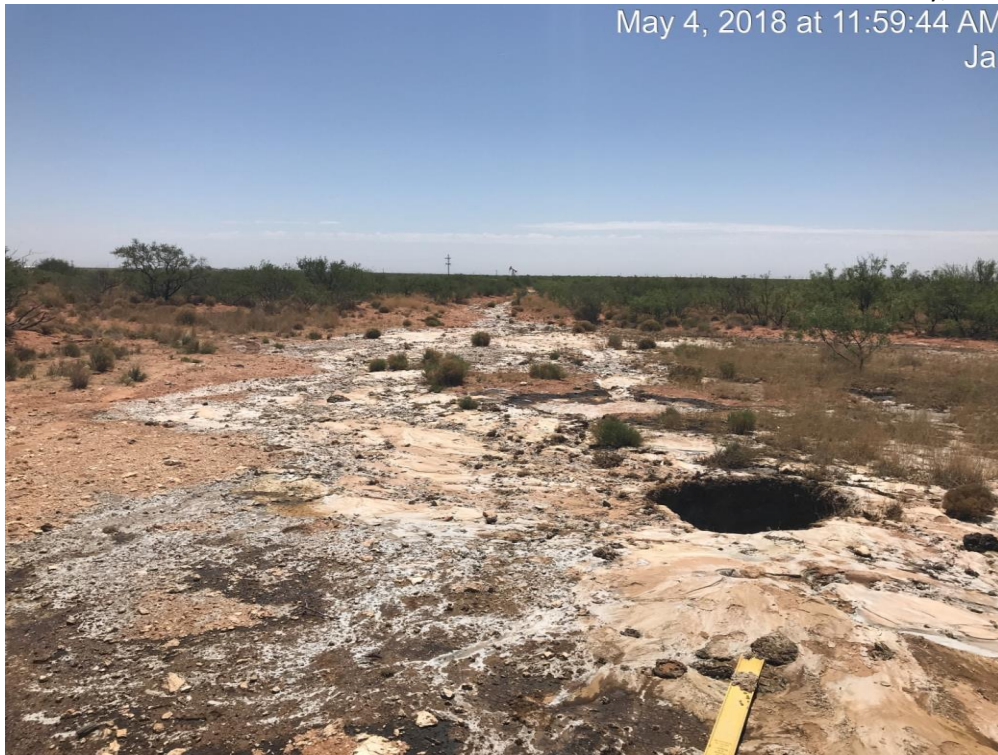
Washout and Spill Viewing Southeast of Cooper Jal Unit #222 (P/A), May 4, 2018

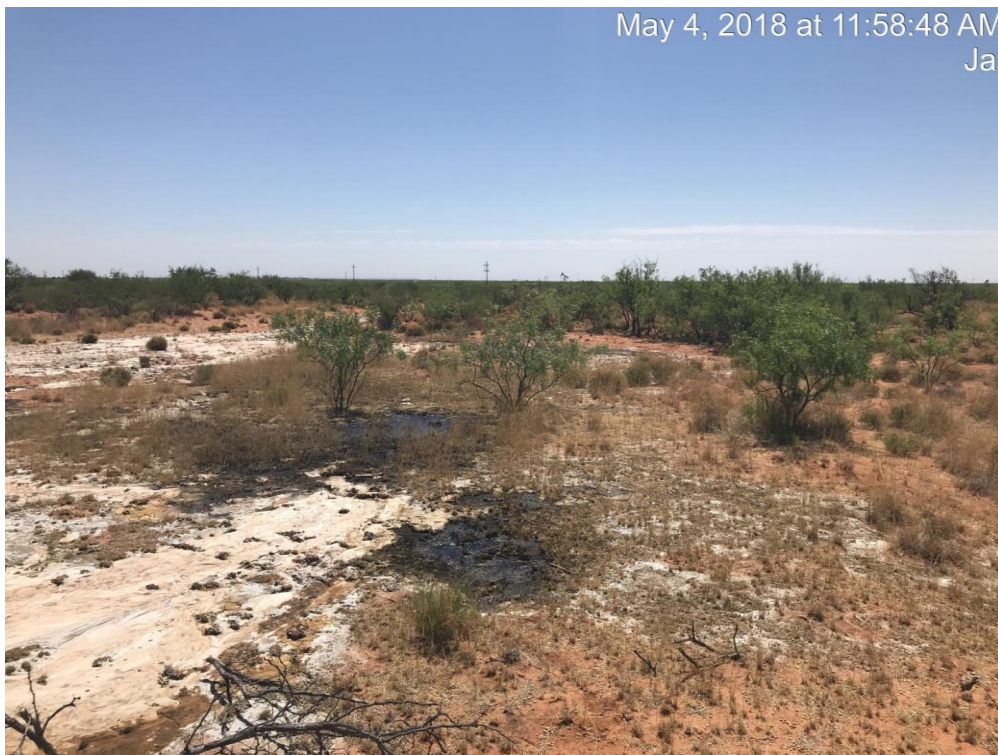
Spill Viewing South from Cooper Jal Unit #222 (P/A), May 4, 2018

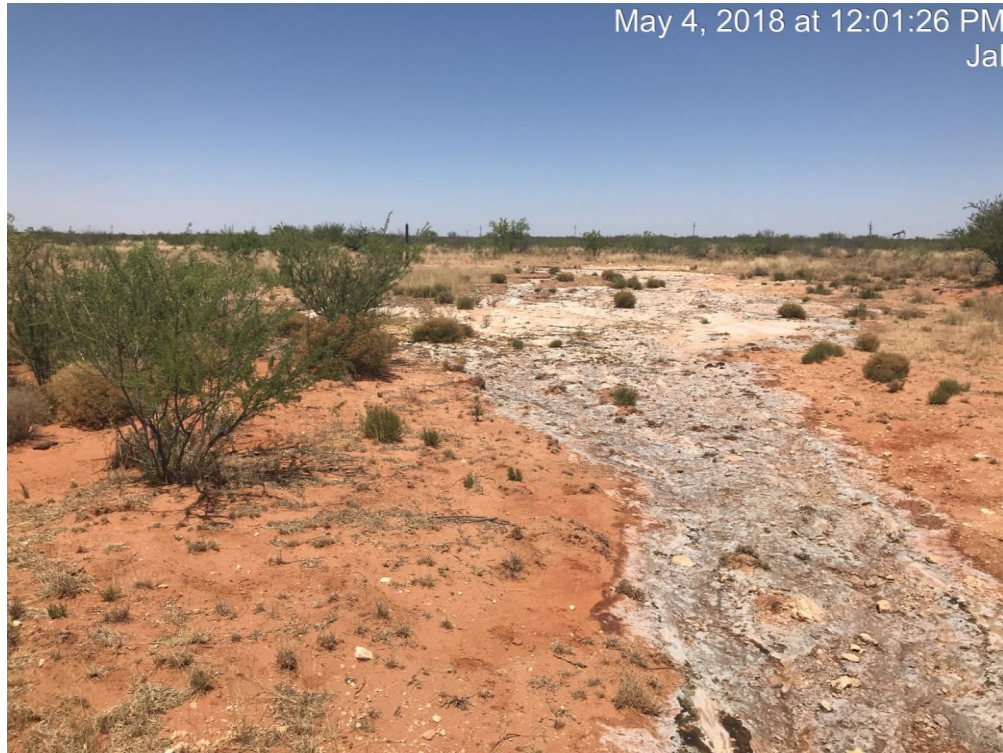
Spill Viewing North to Cooper Jal Unit #222 (P/A), May 4, 2018

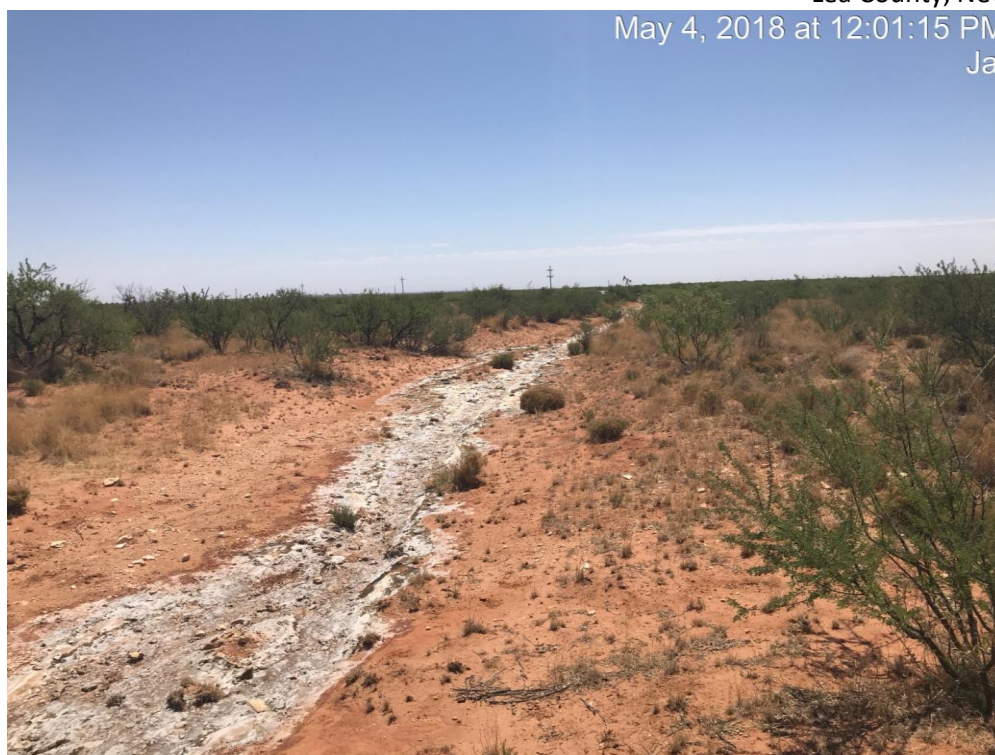
Spill Viewing Southeast from Cooper Jal Unit #222 (P/A), May 4, 2018

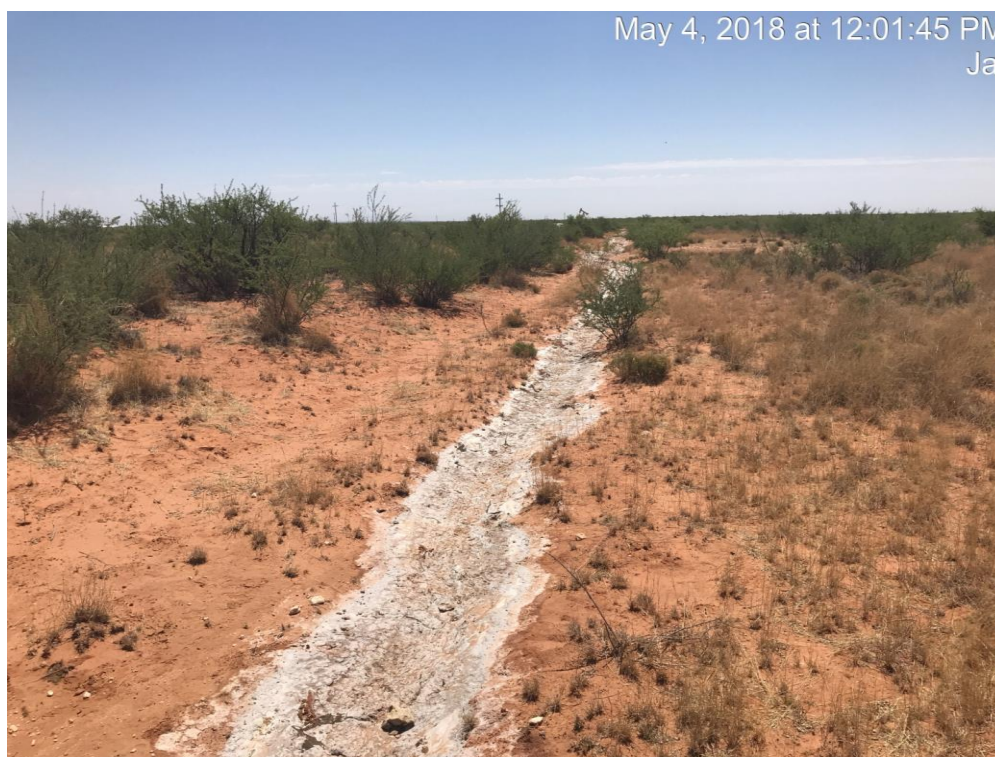
Spill Viewing Southeast from Cooper Jal Unit #222 (P/A), May 4, 2018

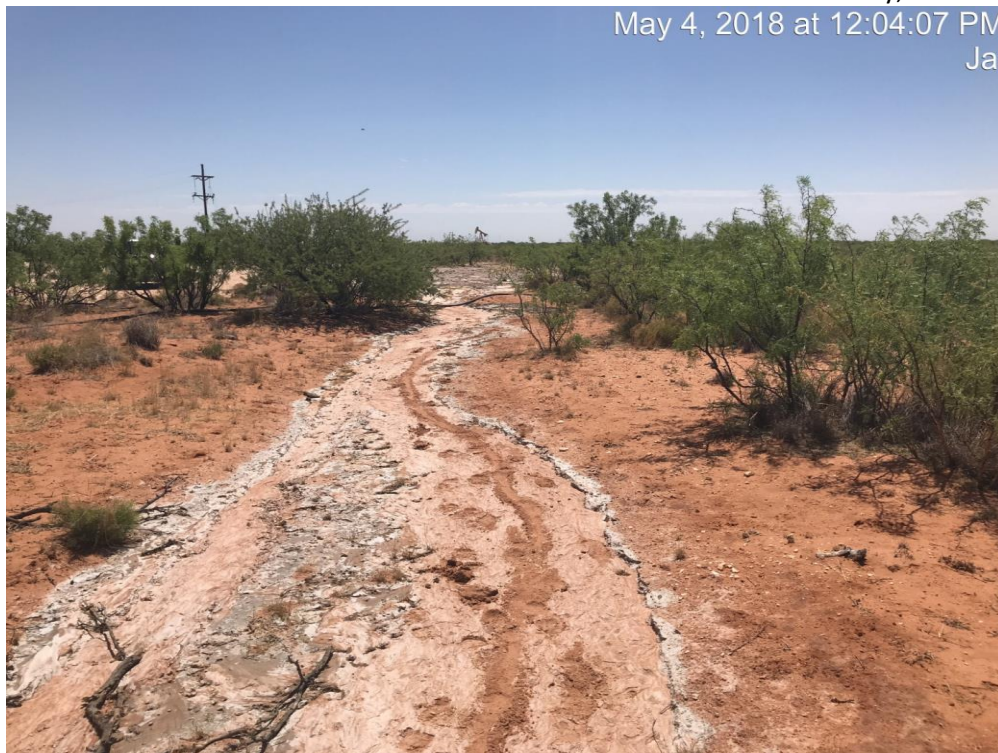
Spill Viewing Southeast to Road Intersection, May 4, 2018

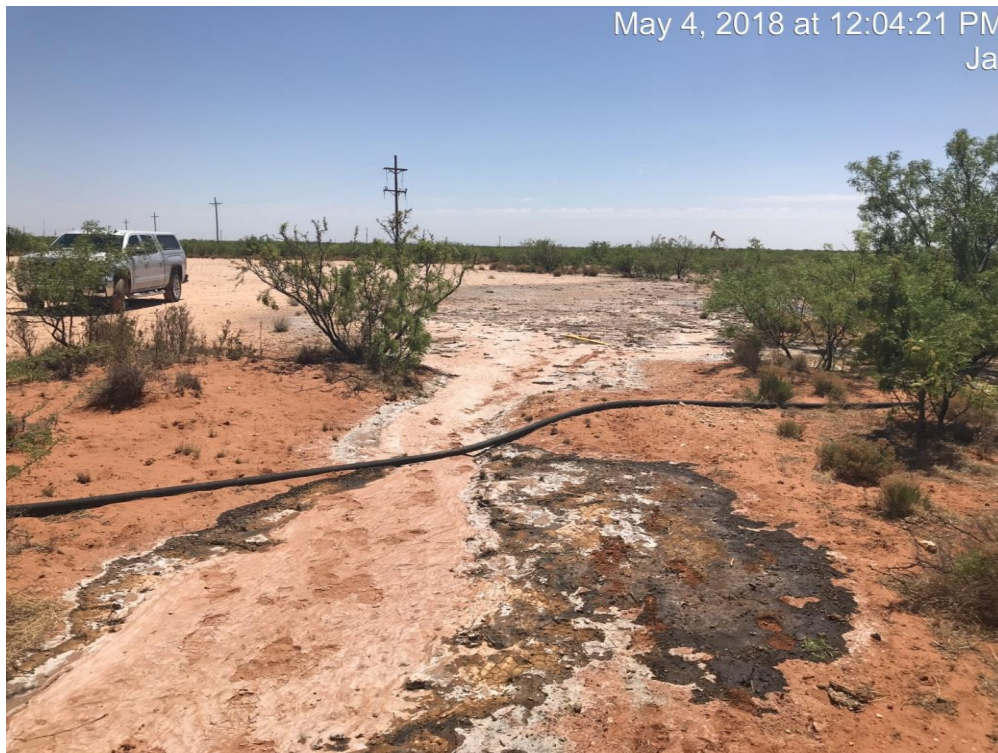
Spill Viewing Southeast to Road Intersection, May 4, 2018

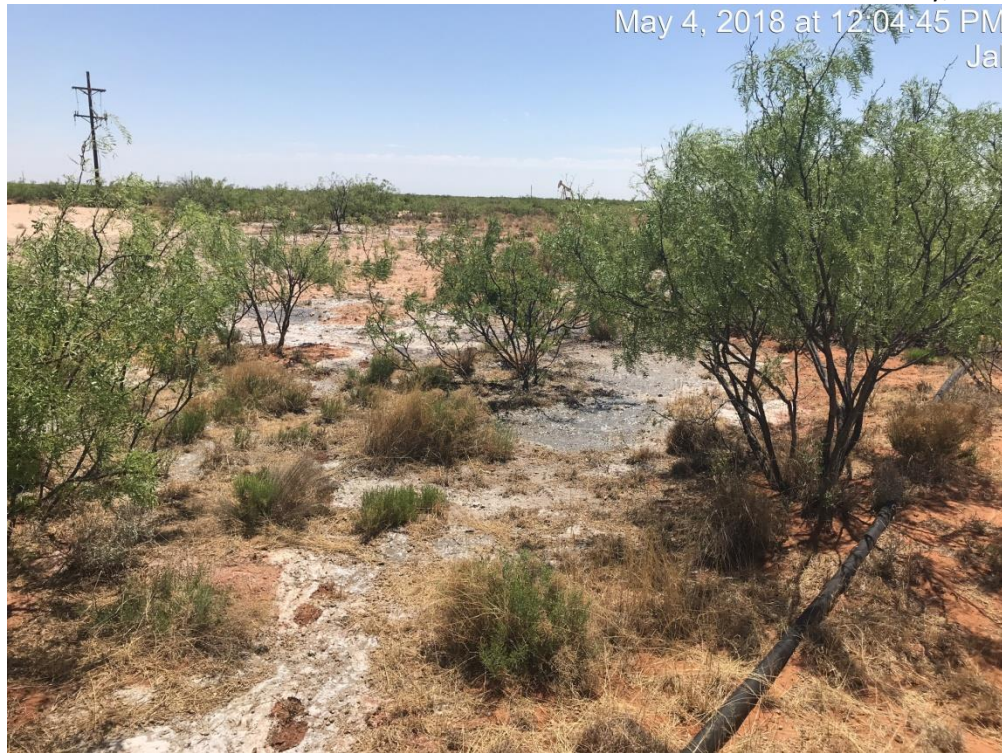
Spill Viewing Southeast to Road Intersection, May 4, 2018

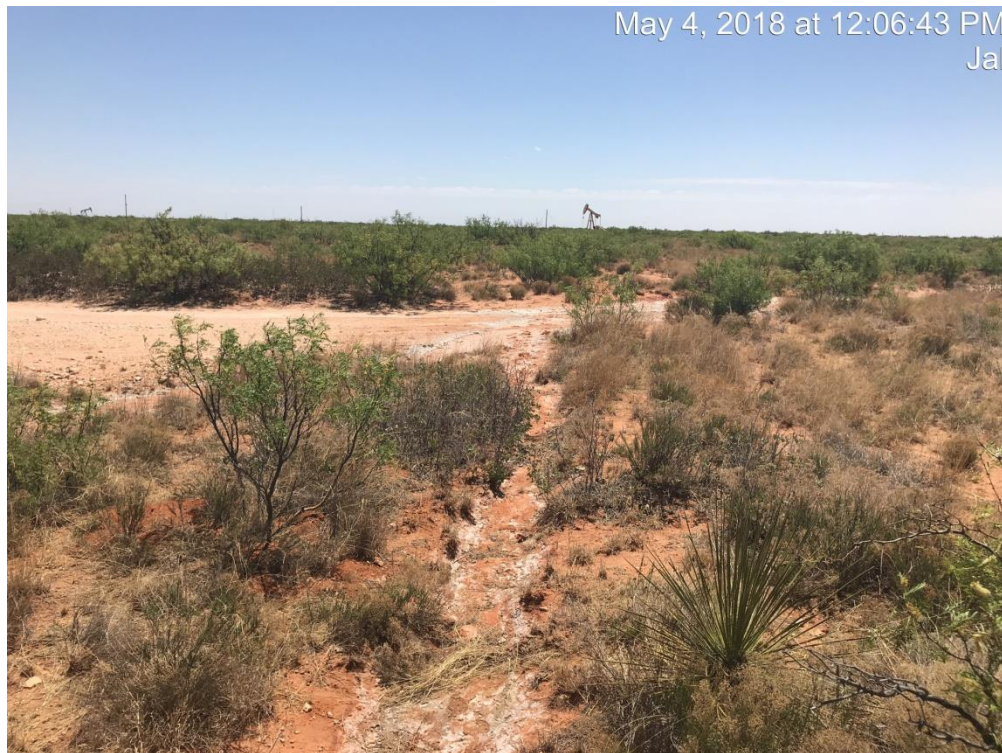
Spill Viewing Southeast to Road Intersection, May 4, 2018

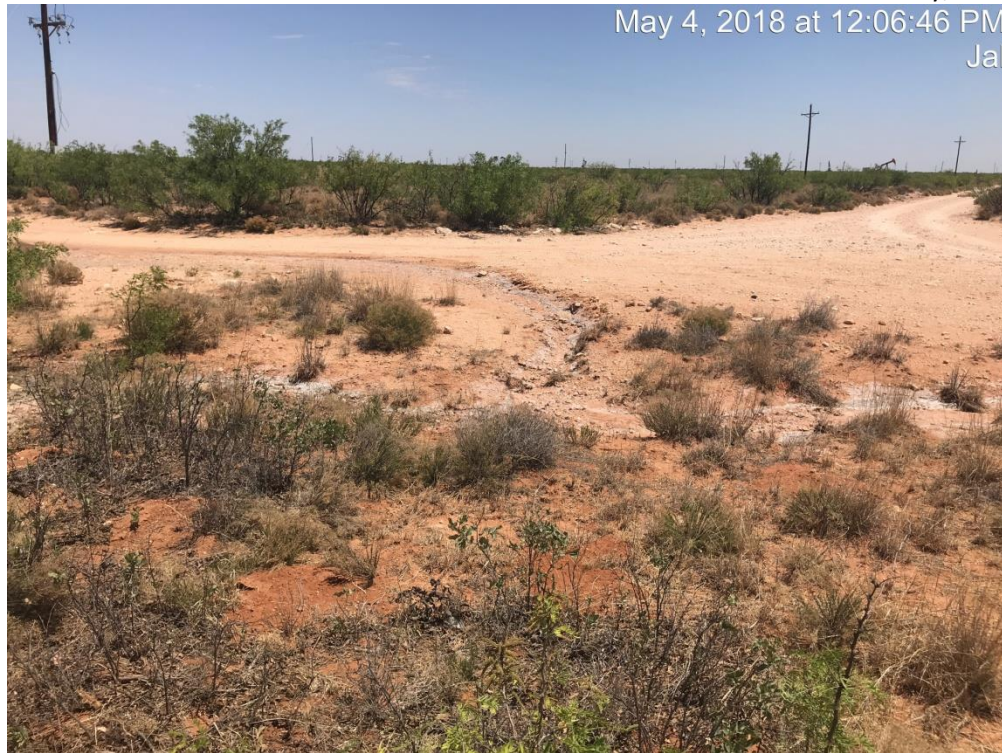
Spill Viewing East South of Road Intersection, May 4, 2018

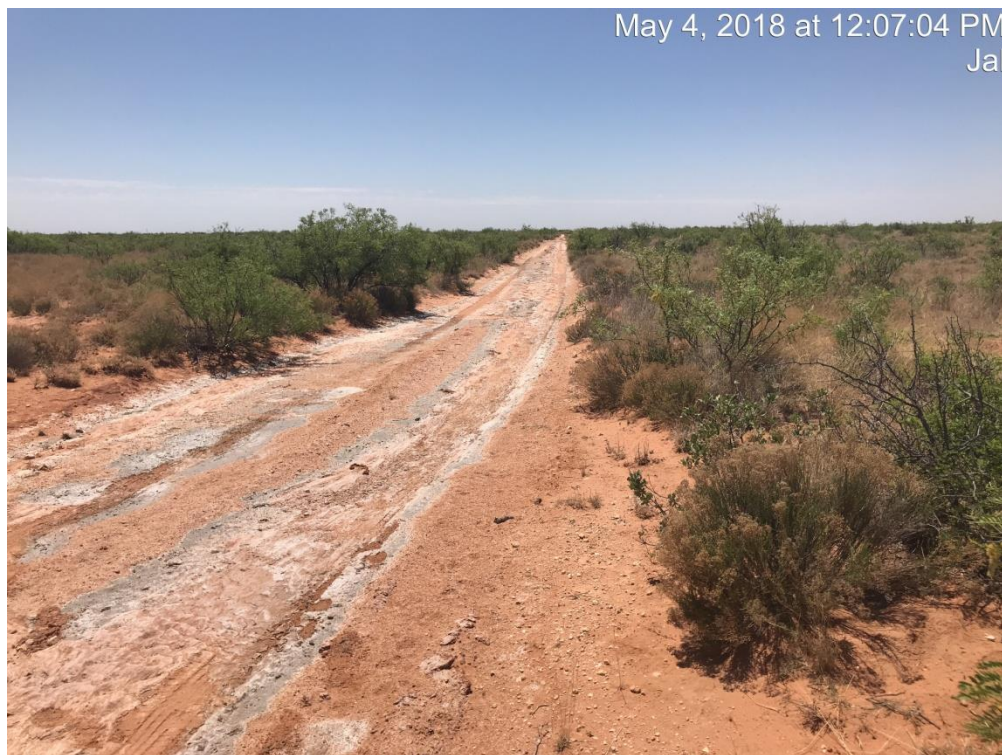
Spill Viewing South of Road Intersection, May 4, 2018

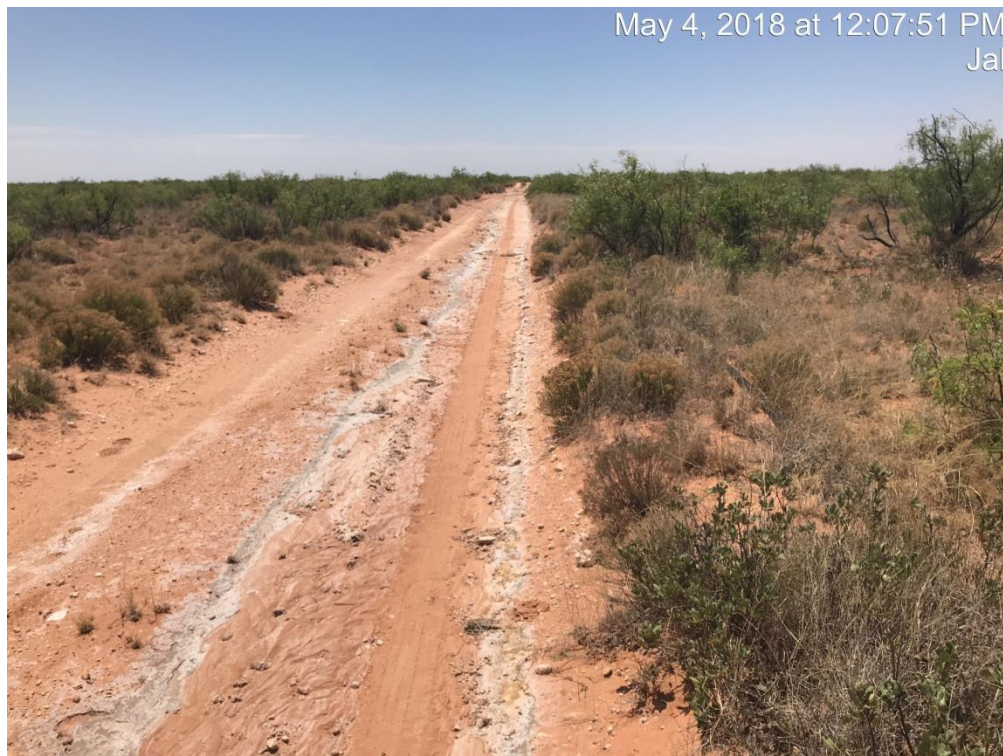
Spill Viewing South of Road Intersection, May 4, 2018

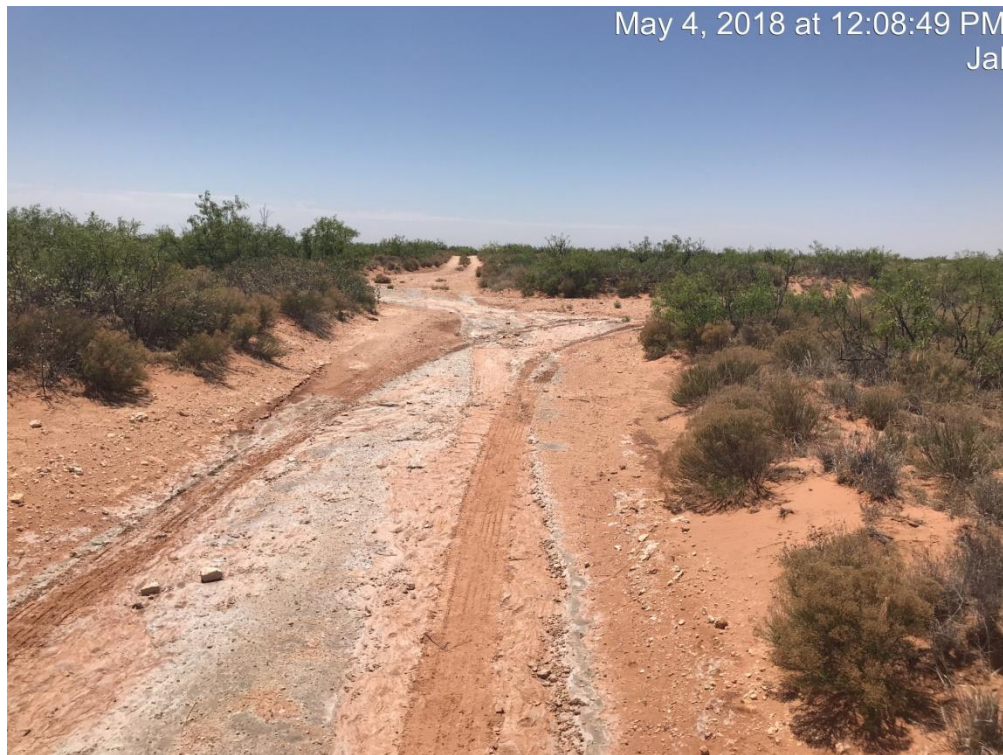
Spill Viewing South of Road Intersection, May 4, 2018

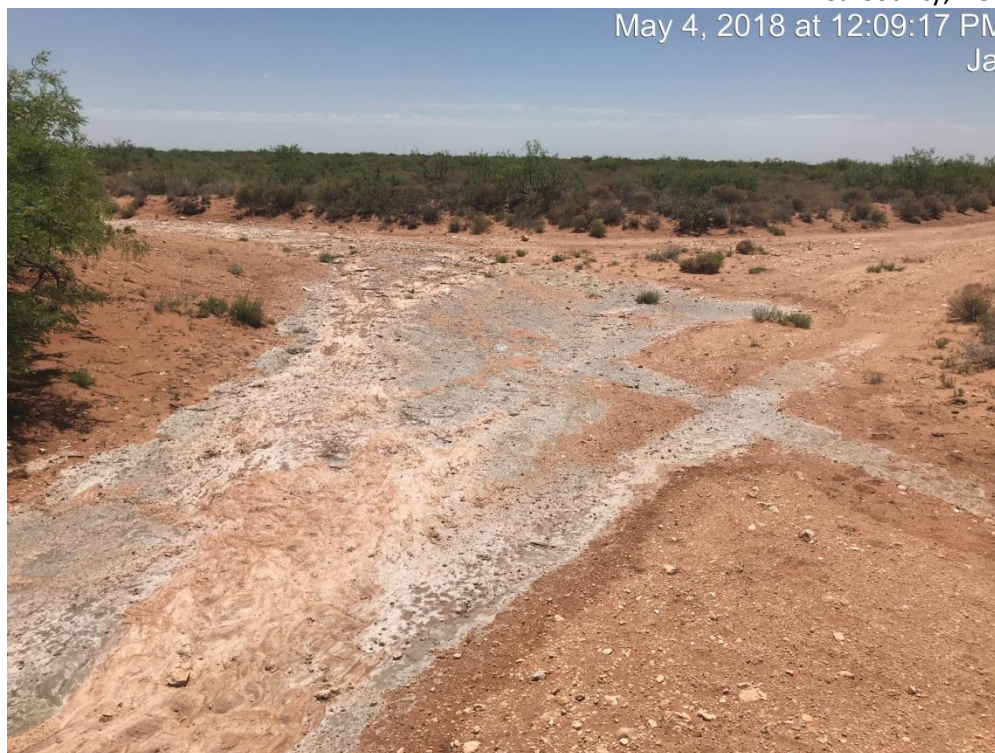
Spill Viewing Southeast to Road Intersection, May 4, 2018

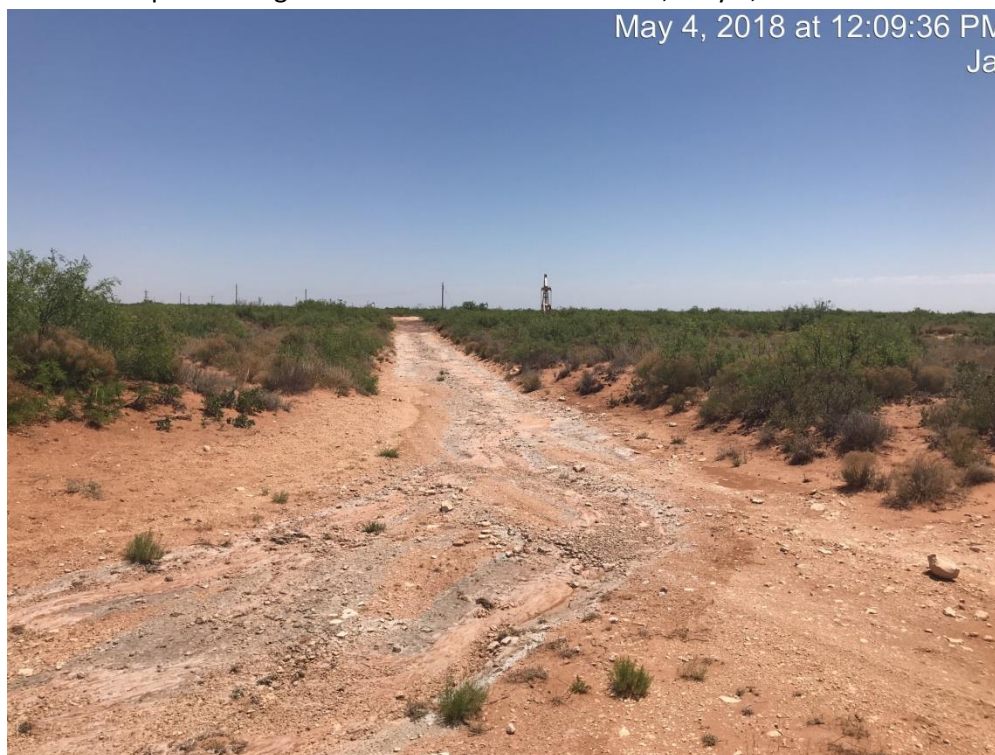
Spill Viewing East of Road Intersection, May 4, 2018

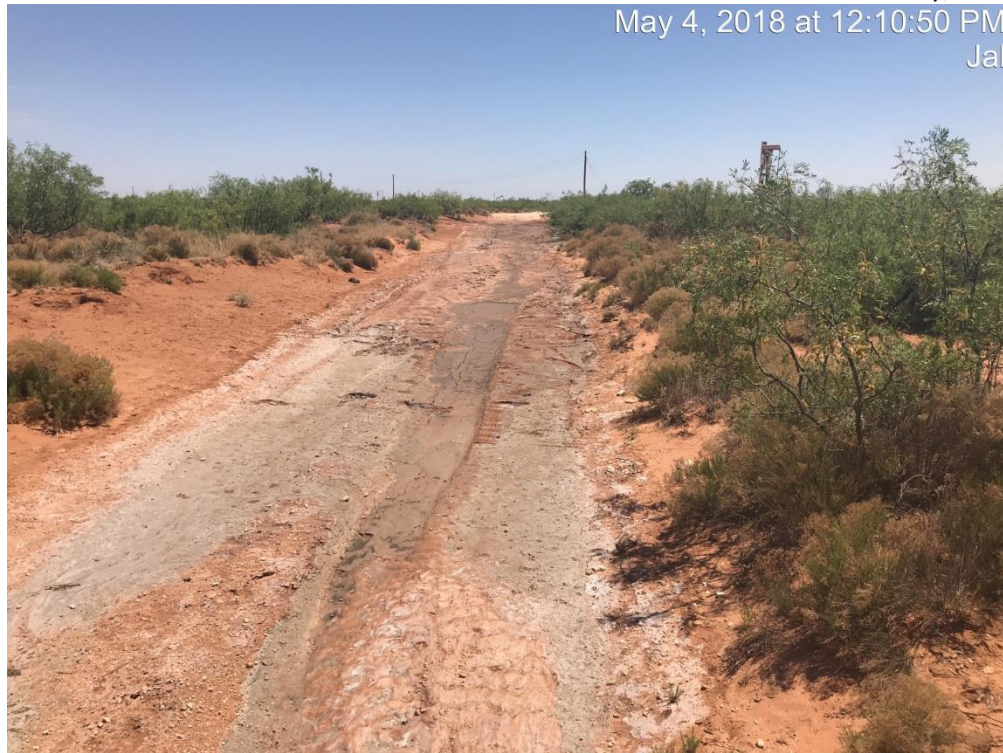
Spill Viewing East of Road Intersection, May 4, 2018

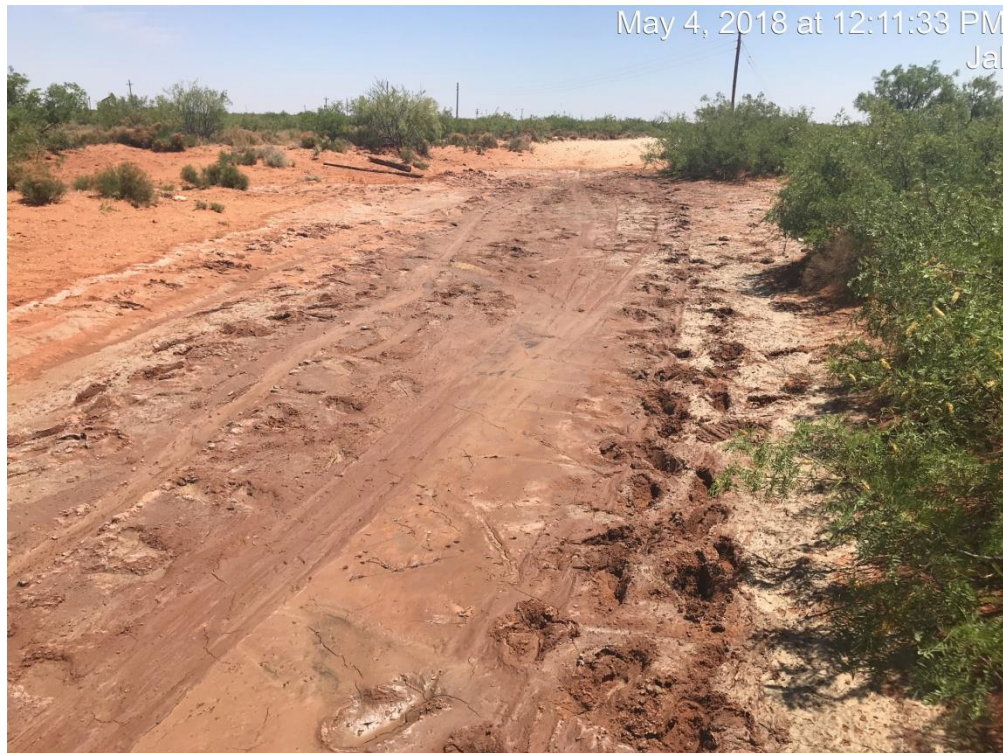
Spill Viewing East of Road Intersection, May 4, 2018

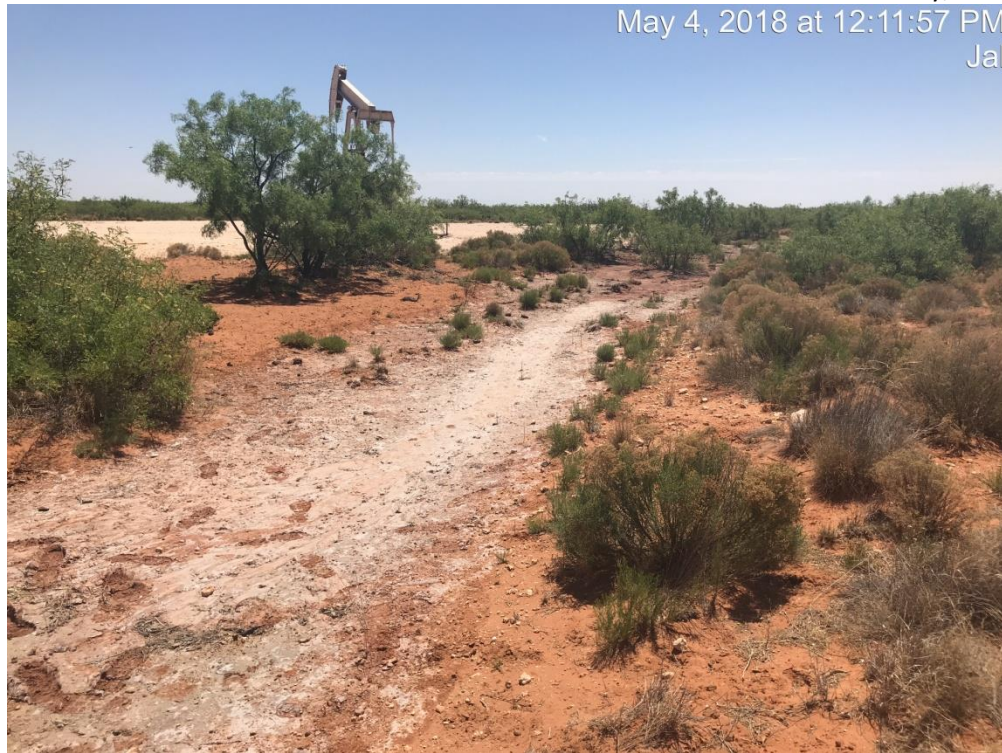
Spill Viewing South to Terminal End of Spill, May 4, 2018

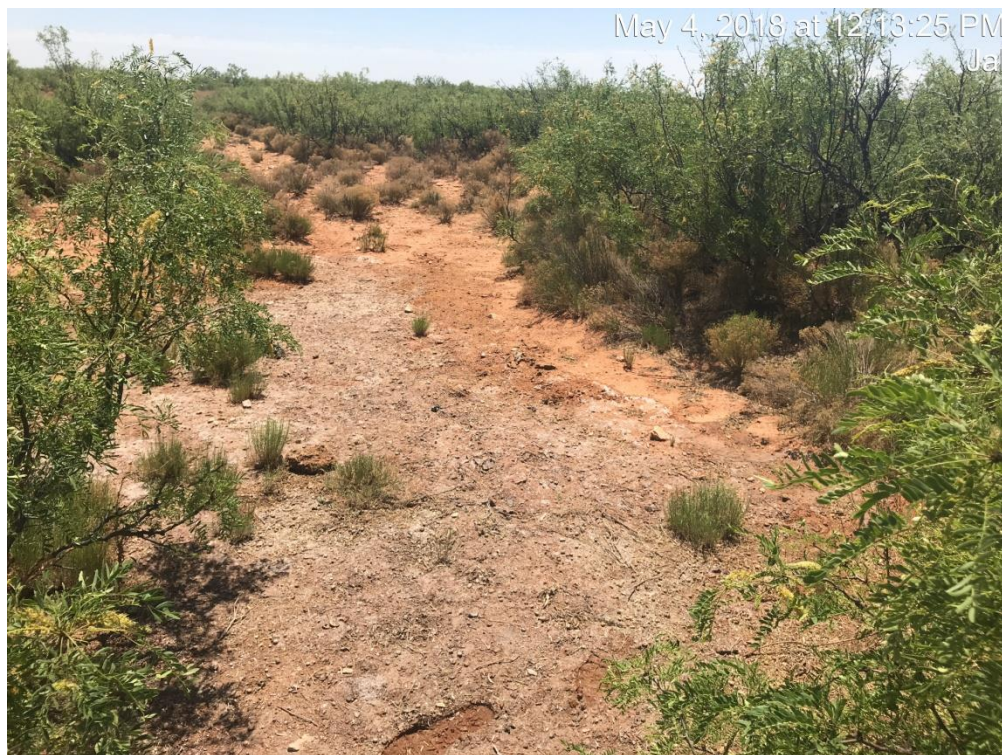
Spill Viewing South to Terminal End of Spill, May 4, 2018

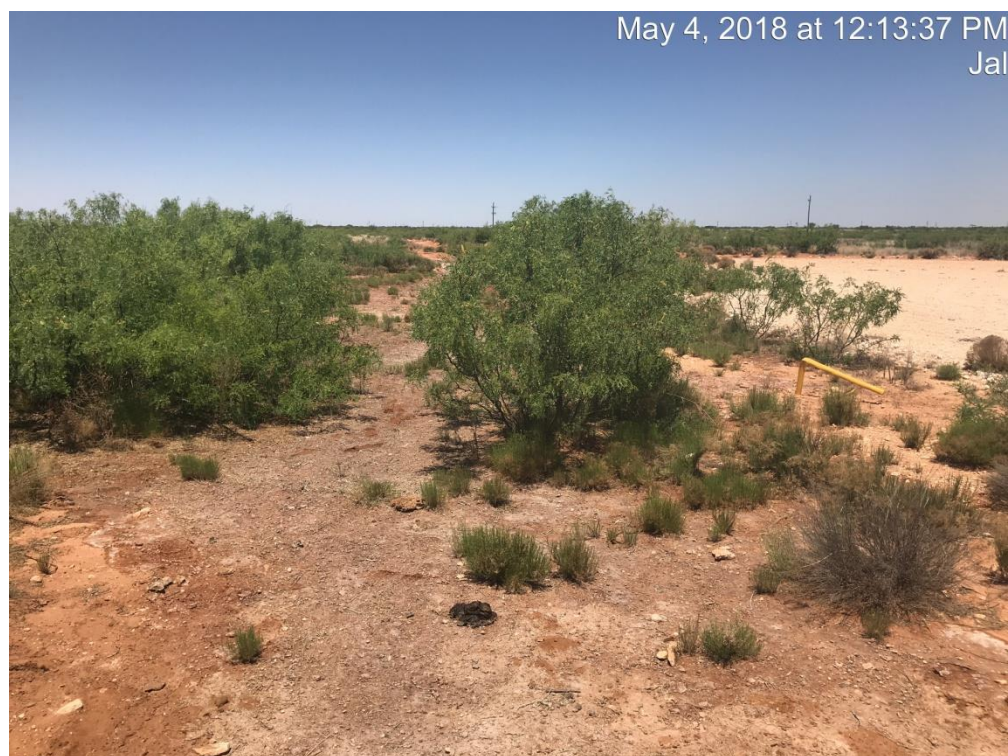
Spill Viewing North from Terminal End of Spill, May 4, 2018
