RE: Remediation Plan
East Eumont Unit Sat 1, 3" poly trunk line
UL 'J', Sec 33, T-18-S, R-37-E

Release Notification and Corrective Action

East Eumont
Unit Sat 1 Trunkline Leak
Driving Instructions

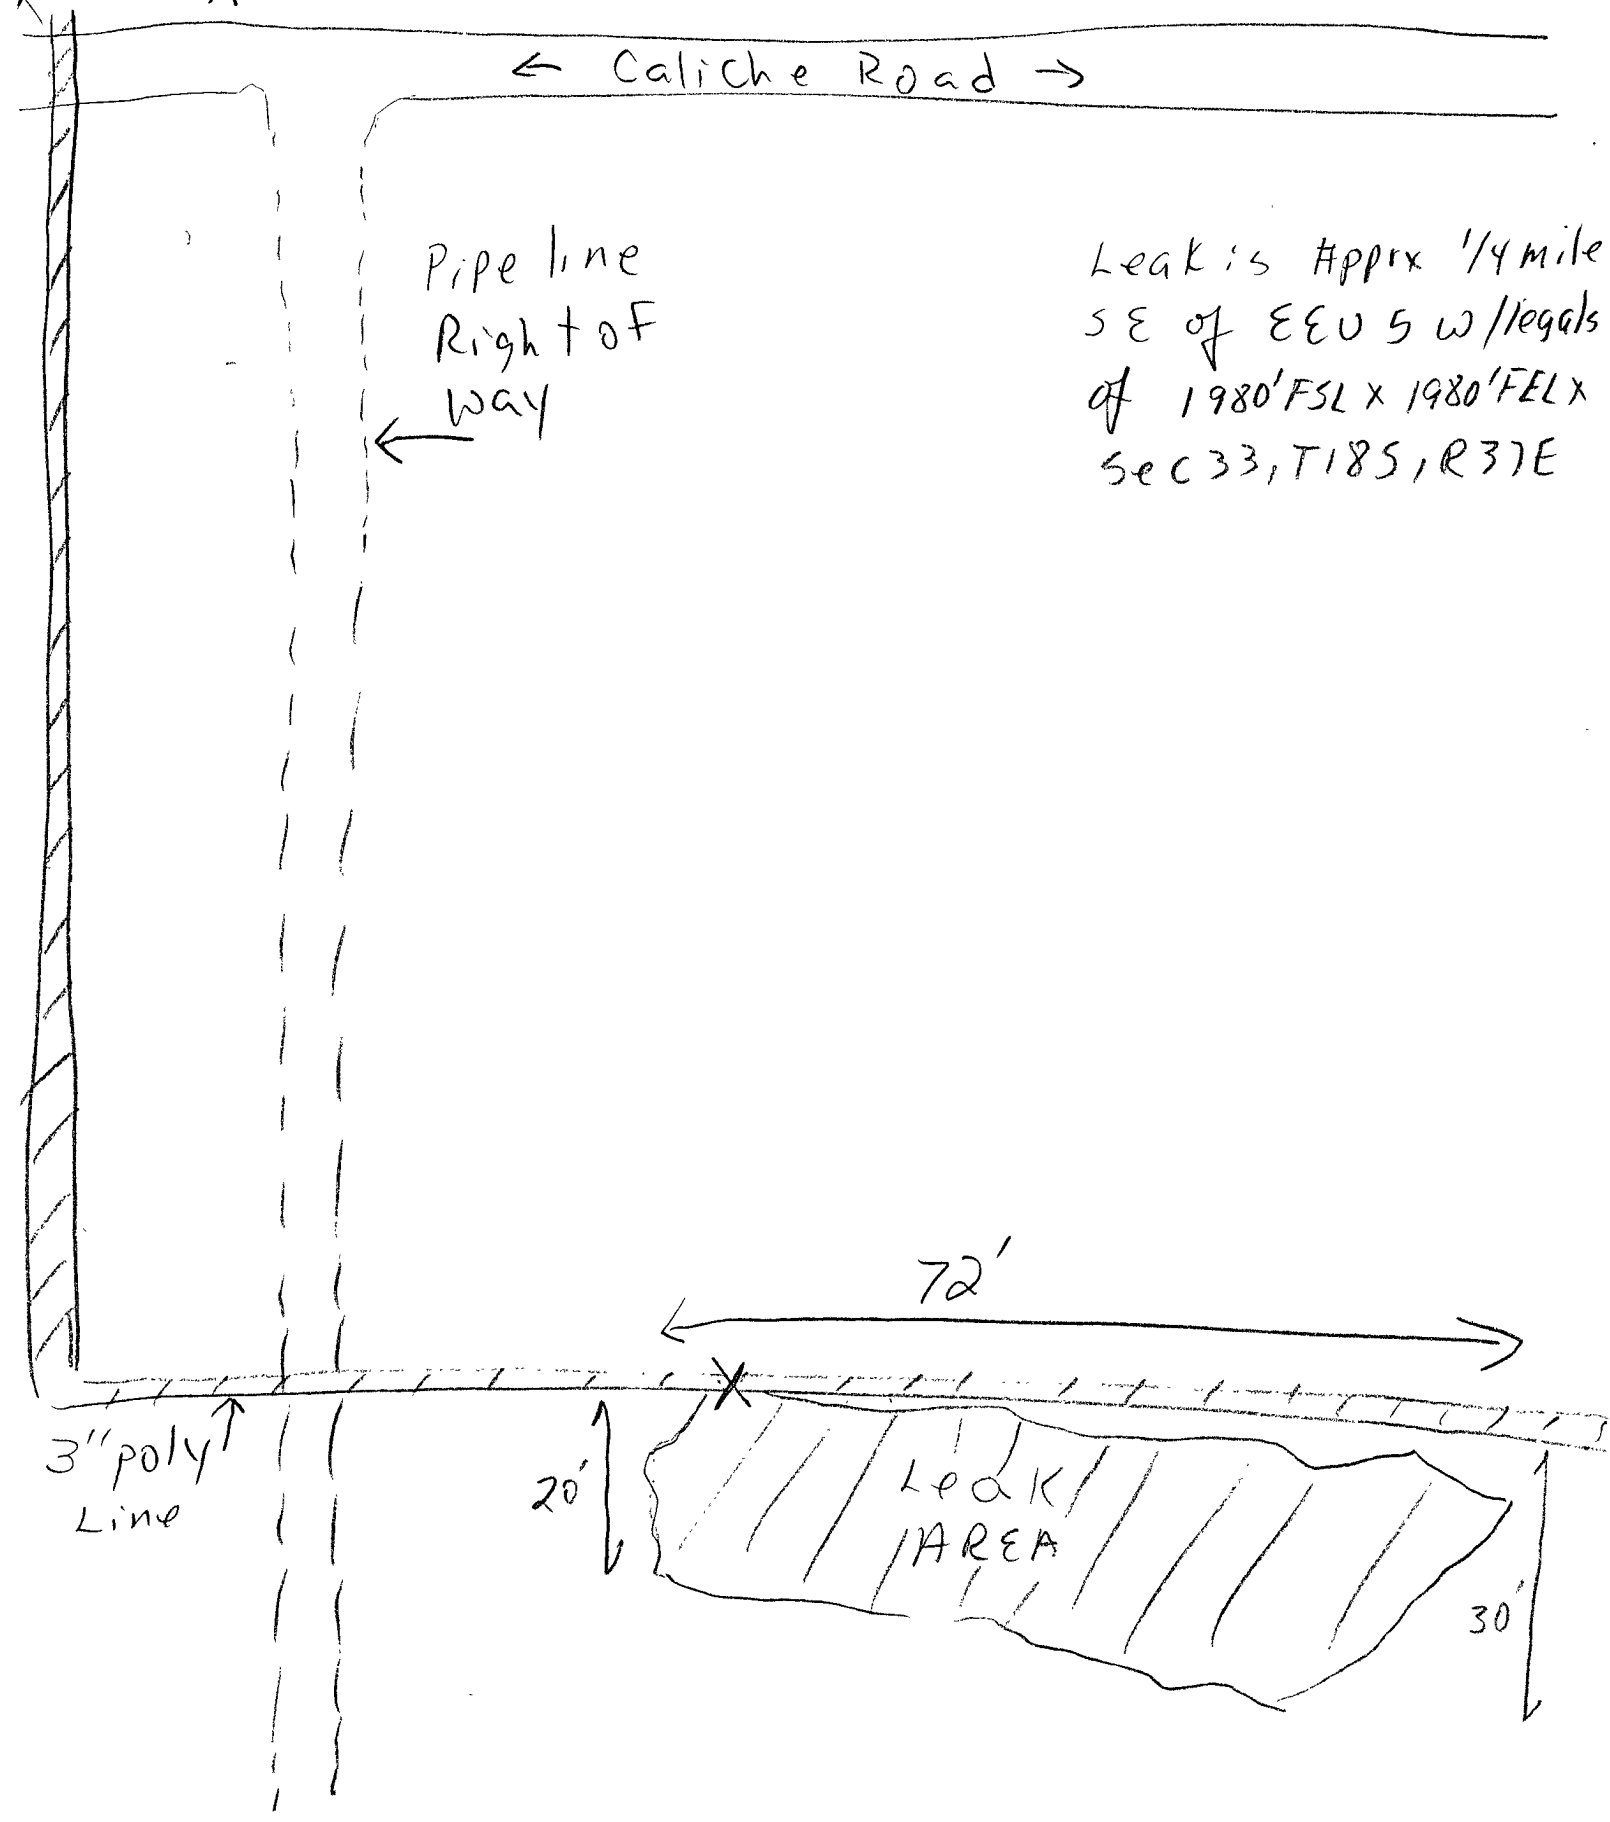
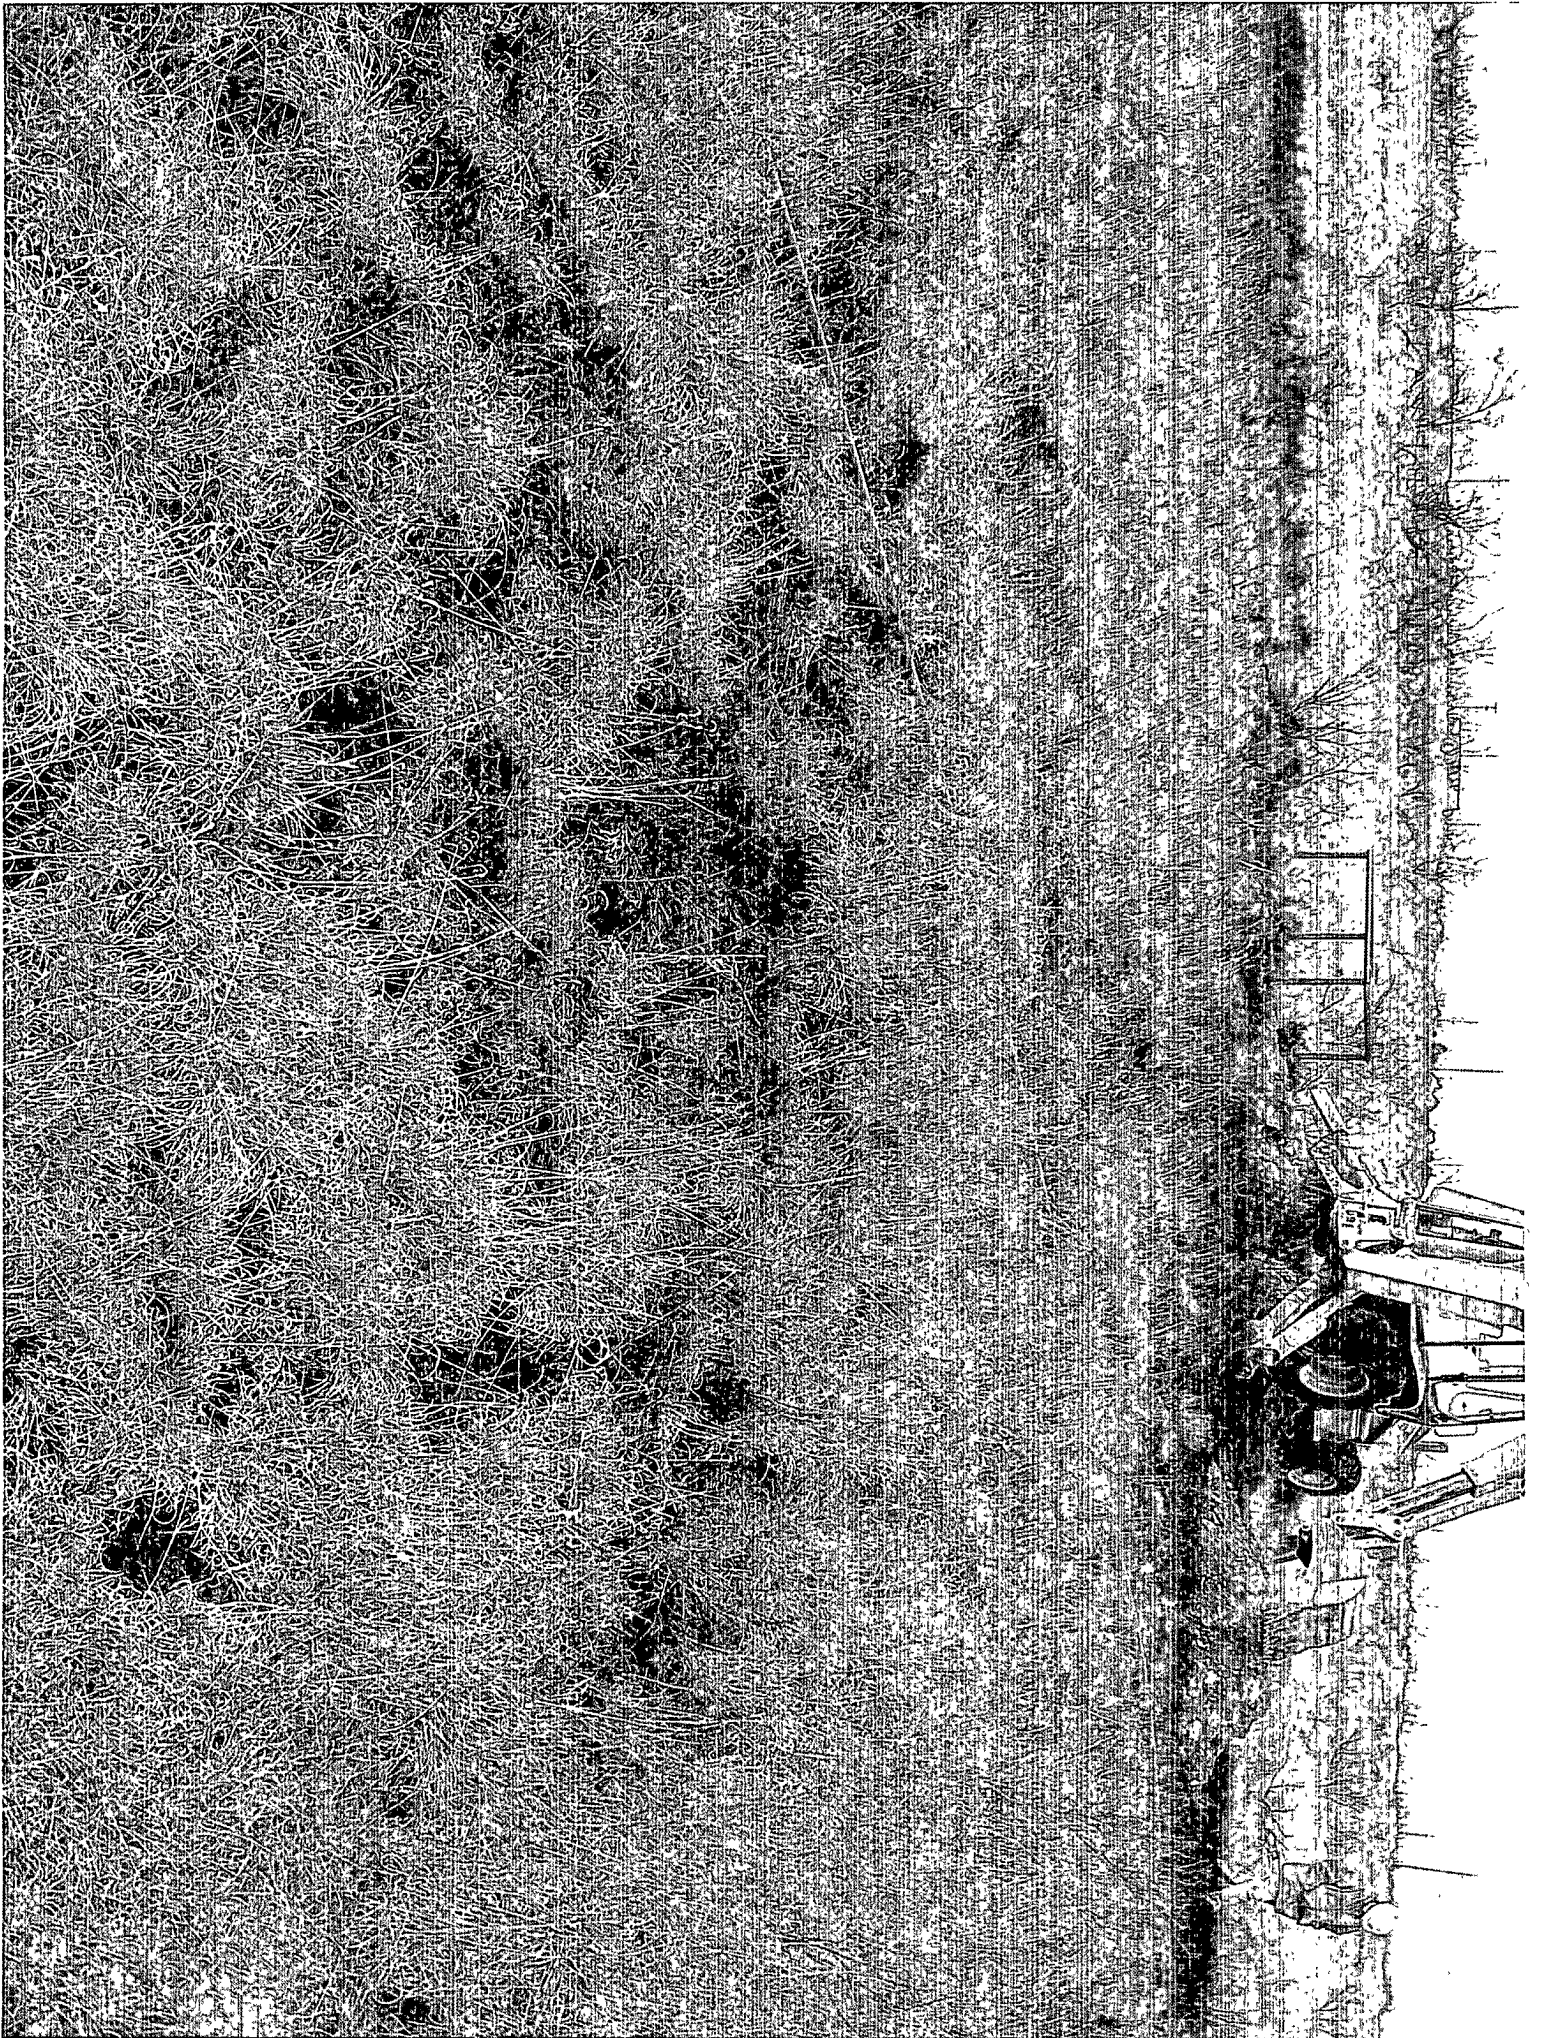
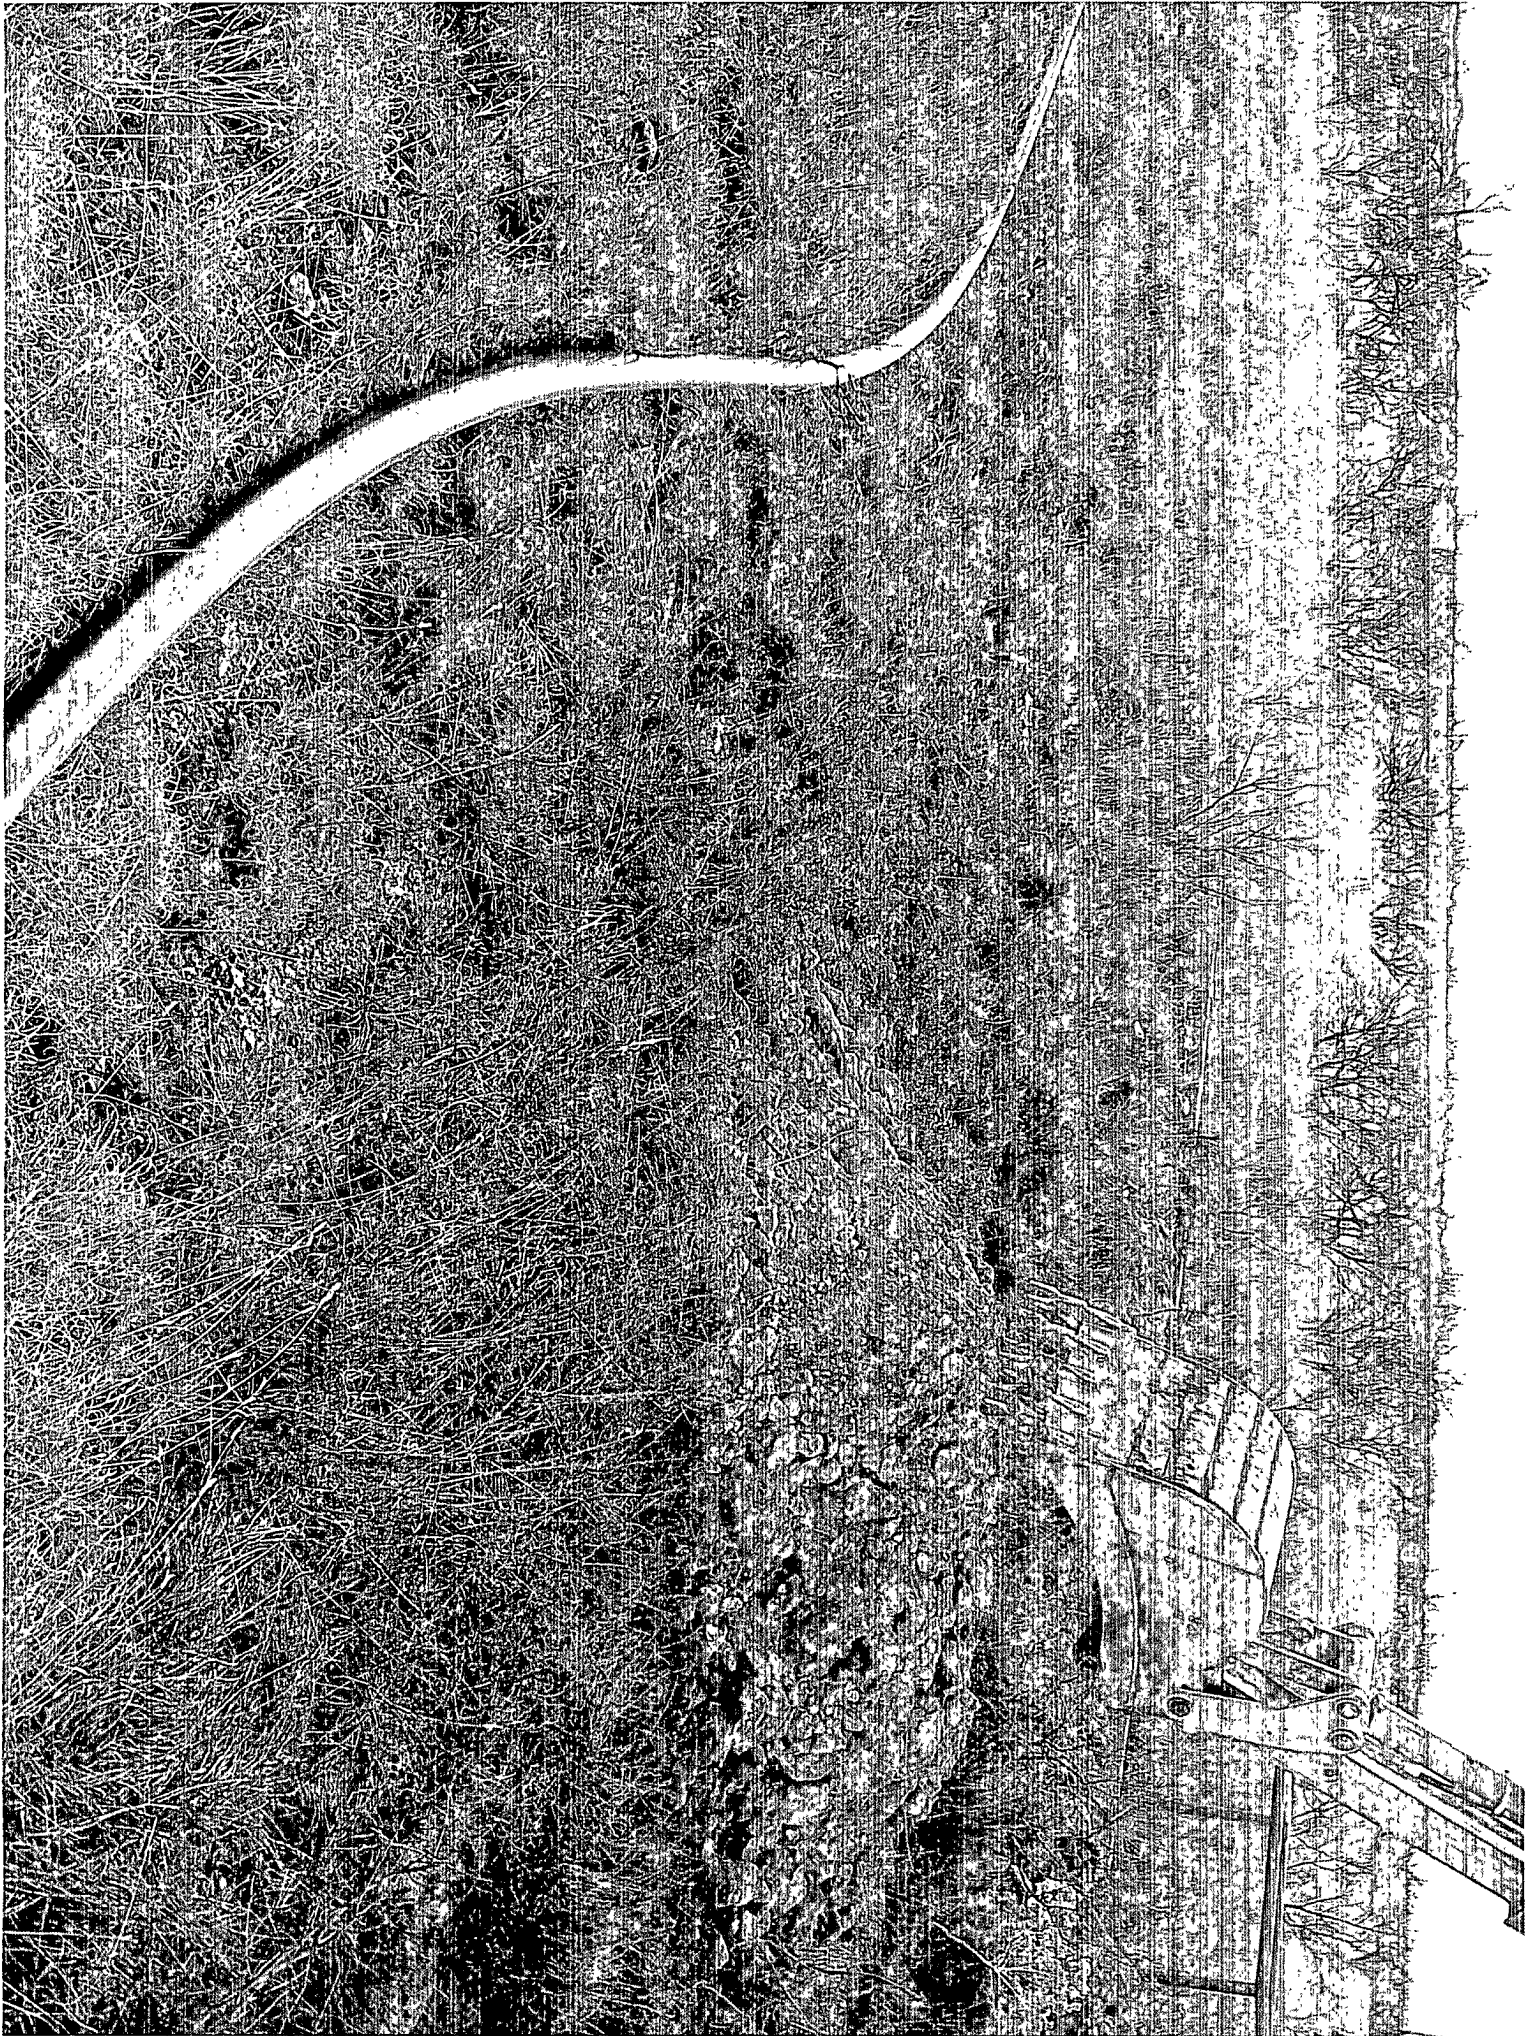
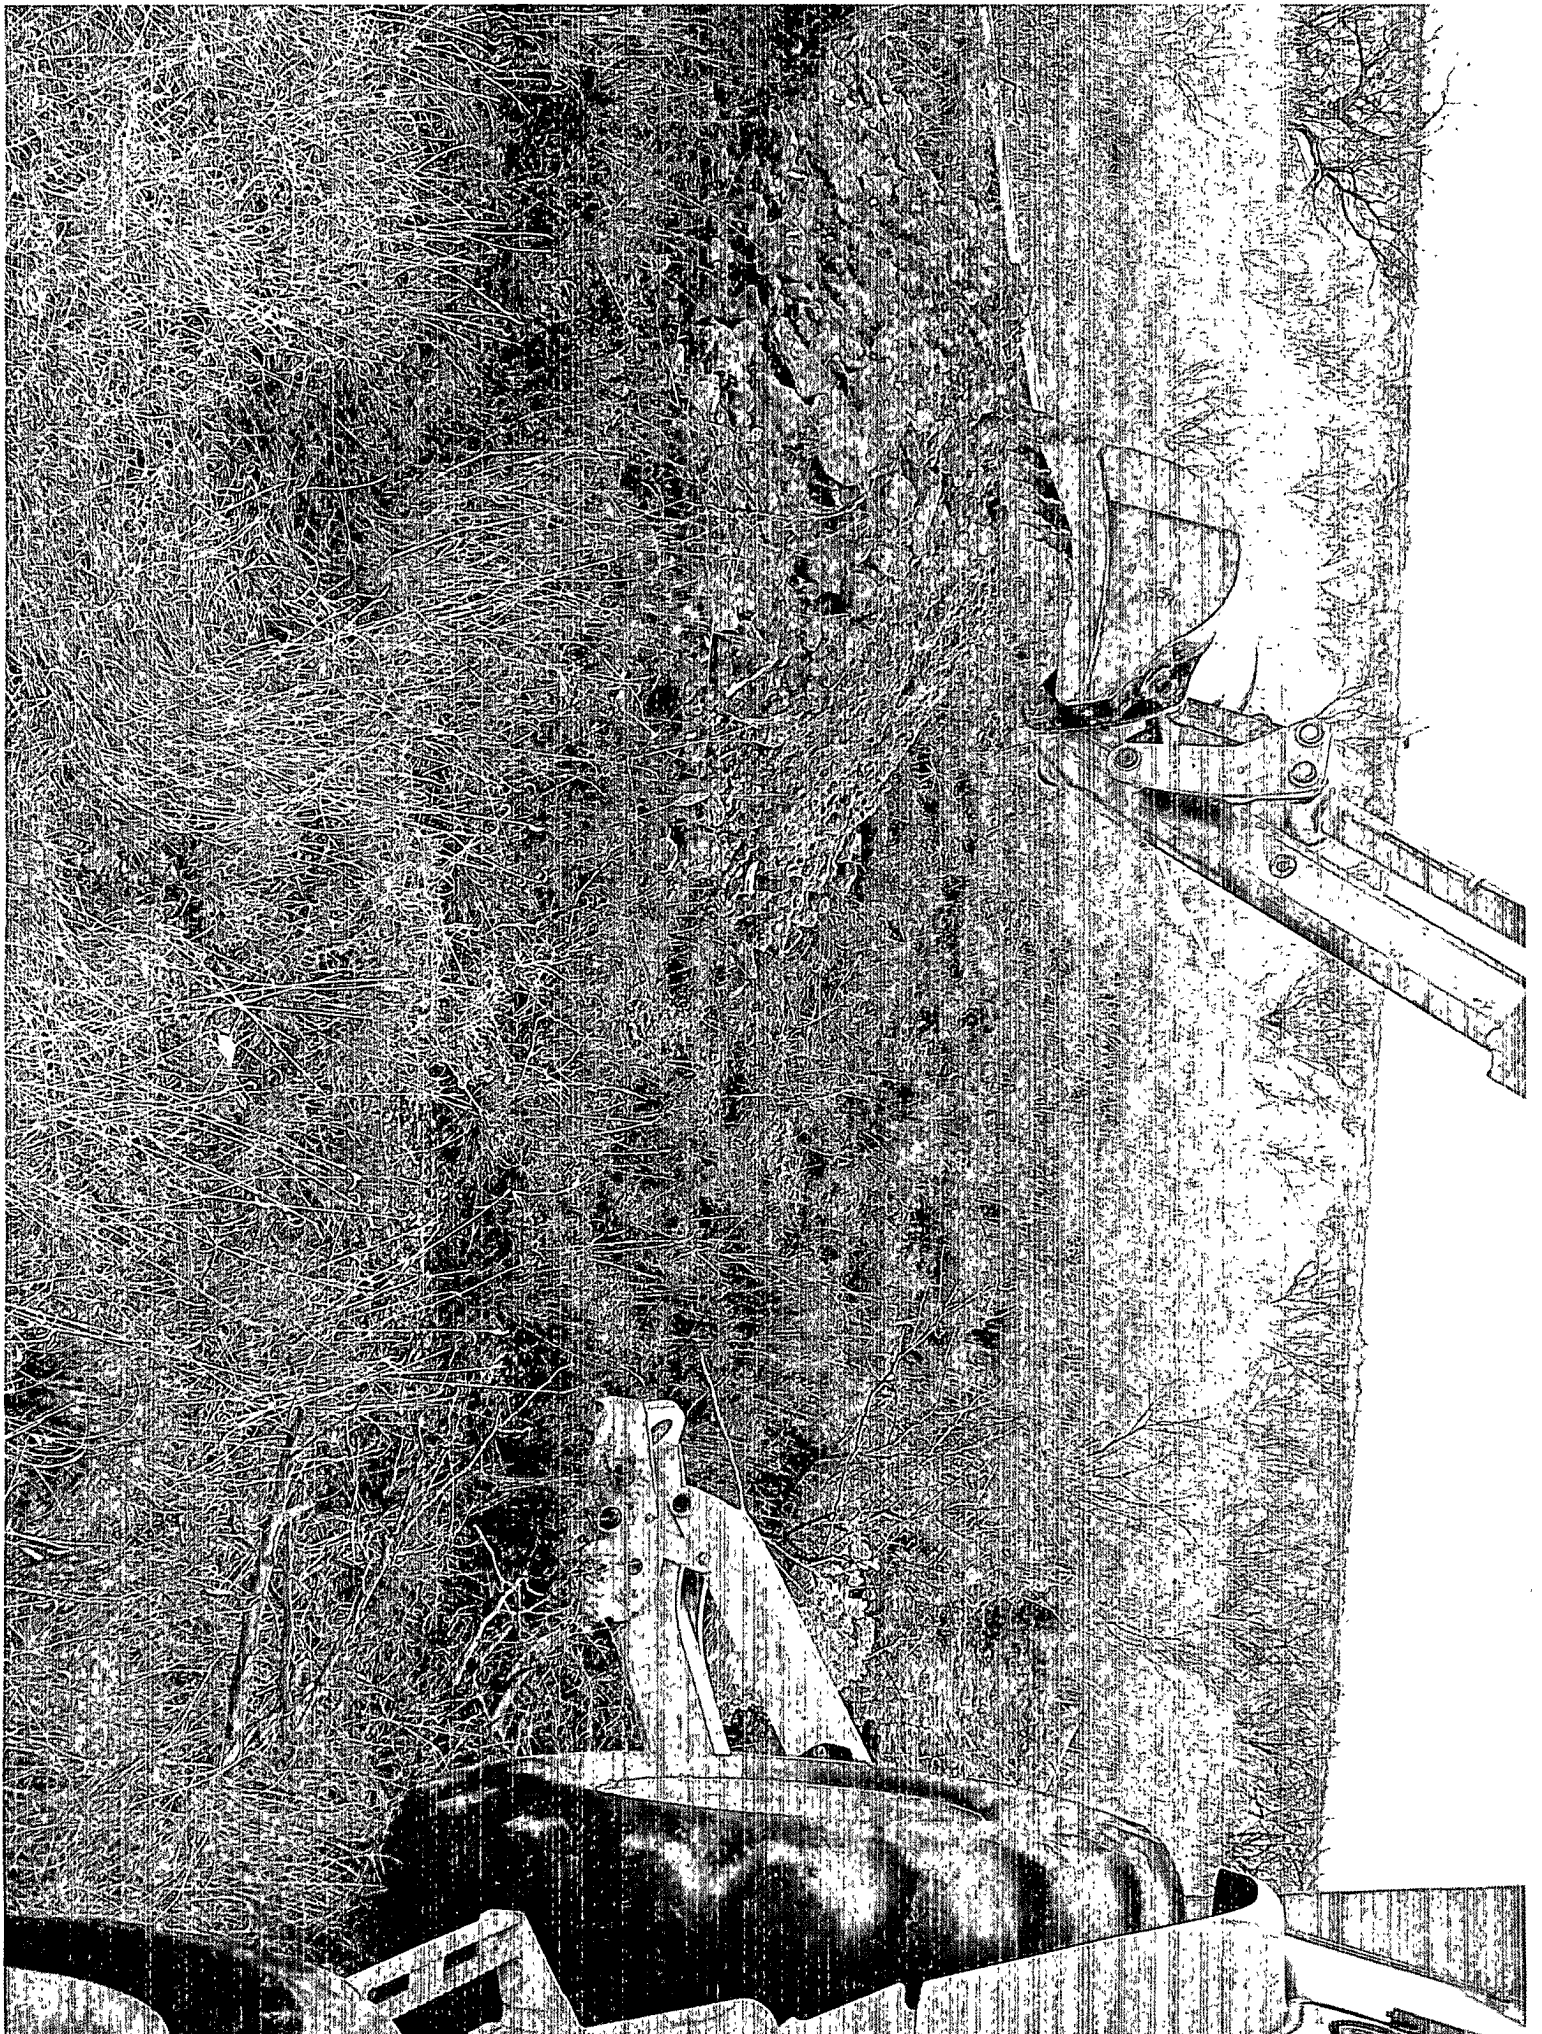
Leak was found on 12/30/07 at approximately 10 am. Leak occurred 3" poly line (not buried) due to freezing. Line is closest to EEU well #5 and the above legals are for that well. All wells were shut in, valves closed until line could be repaired. A vacuum truck was called to pick up all free fluids. Normal liquid rate for line is 140 barrels per day at average 40 psi. with produced waters for lease averaging 2600 ppm chlorides. The area affected by the spill can be seen on the attached hand drawn map. An estimated 5 BO and 7 BW were spilled and 4 BO and 6 BW were recovered. Depth to ground water according to Pat Caperton with NMOCD is 50' giving this spill site a ranking of 10. Remediation of the spill site will be as follows:

Describe Cause of Problem and Remedial Action Taken.* Lease operator found leak at approximately 10 am in a 3" poly trunk line from EEU Satellite 1. Line had froze and busted. All wells were shut in and vacuum truck called to pick up all free standing fluids Line was repaired and returned to production that afternoon.

1. Piping will be replaced/repared.
2. Affected area will be excavated and contaminated soil will be hauled to JL Land Farm.
3. Soil samples will be gathered from affected area and submitted to NMOCD for closure.
4. NMOCD guidelines will be used to insure entire site is in compliance with guidelines.
5. Any soils removed will be replaced with fresh soils as needed..
