WATER CONTAMINATION STUDY

CAPATAZ OPERATING, INC.

Re: Case No. 5051-4270
House #1 Well Site
Lea County, New Mexico

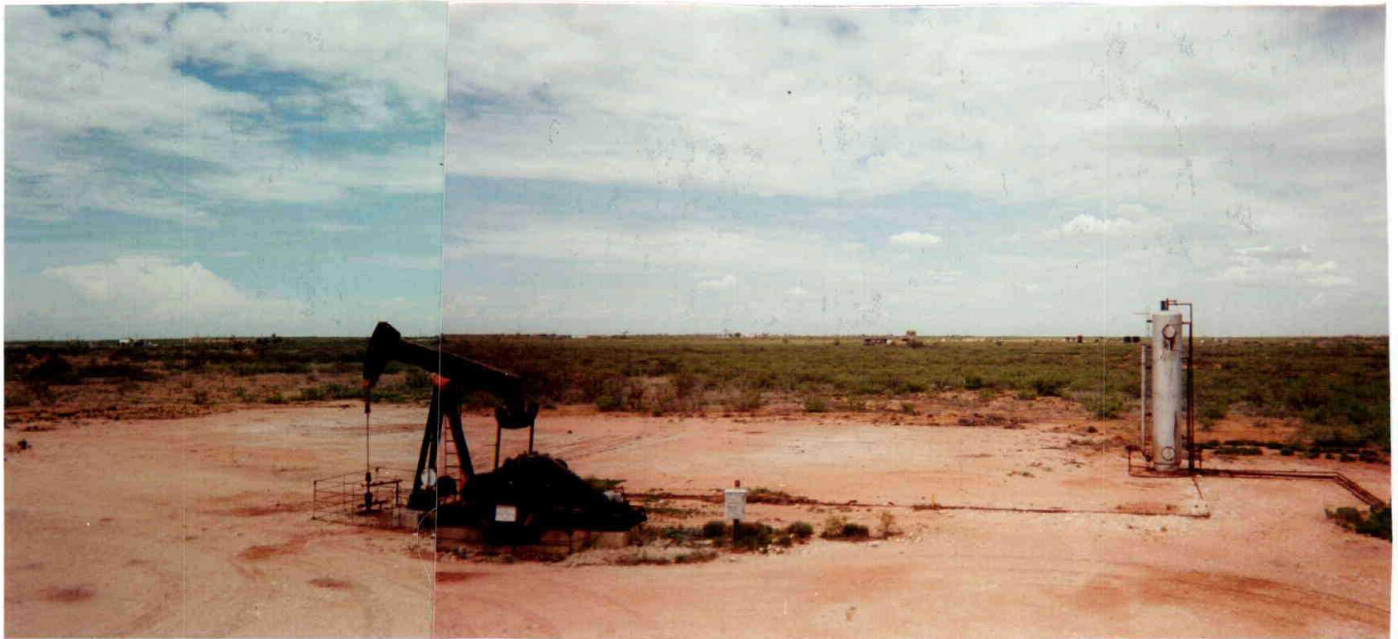
PHOTO #1

Capataz House #1. View to North- Northwest

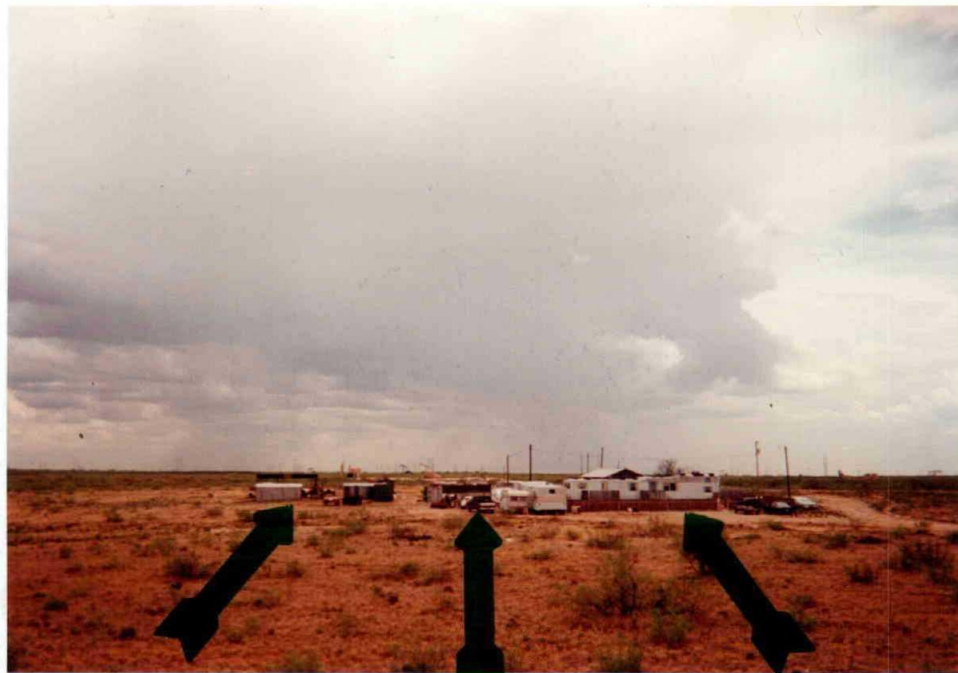
PHOTO #2

View from Capataz House #1 to Brinkley residence, barn & livestock pens.

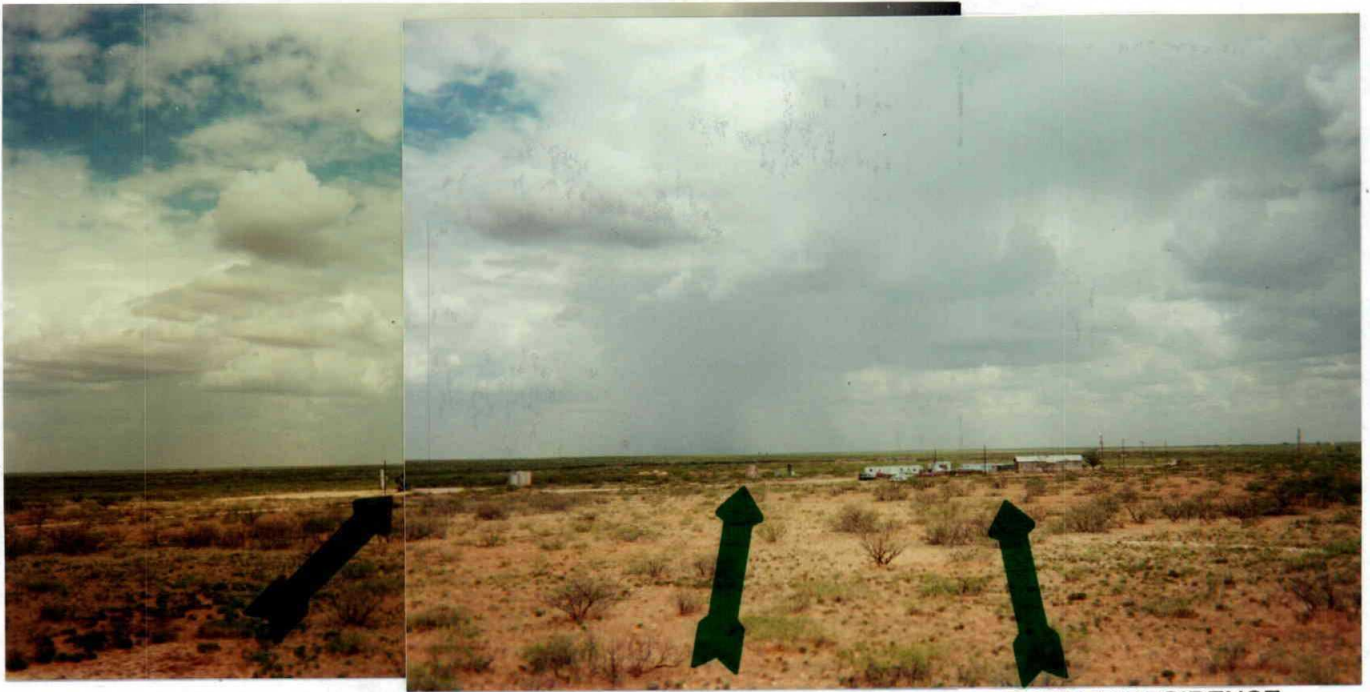
PHOTO #3

The NMOCD has designated the Seay Exploration/Capataz Operating #1 House well as a possible source for the chlorides found in the Brinkley well because of the mobile homes relative proximity to the House well (Photo #3). In October of 1990 Seay Exploration began drilling operations on the captioned well. Surface casing was set to a depth of 1700' and cement was circulated around the entire casing string to protect ground water. On November 1, 1990 4 1/2" casing was run to 7750' and cemented with 800 sacks of 50/50 Pozmix "H". Subsequently, the well was completed in March of 1991 as a Drinkard and Blinebry producing well. In early 1994 Capataz Operating became operator of the lease.

View looking east toward Capataz House #1, Pierce House #1 and Brinkley residence, barn & livestock pens.

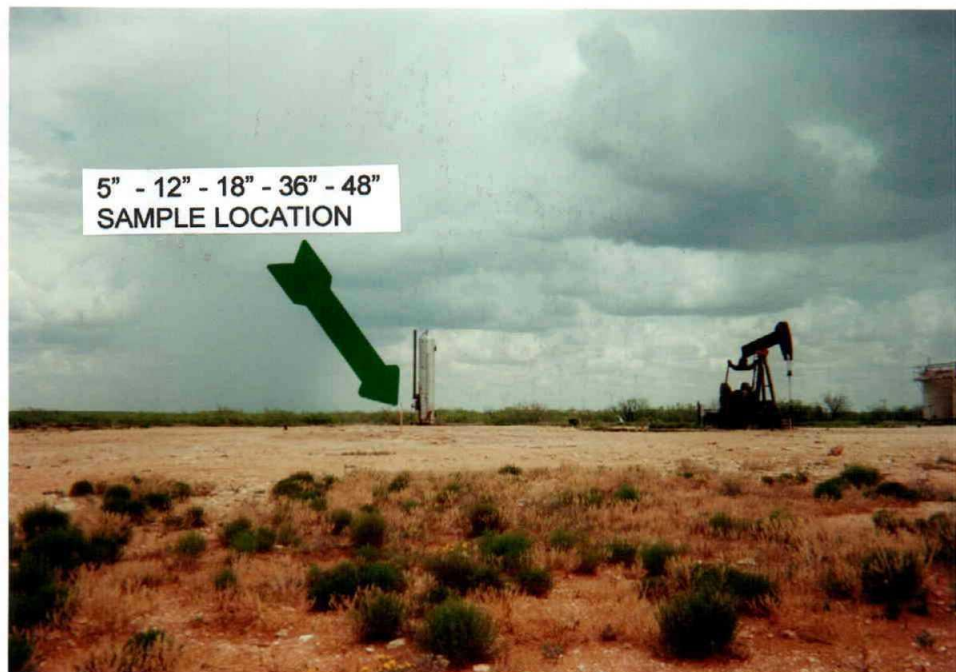
PHOTO #4

Capataz House #1 well site view from west side of site.

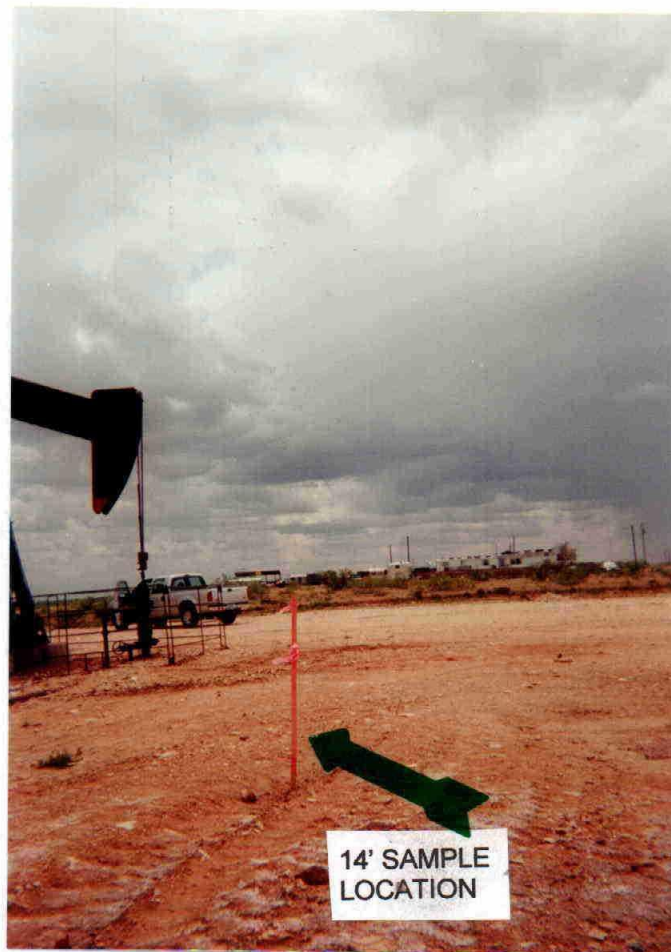
PHOTO #5

View from Capataz House #1 South-Southwest toward Brinkley residence, barn
& livestock pens.

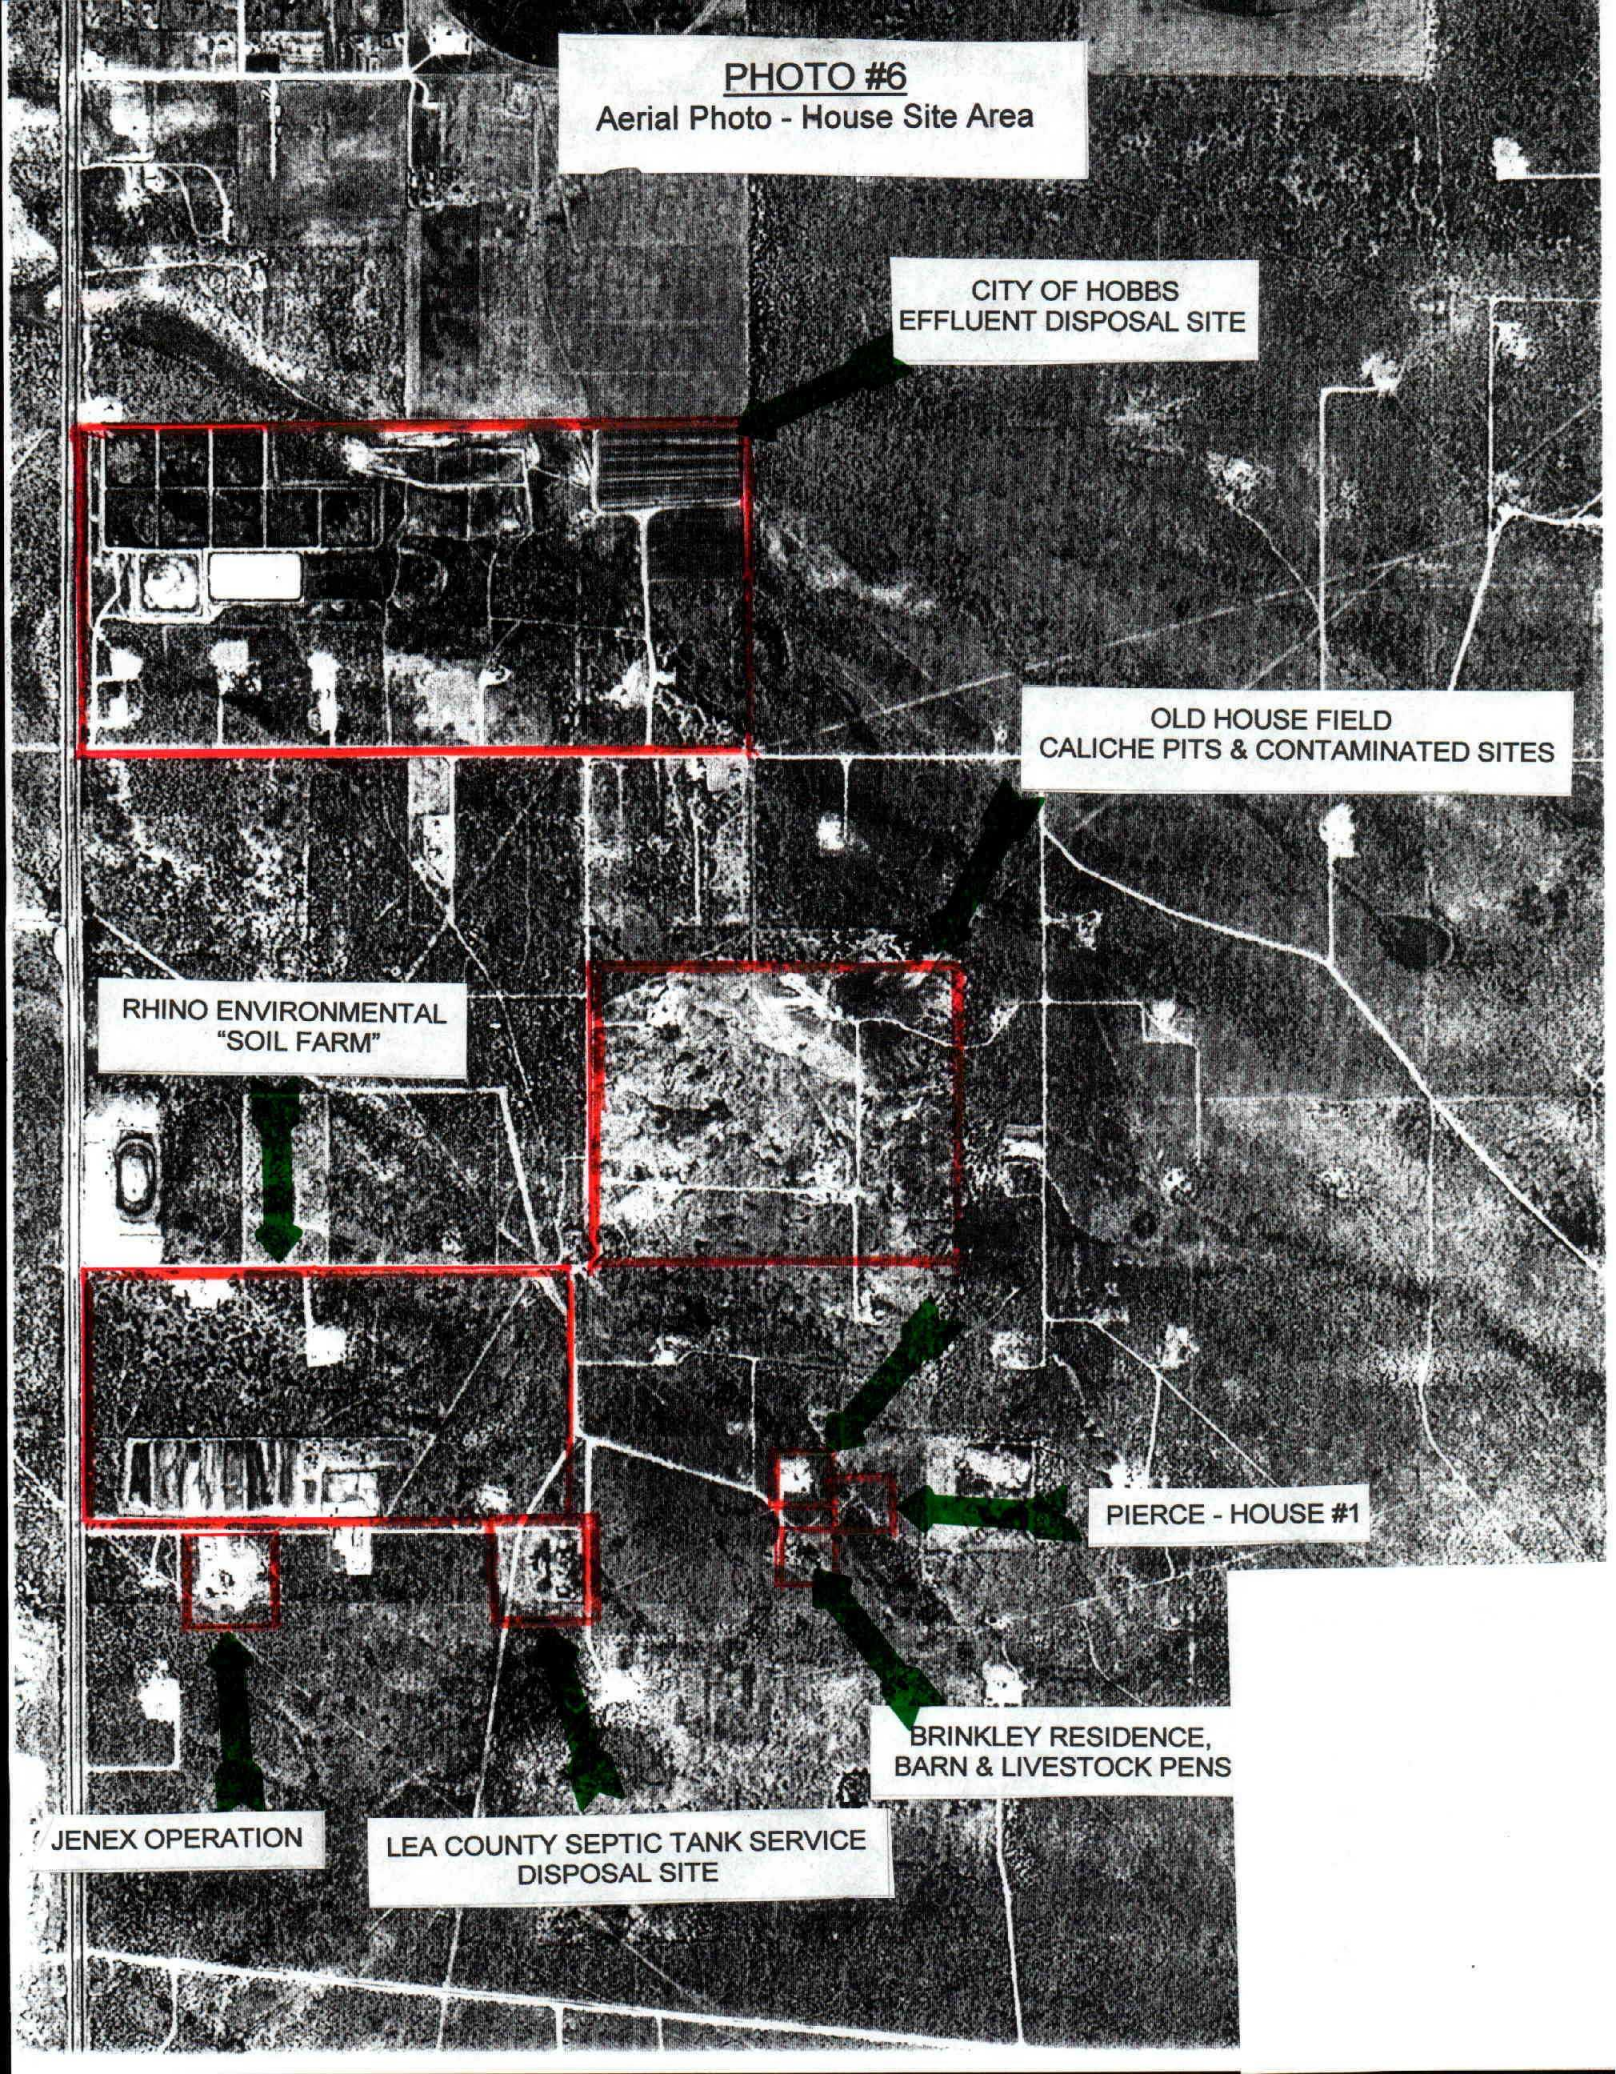
PHOTO #6
Aerial Photo - House Site Area

review is an aerial photograph (Photo #6) of the potential sources proximate to and often up gradient from the Brinkley property. On the aerial photo you will see the location of the City of Hobbs effluent disposal site, the Rhino Environmental "Soil Farm", the disposal facility for Lea County Septic Tank Service, Jenex Operation's oil reclamation site as well as the notable surface disturbance and soil contamination related to the old House field wells located due north of the Brinkley property. In short there are numerous potential on site and off site sources for the poor quality of water found in the shallow interval from which Brinkley produces his household and livestock water.
