Remediation Final Report

Texas-New Mexico Pipeline Co.

Cross Timbers

Closure Request
Texas-New Mexico Pipeline Company
Cross Timbers 4" Pipeline Leak - Below the Caprock
(Company Reference # TNM - 49-95)

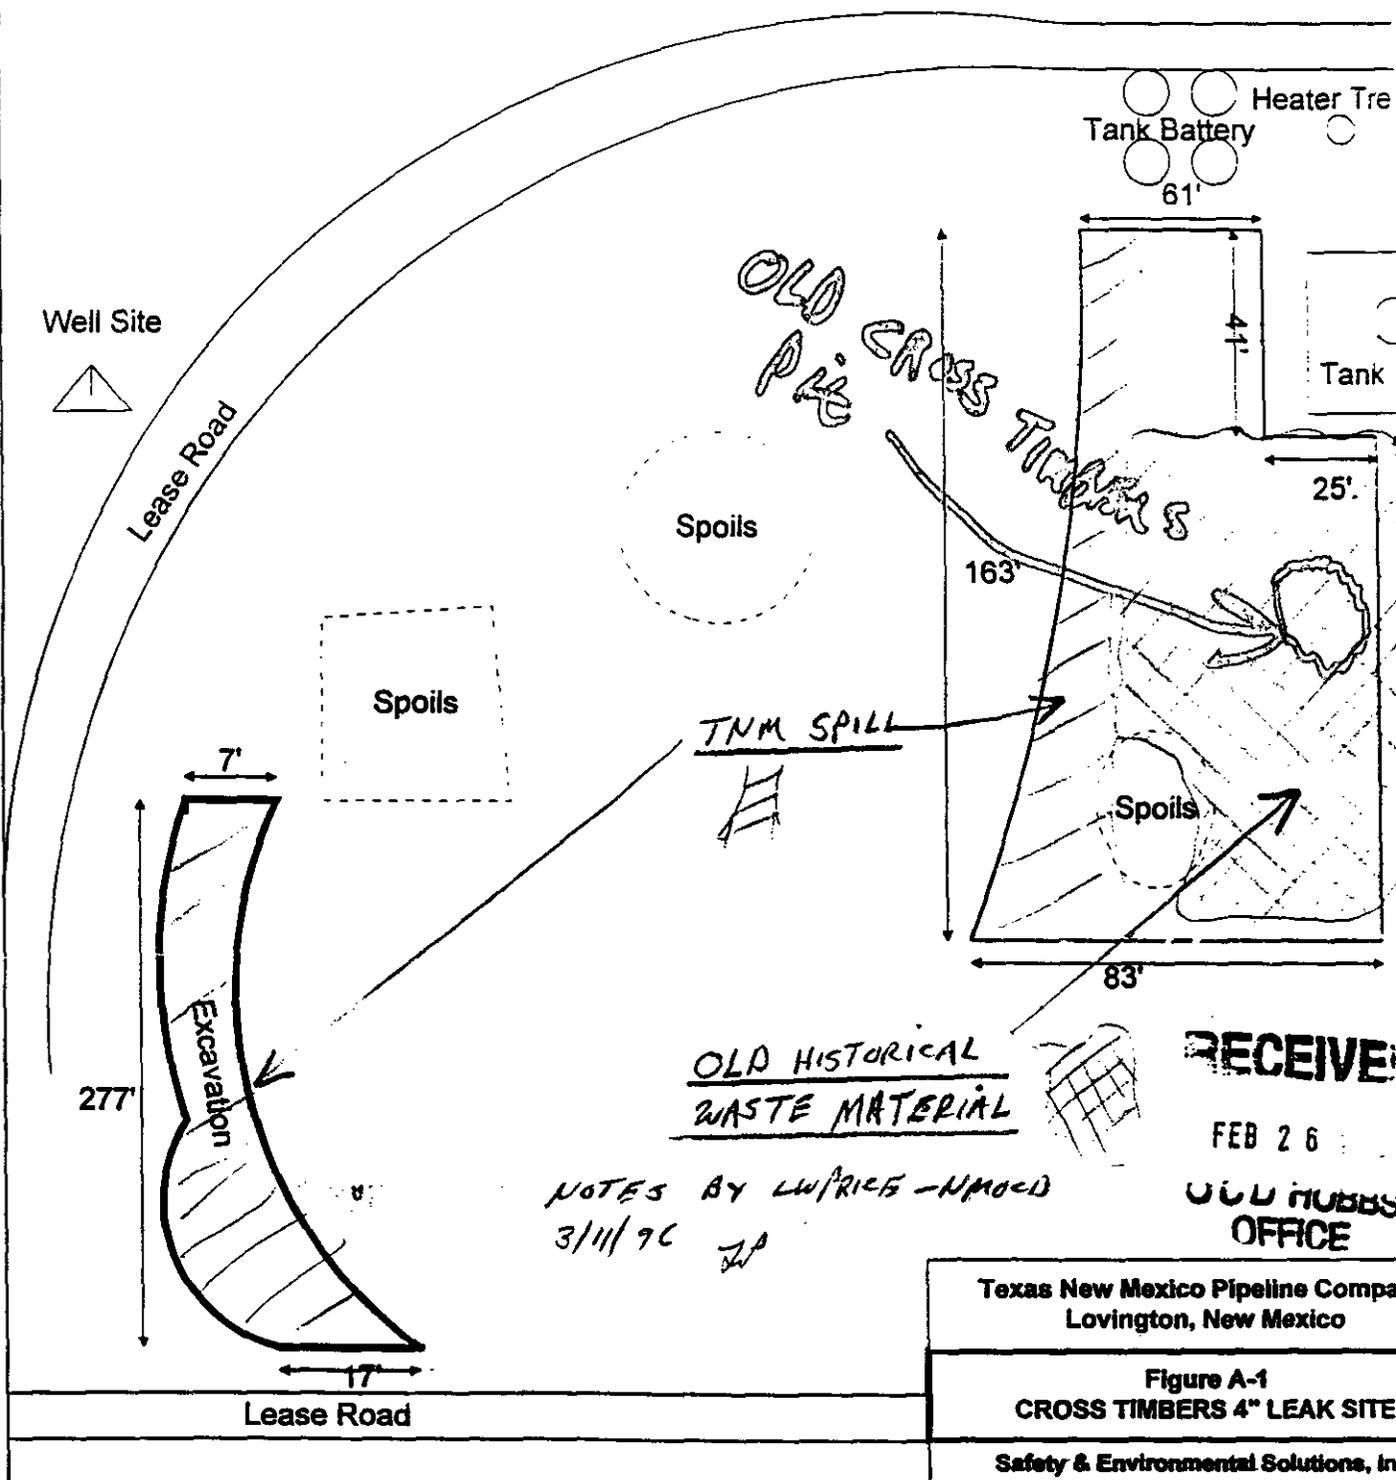
Figure 2

The older material is spread out over an area approx. 100'x50' just south of the Cross Timbers Tank Battery (see attached sketch). The material appears to be old oily sludge i.e. BS&W from crude oil operations.

It presently is exposed from the surface down to 2-3 ft deep in one location. The vertical or horizontal extent is not totally known at this time or the levels of concentration of the contamination. The original source of the contamination is also not known at this time.

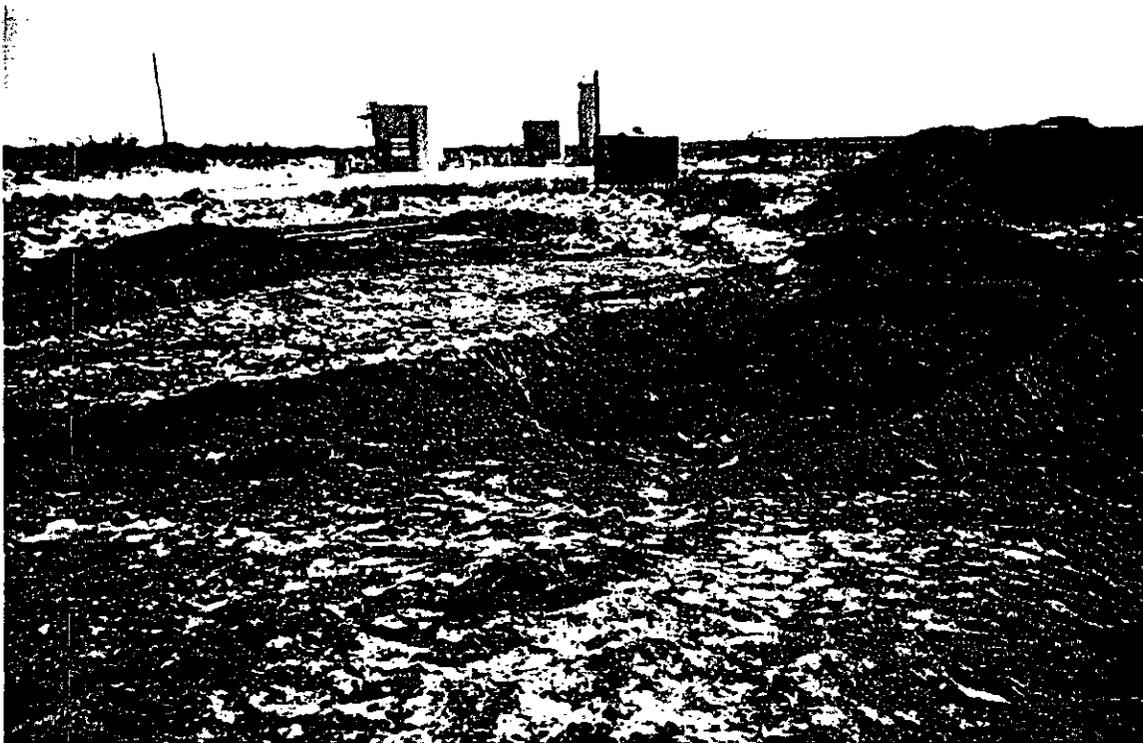
Historical Contamination - From Battery Looking South

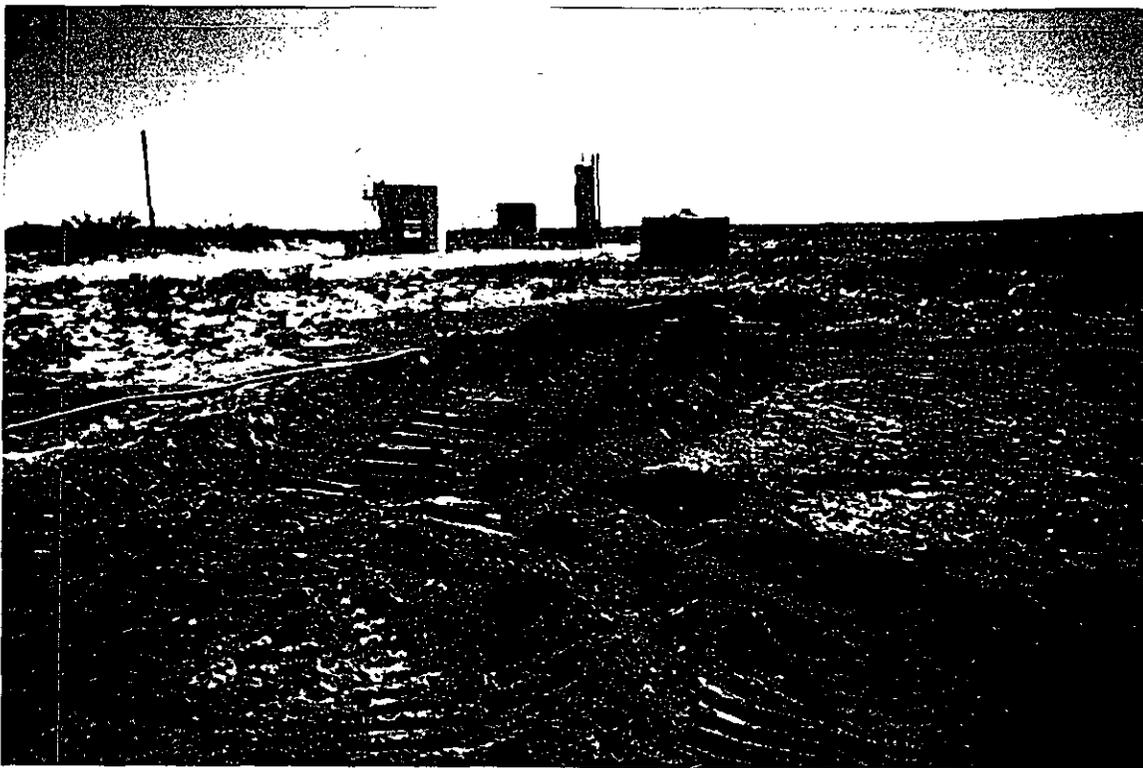
Figure D

East Edge of Historical Contamination
From Battery Looking South

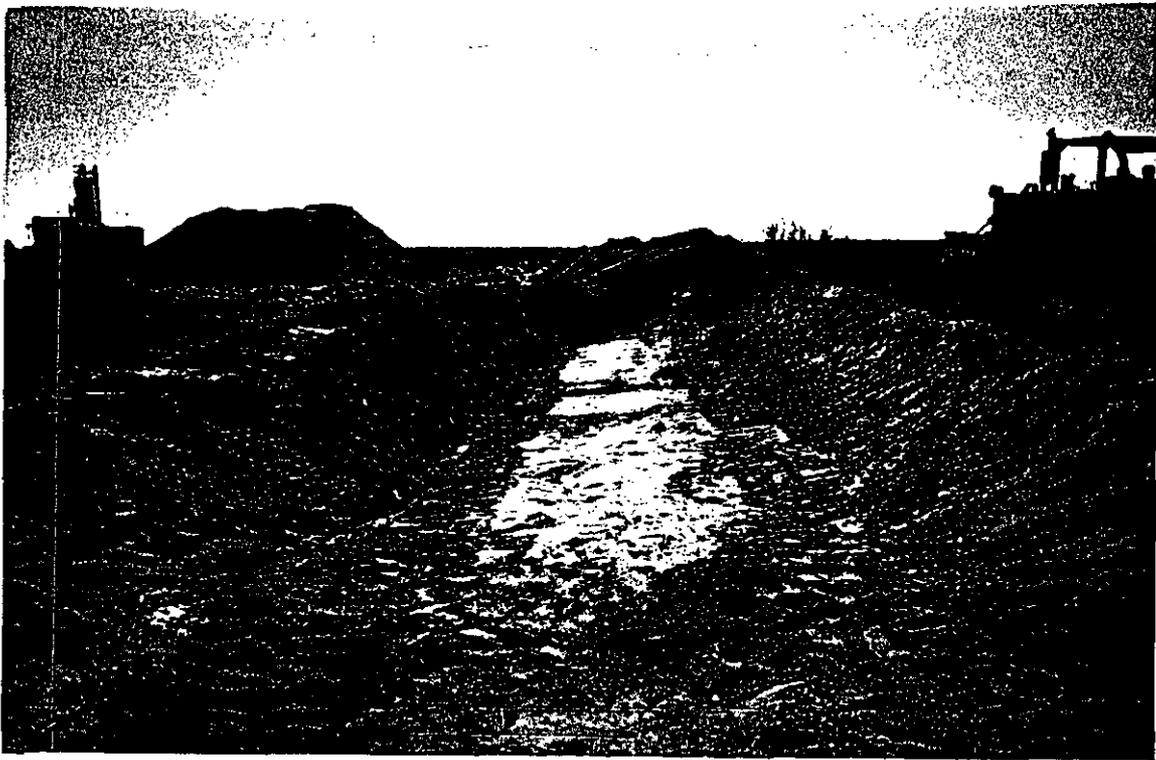
Path of New Leak - From Battery Looking South

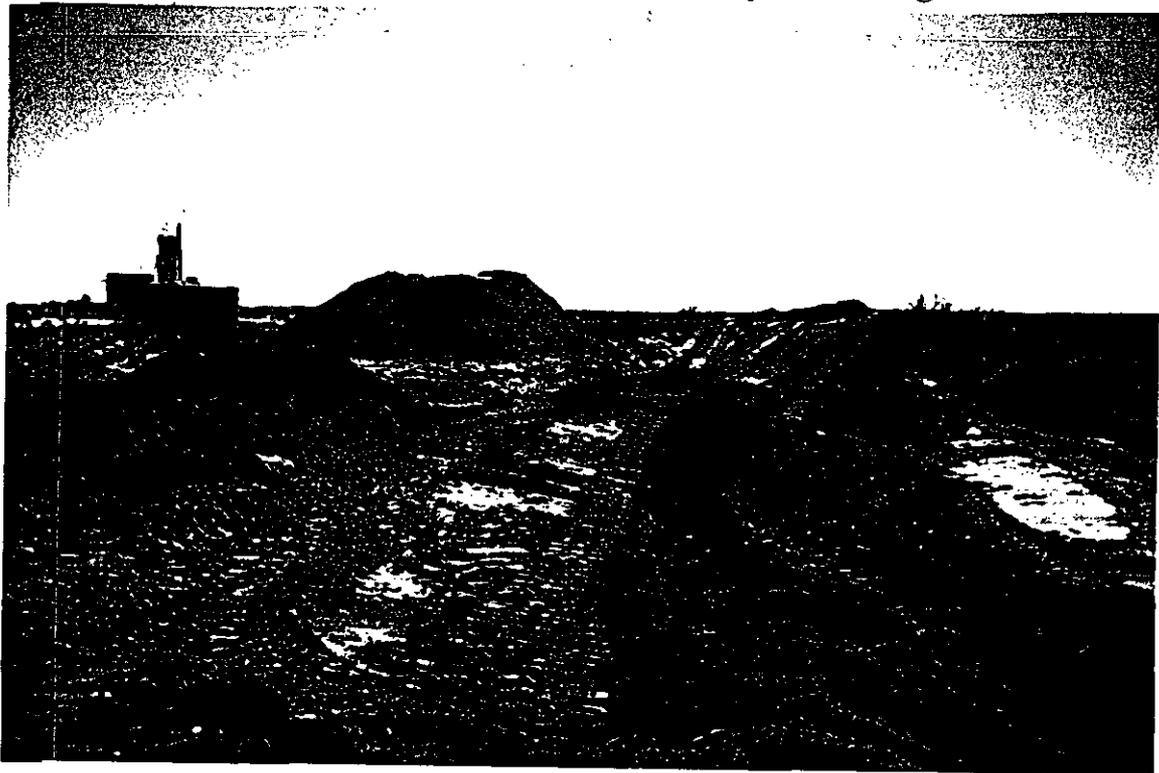
Figure E

Historical Contamination - From Battery Looking South

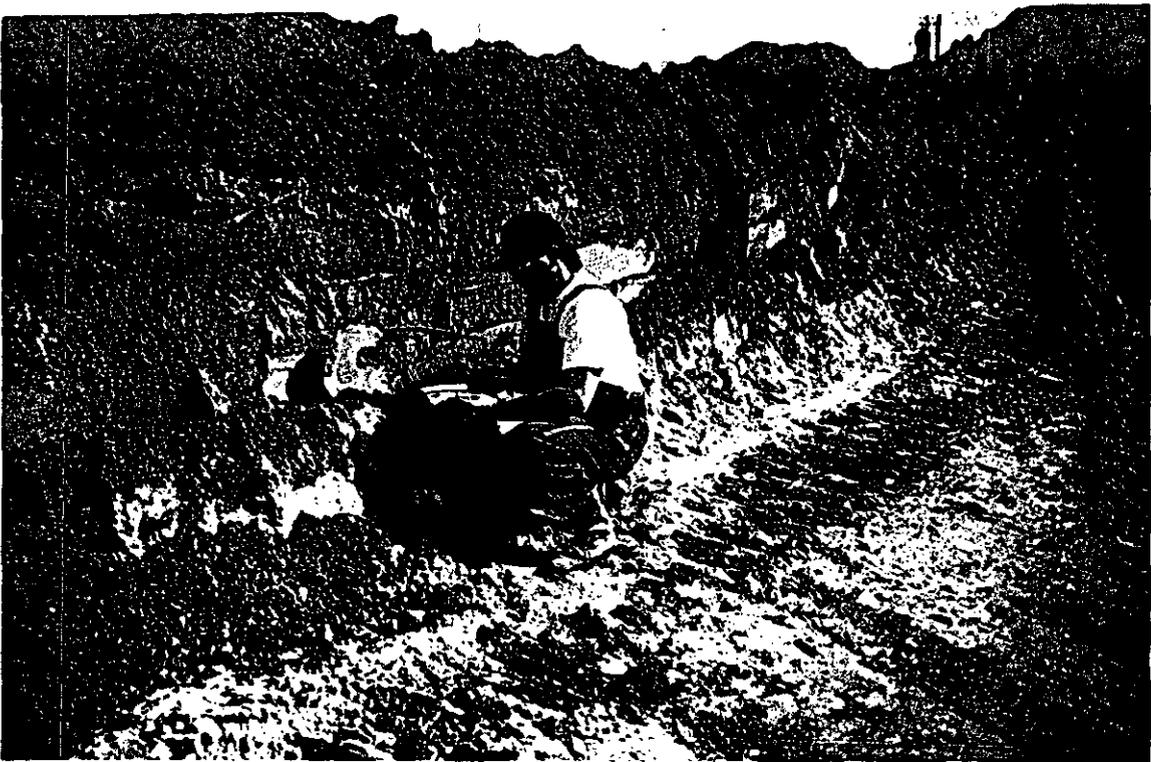
Photo-ionization detector (PID) tests were run as the work progressed to differentiate historical contamination from "new" contamination as a result of the recent leak. (See Figure F) All soil blended as a result of the "new" leak was tested with the PID, and remediated down to below 100 ppm volatiles. ~~(As noted in the field notes,~~ the first PID reading taken on 3/11/96 on the east side of the excavation was 175 ppm. Excavation was continued until new

PID Testing on East End of Location

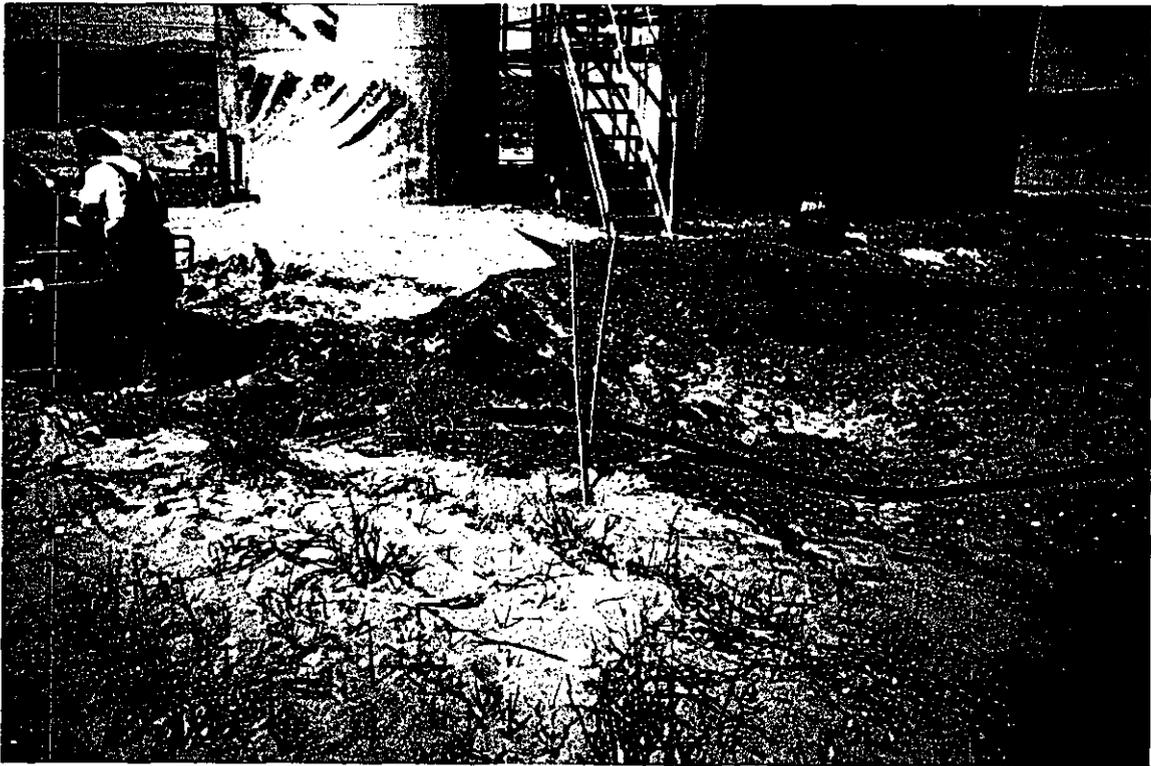
Figure F

Historical Contamination

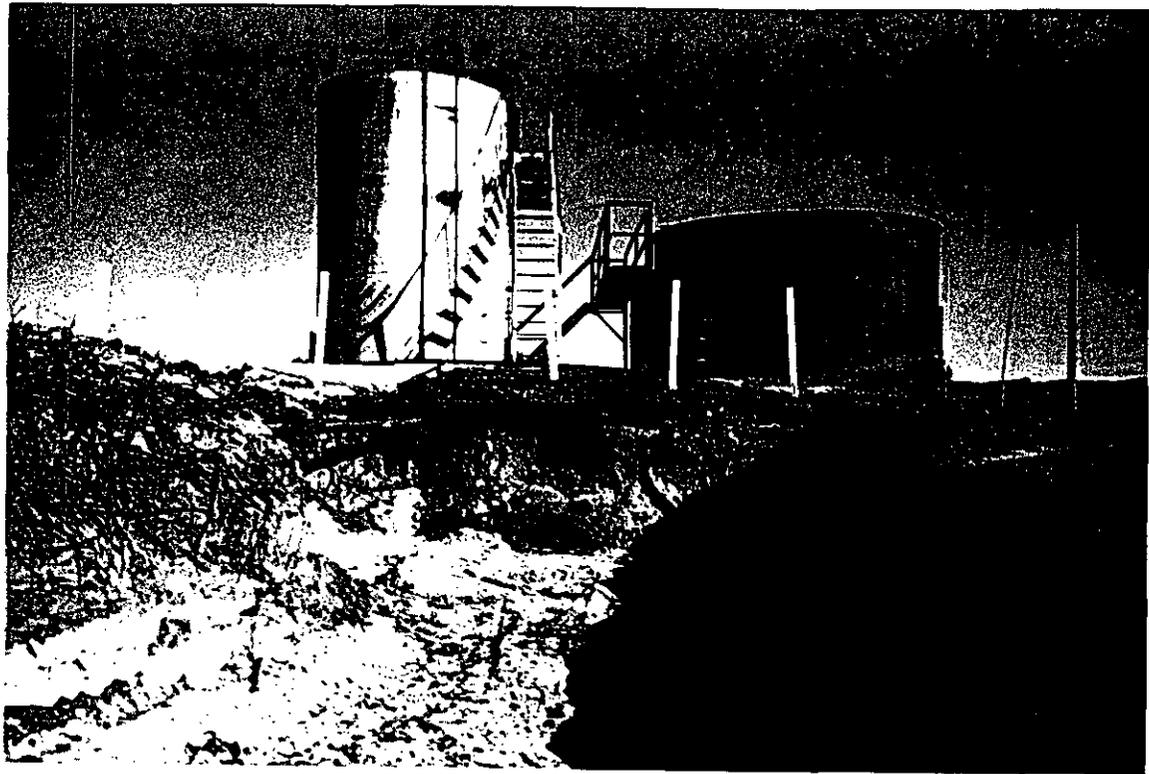
contamination was removed and the next PID reading was 12.2 ppm. The south end slope of the excavation was tested with the PID and showed a result of 8 ppm when excavation was complete. The bottom of the excavation nearest the "old pit" area was tested and showed a PID test result of 42.5 ppm. The area just south of the tank battery was carefully excavated with a backhoe to completely remove any soil affected by the leak. (See Figure G) As the excavating progressed, several pictures were taken to illustrate the presence of historical contamination. (See Figures H & I).

North Wall of East Excavation

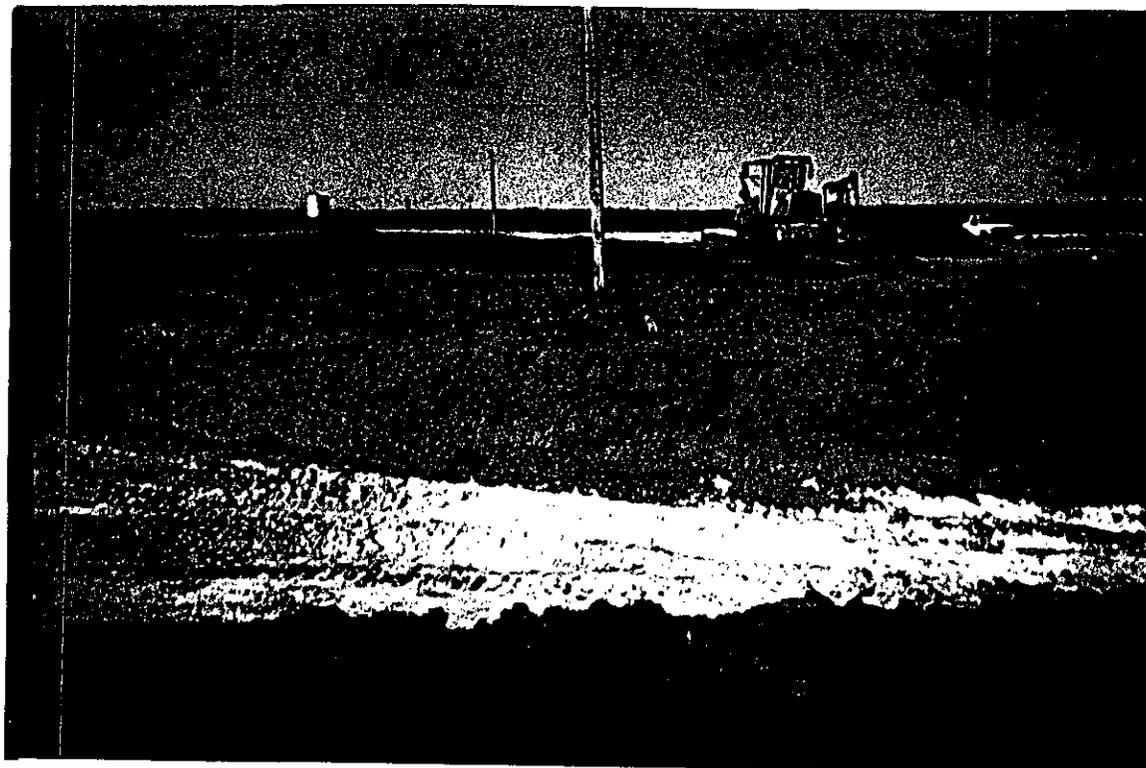
West Wall of East Excavation

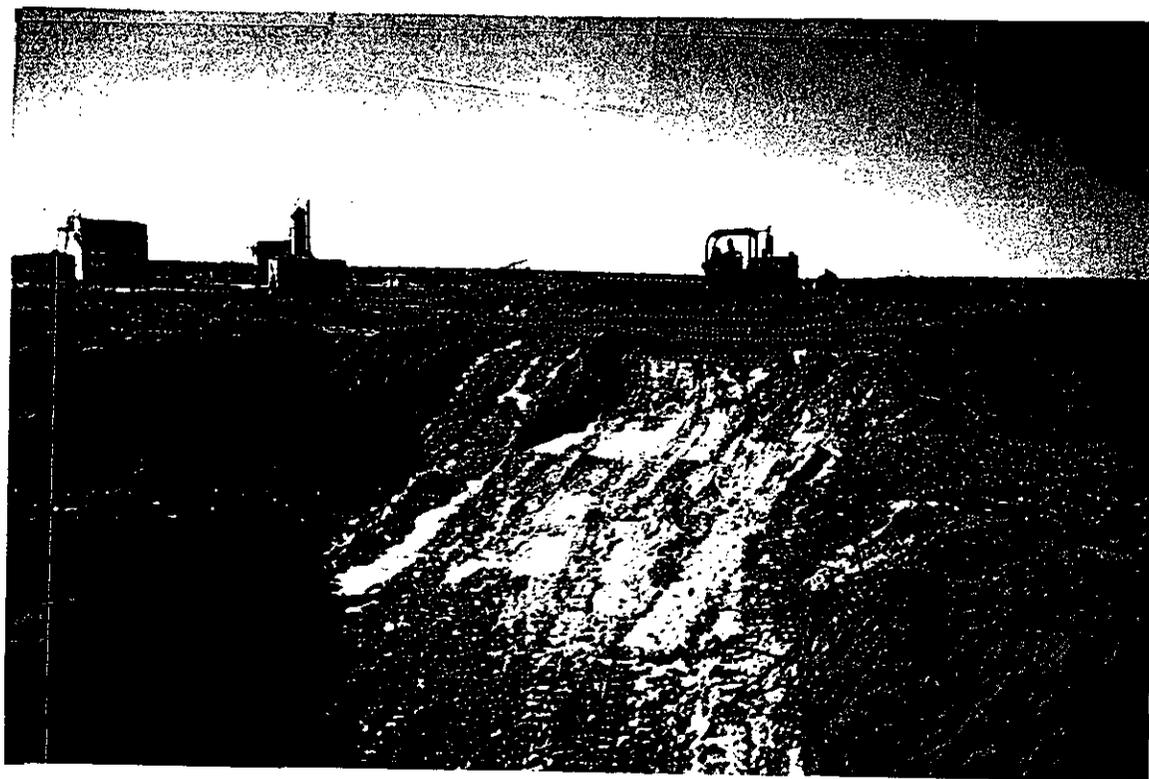
Figure I

South Slope of East Excavation
