Appendix Site Photographs

Photos of Former Fresh Water Frac Pond

Operator:	SOLARIS WATER MIDSTREAM, LLC	907 Tradewinds Blvd, Suite B	Midland, TX79706	OGRID:	371643	Action Number:	22767	Action Type:	C-147L
-----------	------------------------------	------------------------------	------------------	--------	--------	----------------	-------	--------------	--------

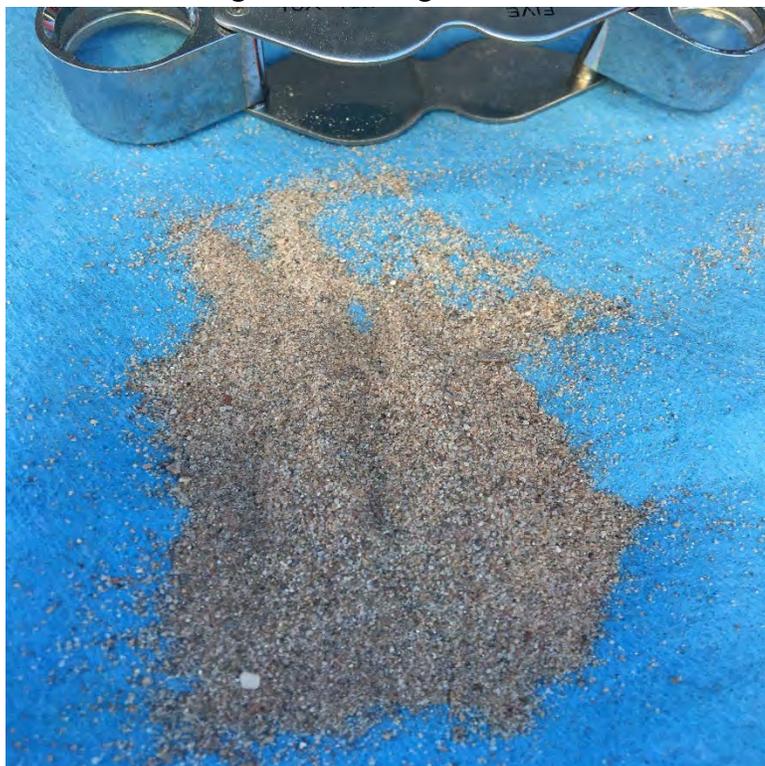
Figure 1SP Cuttings from 0-24 feet are fine sand and silt typical of eolian deposits

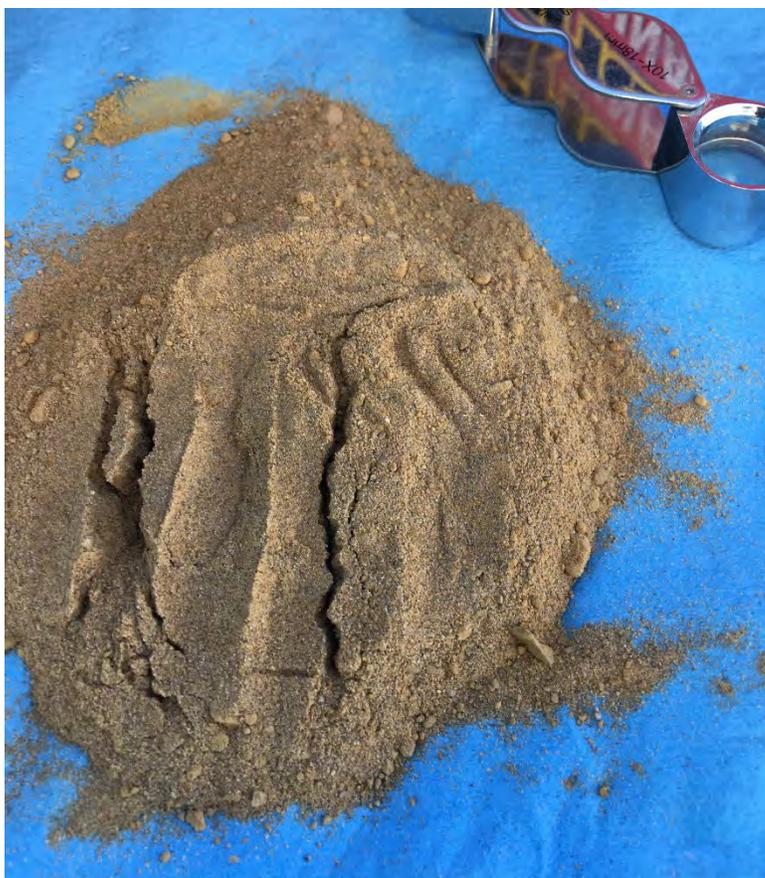
Figure 2SP - Cuttings from 25-47 feet are sandy silt sized with a few angular fragments suggesting some cementation.

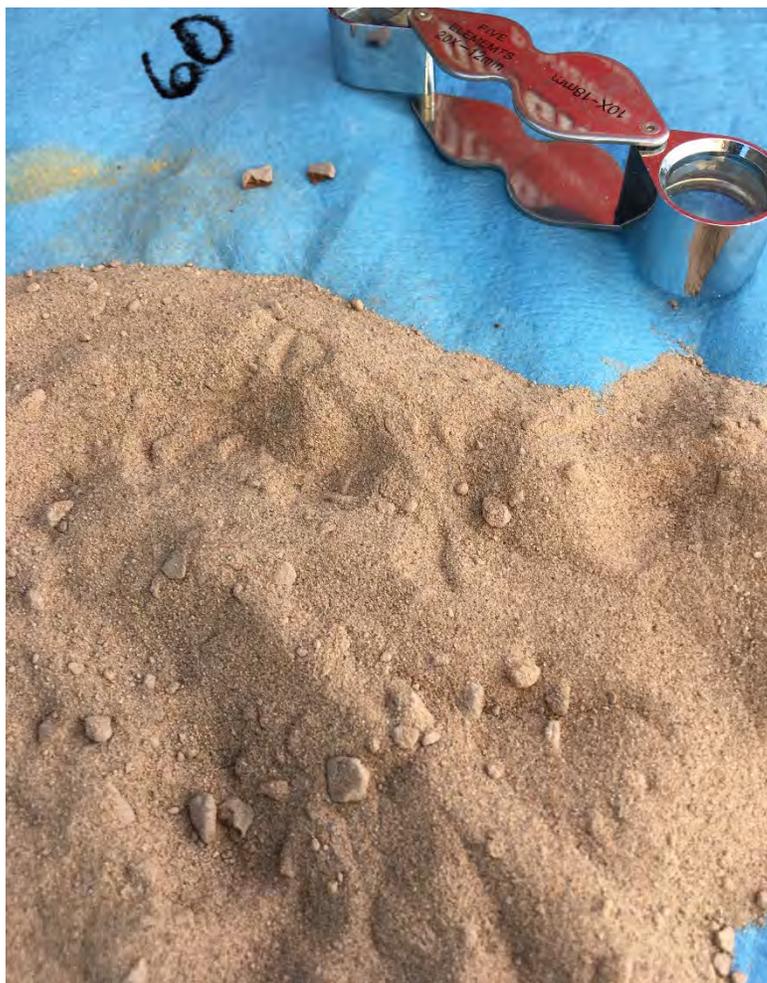
Figure 2SP - Cuttings from 48-60 feet similar grain size with redder color and more broken rock suggesting slightly more cementation.

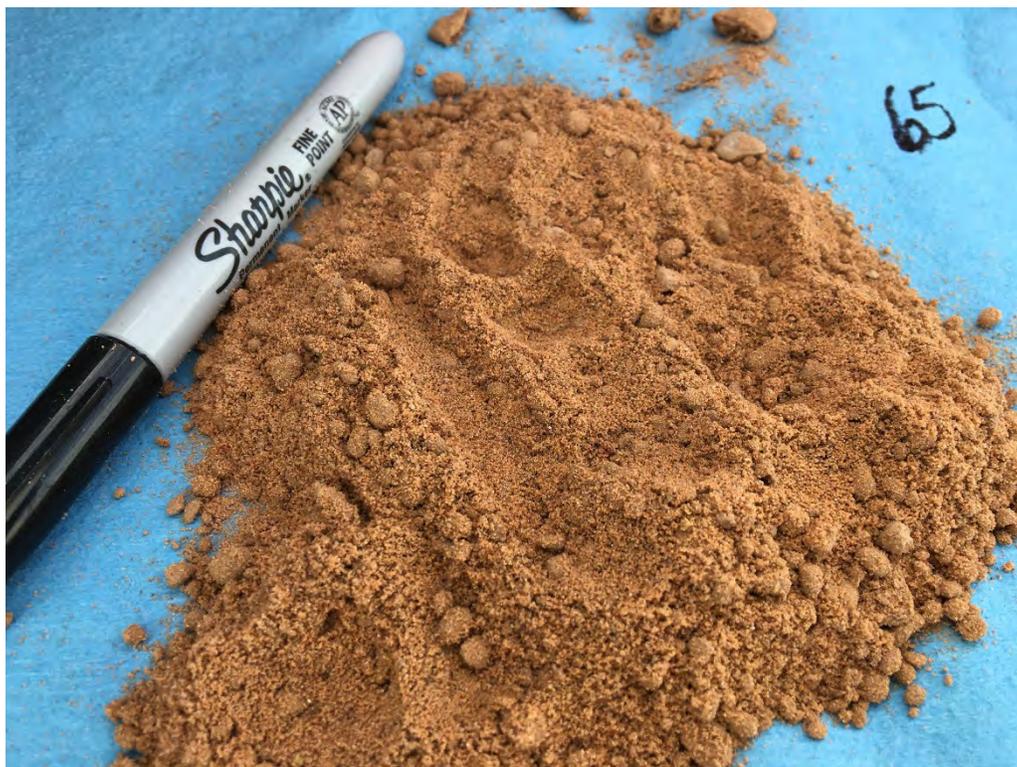
Figure 3SP - Cuttings from 60-65 feet are silt size with broken fragments common, indicative of cementation

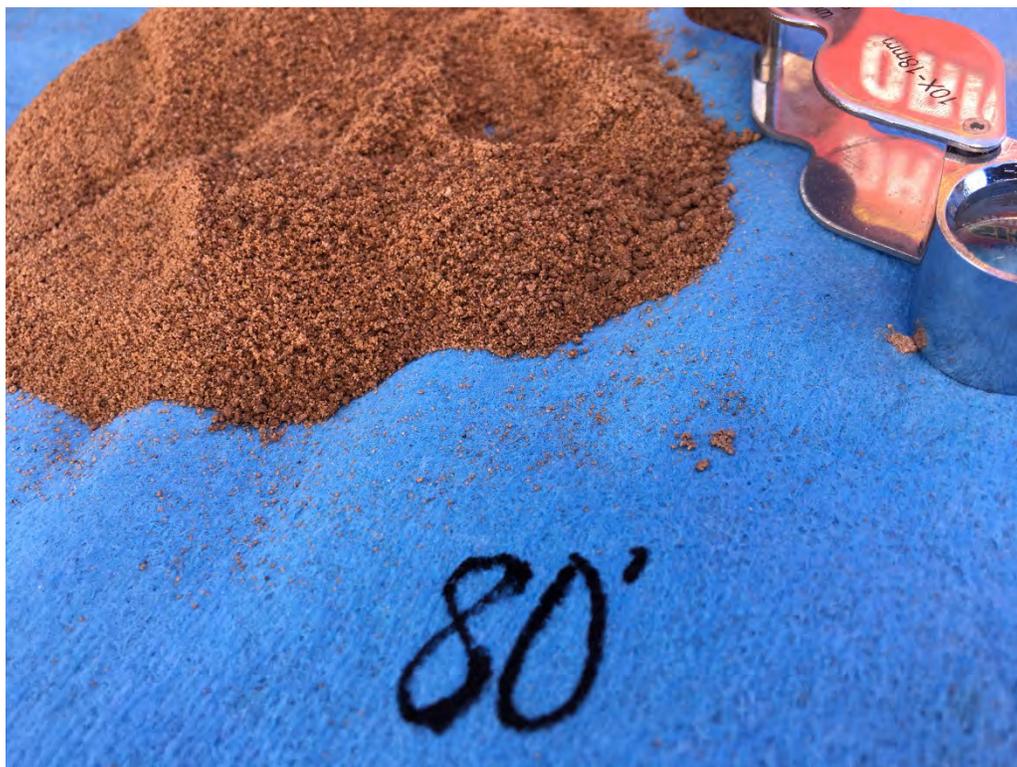
Figure 4SP - Cuttings from 65-80 feet is silt sized grains with strong red color.

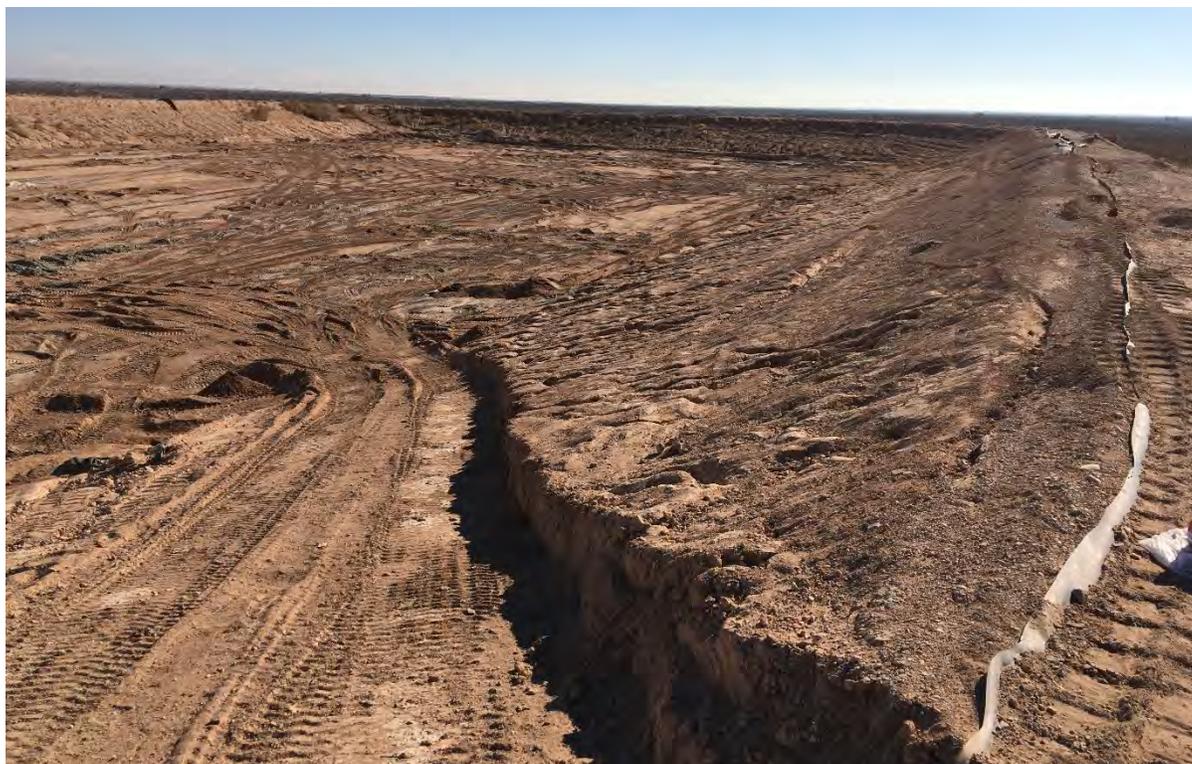
Figure 5SP - View south from northwest corner of former fresh water frac pond excavation

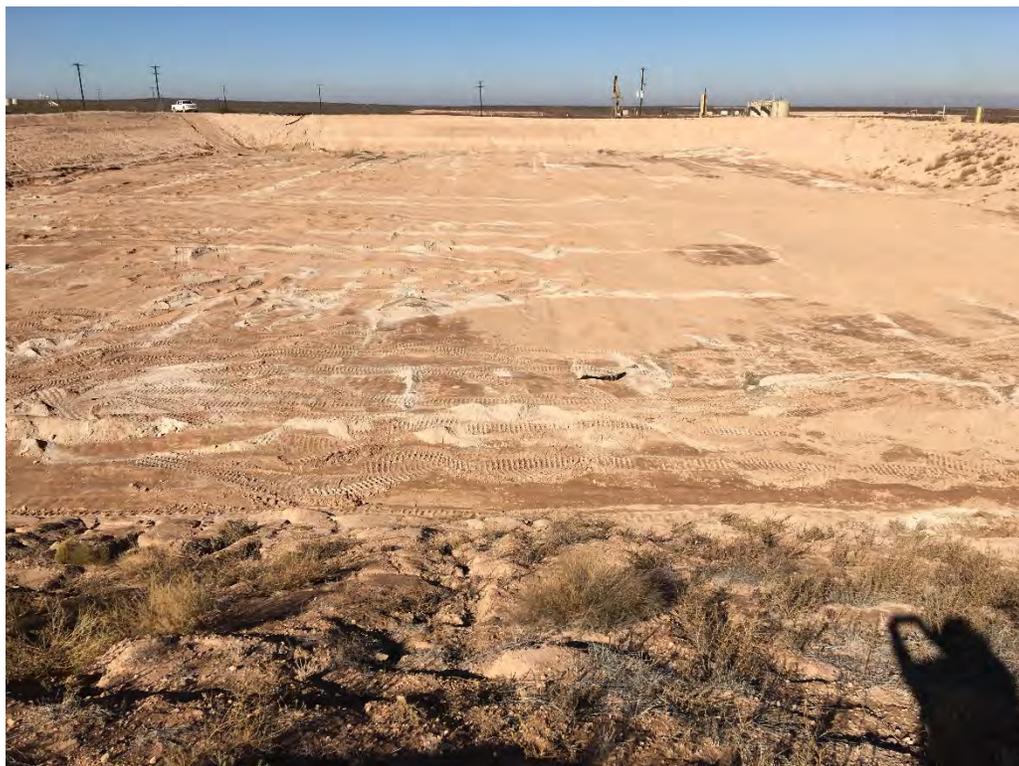
Figure 6SP - View north from southern berm. There is no evidence of subsidence of the alluvial material or evidence of unstable ground...

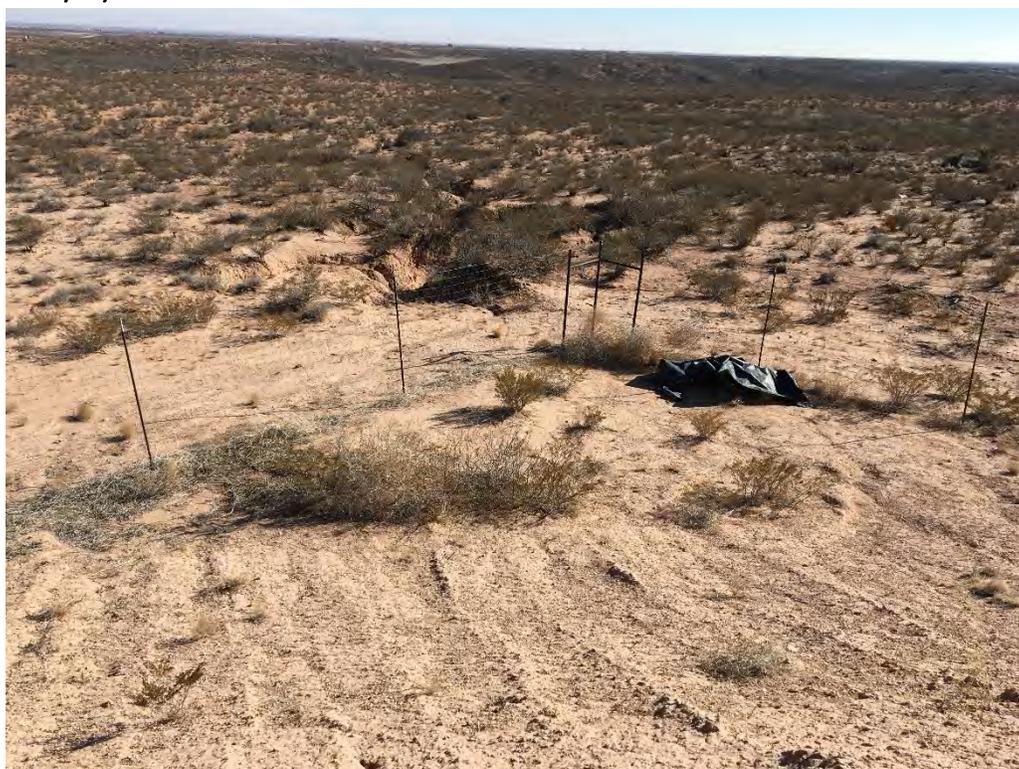
Figure 7SP - View southeast from southeast corner of excavation. Gully and possible headward erosion in center of image. While not a watercourse, the operator will provide erosion protection and divert stormwater to natural gully east of proposed containment.

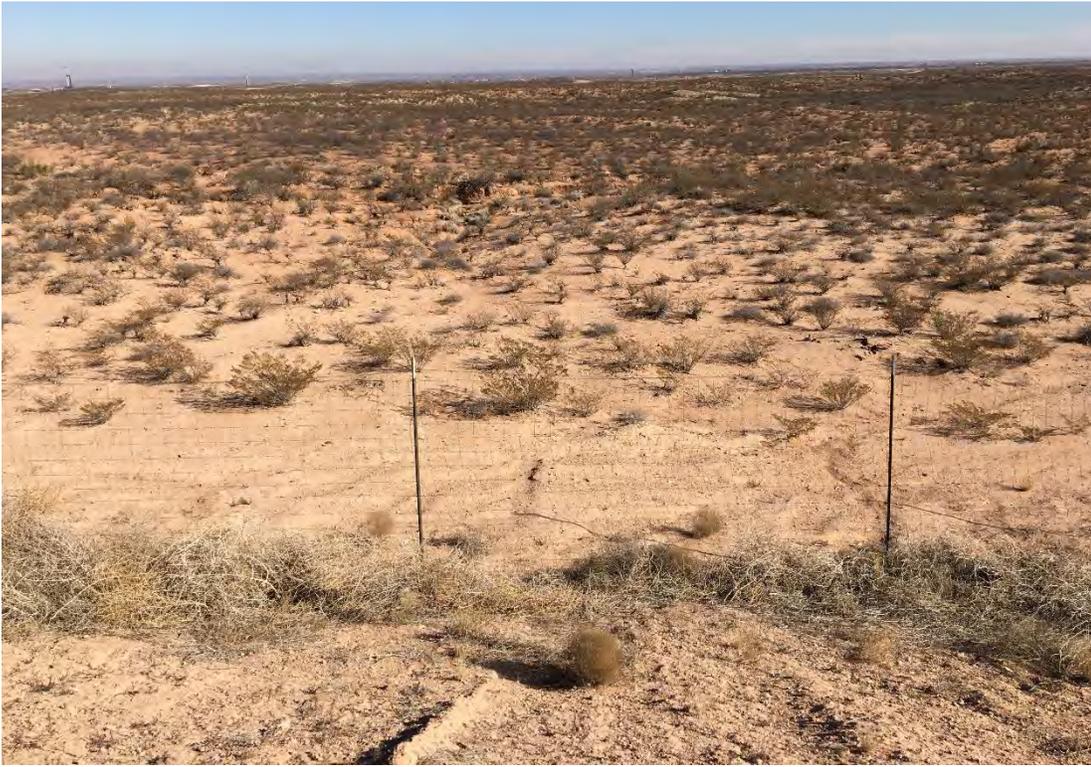
Figure 8SP - View east from eastern side of frac pond excavation. Google Earth images suggest this gully was caused by stormwater diversion from the frac pond. During construction of the containment, Solaris will install erosion control and stormwater diversion to mitigate western erosion of the gullies.

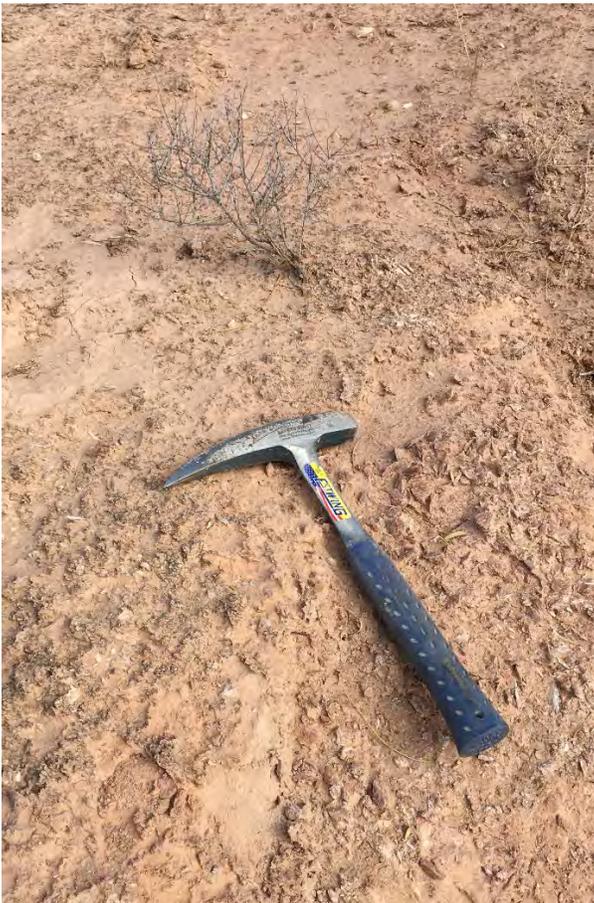
Figure 9SP - Gypsum on the ground surface due to weathering and erosion of the bedrock.

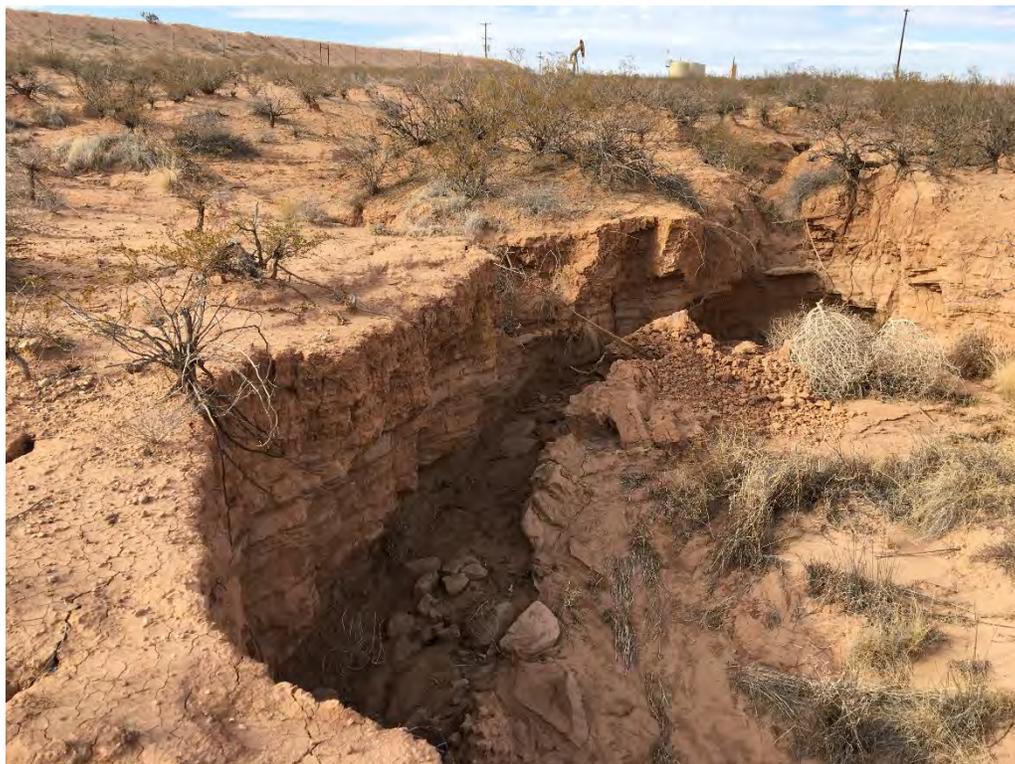
Figure 10SP - Layered siltstone and red mudstone exposed in the gully east of the EKG containment location.

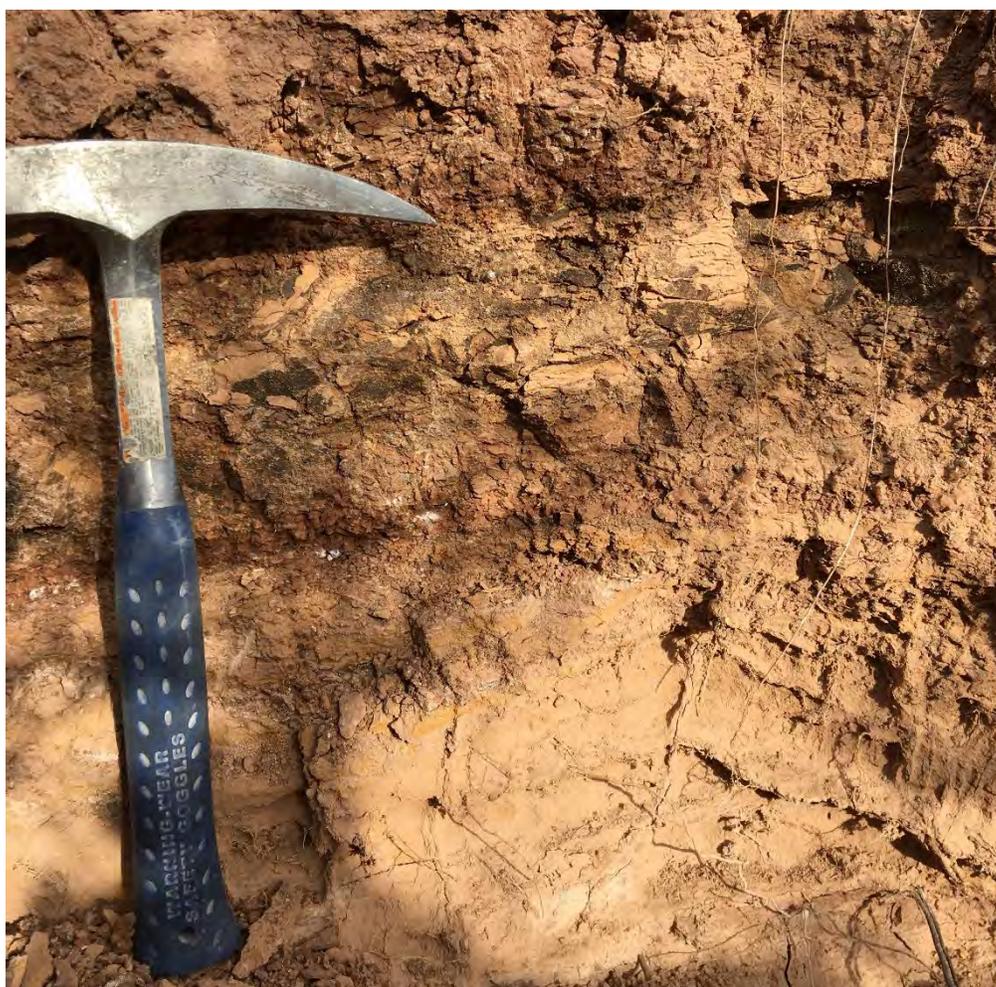
Figure 11SP - Close view of the siltstone and mudstone layers with obvious gypsum (32 11 19.81, -104 6 43.69)

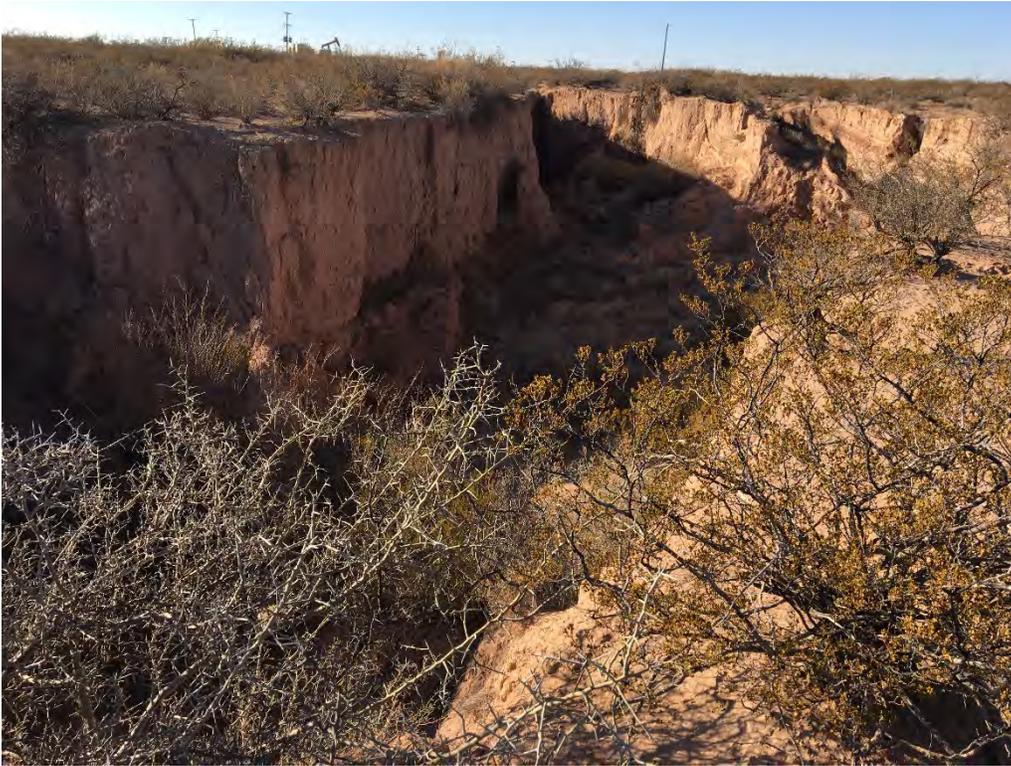
Figure 12SP - View north showing head of large gully about 900 feet due east of EKG containment. Bedrock exposed within the gully is highly weathered and friable. A 12- to 18-inch thick red siltstone layer dips to the southeast in the upper right corner of this image underlain by beds of red siltstone and well-cemented siltstone/fine-grained sandstone. The 7.5 minute Malaga geologic map shows this unit as the Los Medanos Member of the Rustler Formation. We did not observe evidence of gypsum layers that are common in the Los Medanos. (32 11 22.04, -104 6 33.12)

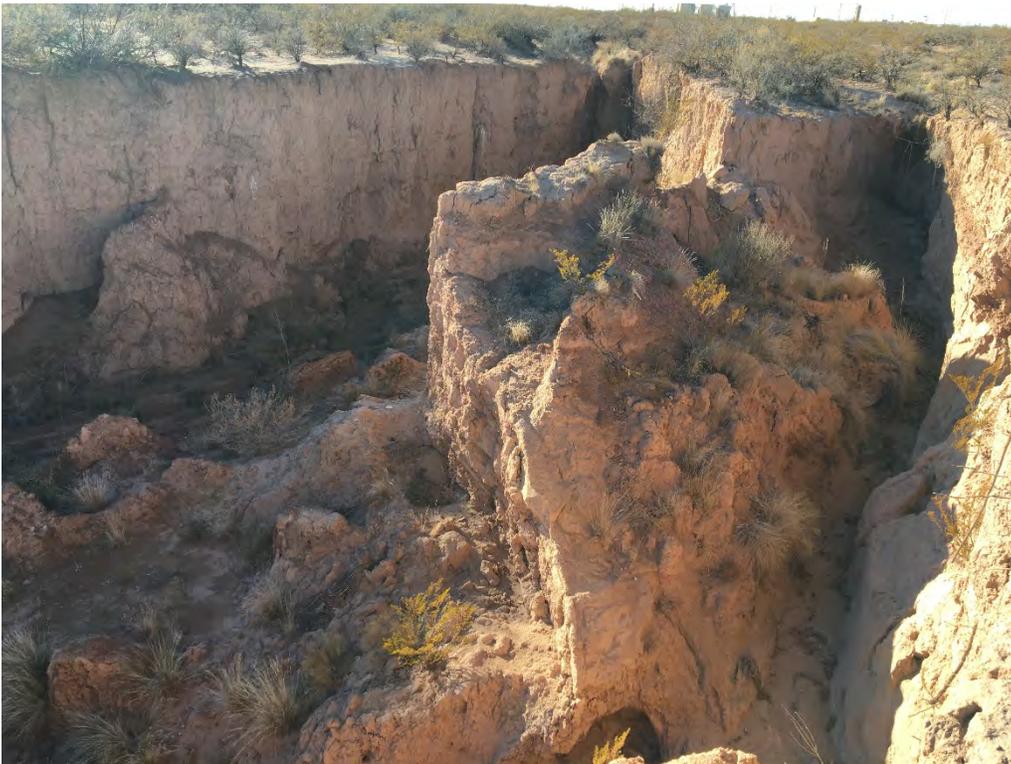
Figure 13SP - View to the north, upstream from Figure 5SP. This image is a close-up of the exposure shown in Figure 5SP. (32.18967, -104.10931)
