Recycling Facility and/or Recycling Containment

– Notice of Fluid Detection for Section 13W Containment

1RF-13 - Salado Draw 13 Recycled Water Containment Structures - Section 13W Containment, Facility ID [fTO1716430540](#). Recommencement of Operations.

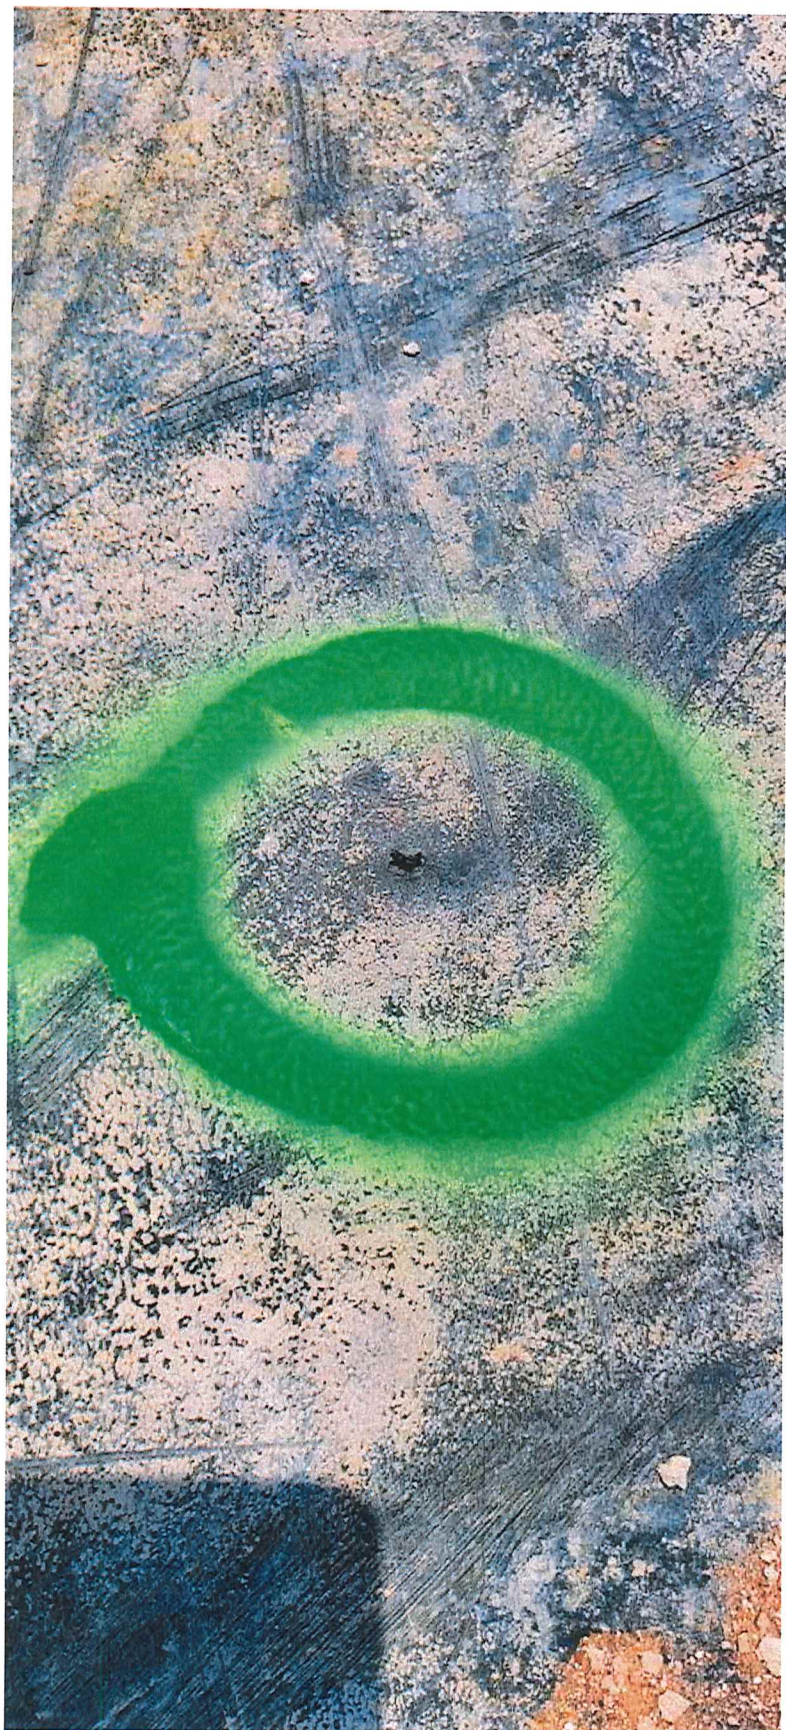
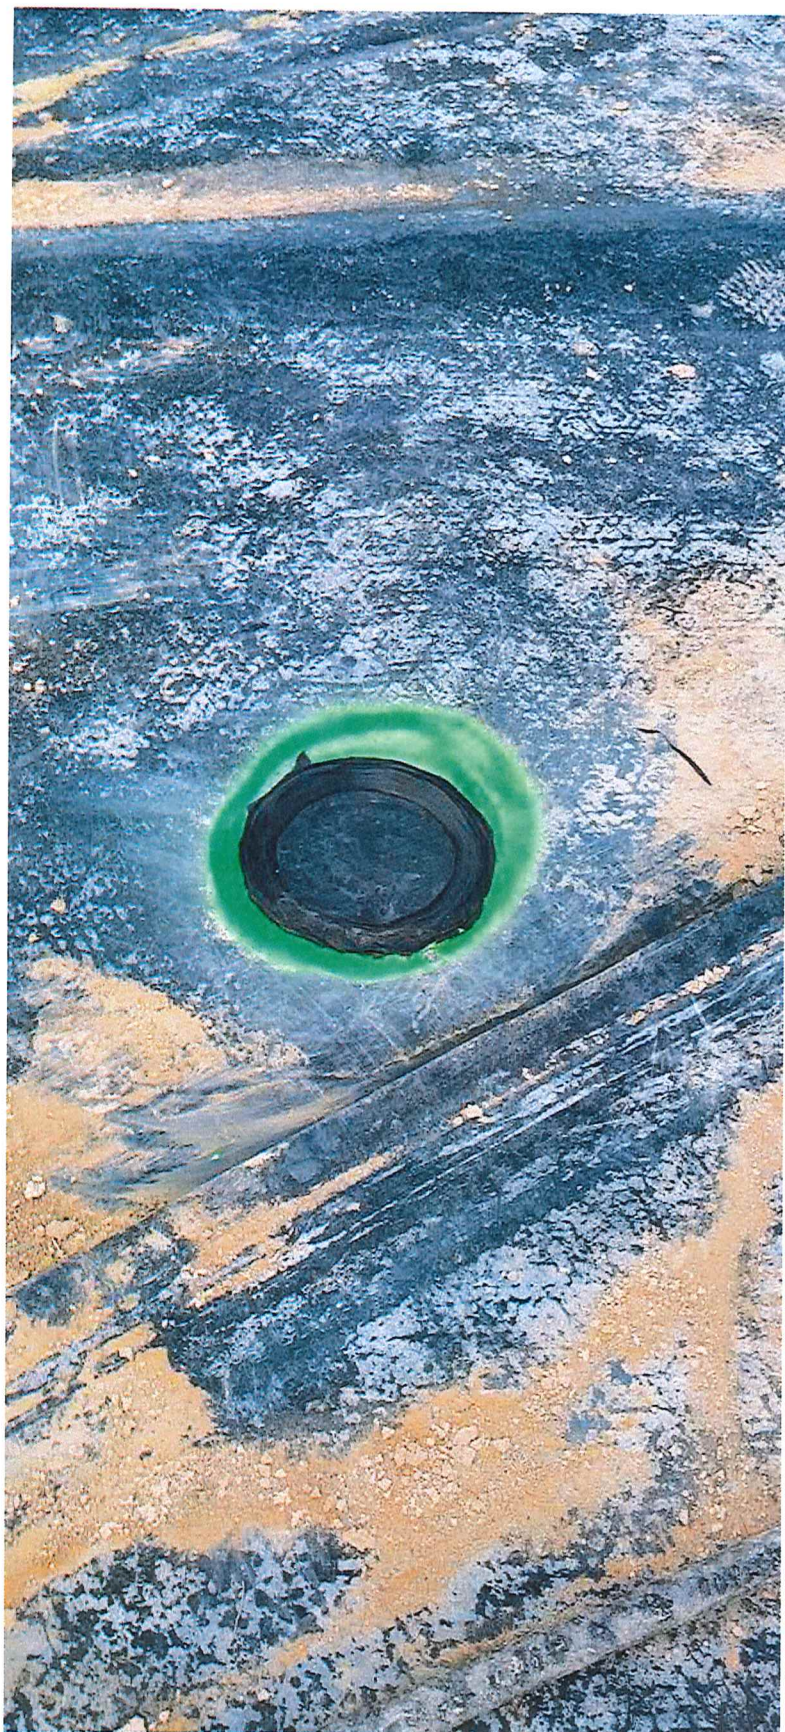
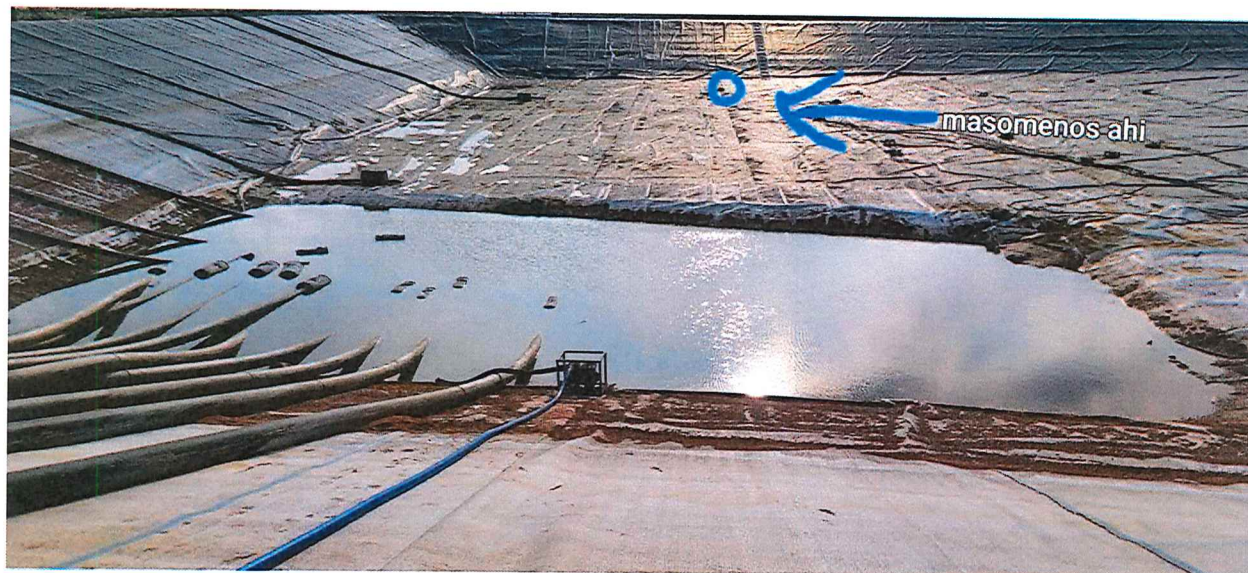
Is there evidence of structural failure or cracks in seams?	n	
Is there evidence of erosion in liner?	n	
Are there signs of cracking, tears in liner ?	n	
Is there evidence of oil or chemicals that could damage liner in pond.	n	
Floor (*Image # 1 _____)		
Is there evidence of structural failure or cracks in seams?	n	
Is there evidence of erosion in liner?	n	
Are there signs of cracking, tears in liner ?	y	SW on floor, 100ft from sump. On 4th long panel.

Inspector Name: Jesus RojasCrew Members: Felix RodriguezInspection Date: 8-02-21Rodolfo ReyRepair Date: 8-03-21Site Address/ Project Name: Salado Draw 13 West FPLocation: New MexicoLeak Detection: yesDepth of Pond: 18ft
