**NM1 - \_\_\_\_66\_\_\_\_**

**Operational  
Infrastructure and Cell  
E-1 Construction  
Certification Report**

## **APPENDIX D: CQA DAILY FIELD REPORTS**

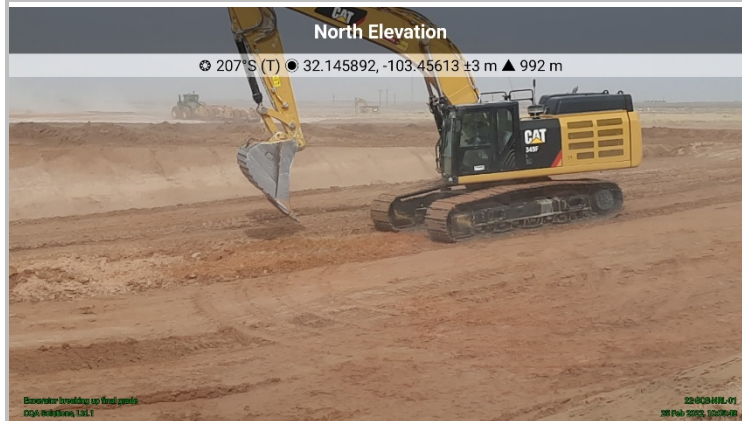
- An excavator was used to rake the truck wash area, followed by a water truck spreading water within the area. After this was done, a compactor compacted the soil. This series of actions were done repeatedly.
- 2 density tests were taken. All 2 tests were taken from the final grade of the truck wash area, which was cut down to grade.
- 1 tests failed due to being outside of the acceptable Standard Proctor Range. After the final grade was raked, watered, and compacted, the retest passed.

- Due to the number of failed density tests before getting the required number of successful tests for the truck wash area, a dozer was used to cut the natural soil 6 inches below final grade in order to add material from the approved stockpiles.
- 2 tractors were taking excess cut material from the area within both drying pads and spreading it across the yard area south of the drying pad areas.

Filename: 22-SCS-NRL-01-2022-02-25-10-05-48-Excavator breaking up final grade (1)

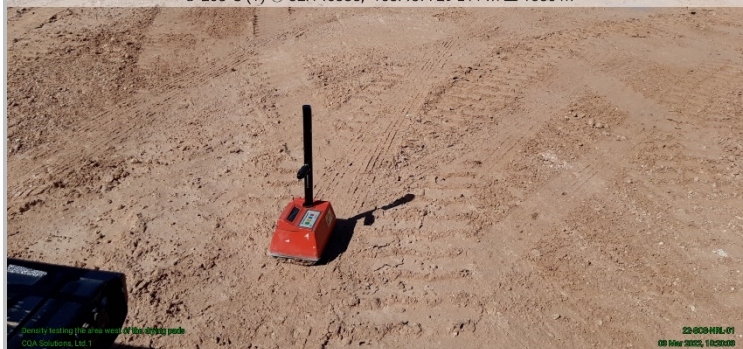
- 7 tests were taken from the immediately west of the west drying pad. 6 of the 7 tests failed due to being outside the acceptable range of OMC, with 1 of those failed tests also being outside the acceptable range of Proctor.

Filename: 22-SCS-NRL-01-2022-03-03-10-20-03-Density testing the area west of the drying pads (1)

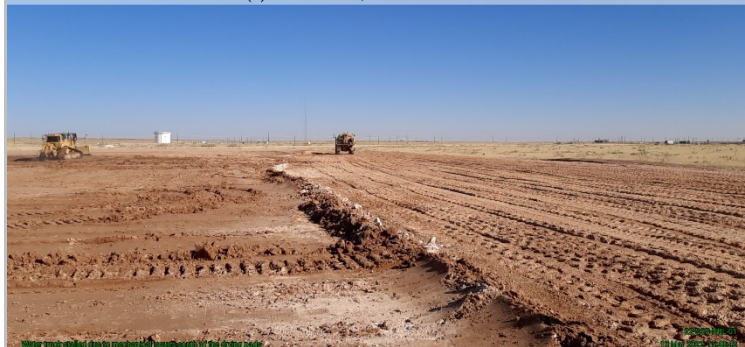
A water truck broke down due to mechanical issues, which was repaired within the day.

Filename: 22-SCS-NRL-01-2022-03-10-15-40-42-Water truck stalled due to mechanical issues south of the drying pads (1)

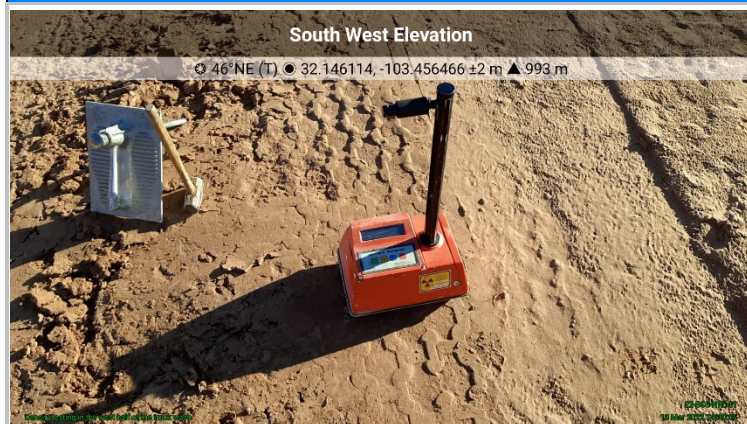
- 1 smooth drum was used to compact the material with the moisture obtained overnight
- 3 tests were taken in the east drying pad. All 3 of the test was outside the acceptable range of the Proctor and failed.

Due to repeated failure within the east drying pad and truck wash, T-5 has planned corrective measures to get more compaction deeper within the final lifts.

Filename: 22-SCS-NRL-01-2022-03-13-08-30-05-Density testing in the west half of the truck wash (1)

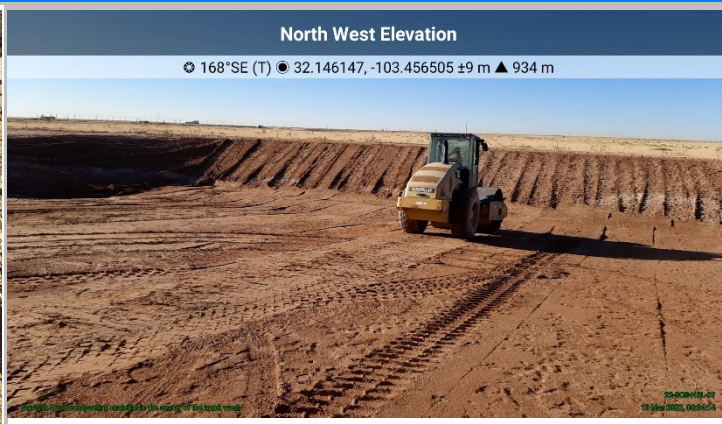
- 1 smooth drum was used to compact the material with the moisture obtained overnight.
- 2 tests were taken within the area. Both tests were outside the acceptable range of Proctor and failed.

Filename: 22-SCS-NRL-01-2022-03-13-08-34-14-Smooth drum compacting material in the center of the truck wash (1)

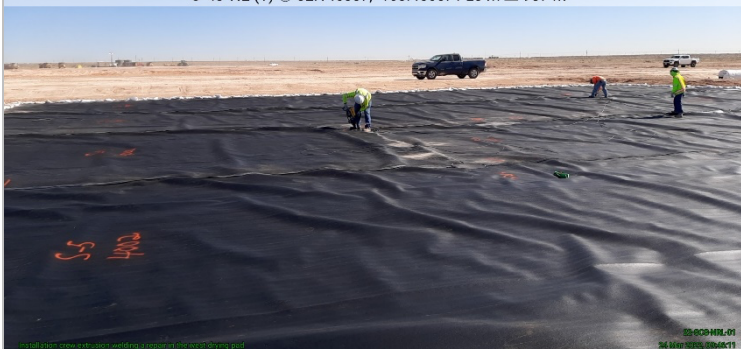
Filename: 22-SCS-NRL-01-2022-03-24-09-46-11-Installation crew extrusion welding a repair in the west drying pad (1)
