NM1 - ____66____

**Operational
Infrastructure and Cell
E-1 Construction
Certification Report**

July 2022

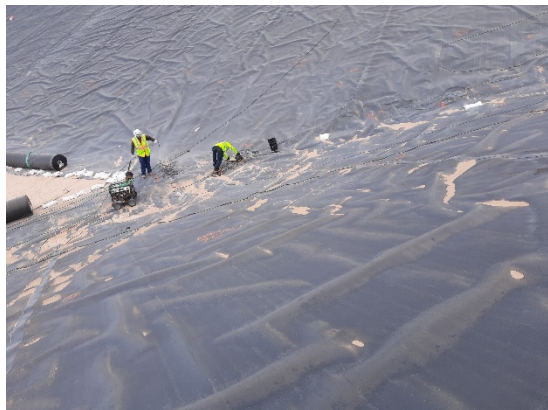
Installation crew vacuum boxing repairs on the toe of the northeast corner of Cell E1

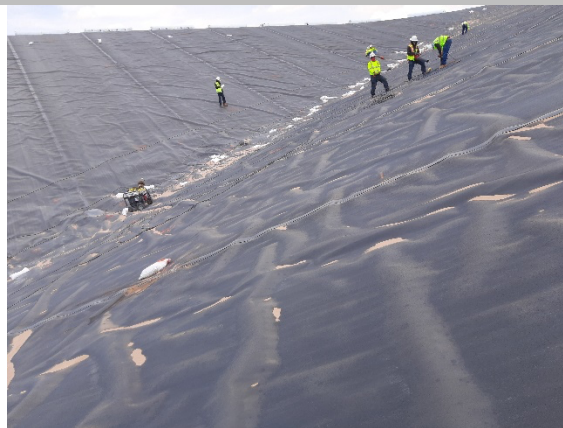
Installation crew removing blown in material from a repair on the east slope.

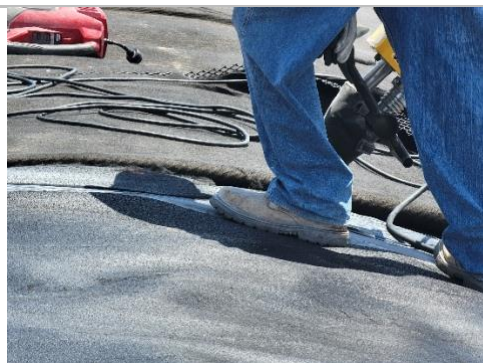
2 panels had to be dealt with due to having horizontal cross-seams on the slope of Cell E1. P16 had a panel extrusion welded over it with a 45-degree cross seam. P124 was removed and replaced with a panel with a 45-degree cross seam in it.

Filename: 20220517_113312
Installation crew extrusion welding replacement panel over P16

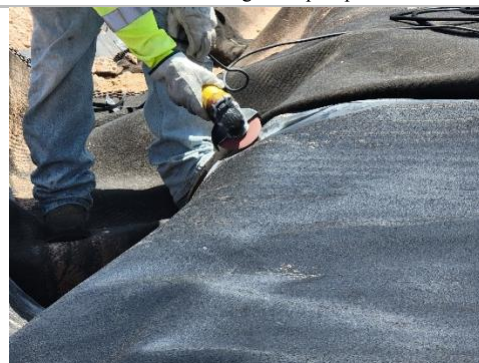
Filename: 20220517_113316
Installation crew gridding overlap of the replacement panel and P16

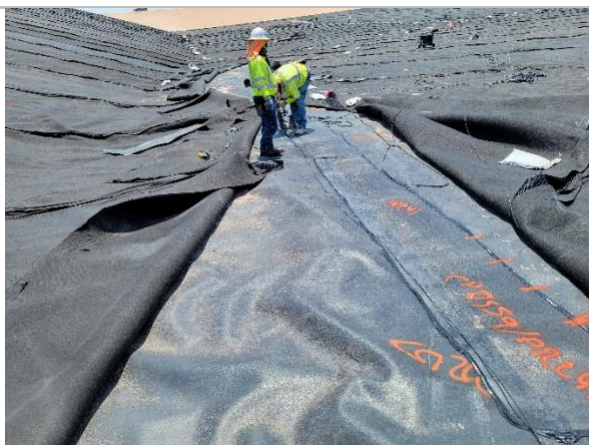
Filename: 20220519_133016
Installation crew welding a cap over the failed seam in Cell E1

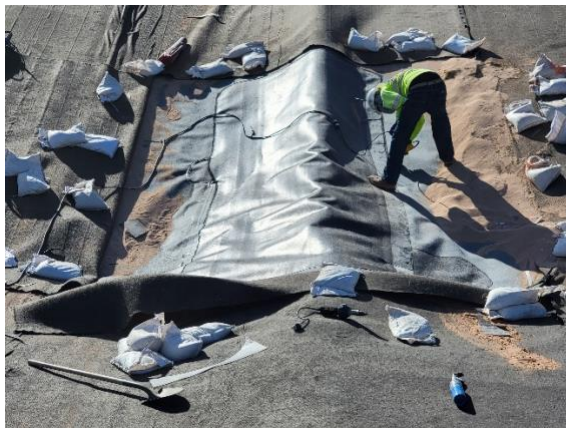
Filename: 20220520_082417
Repair in the riser trench being cleaned for extrusion welding

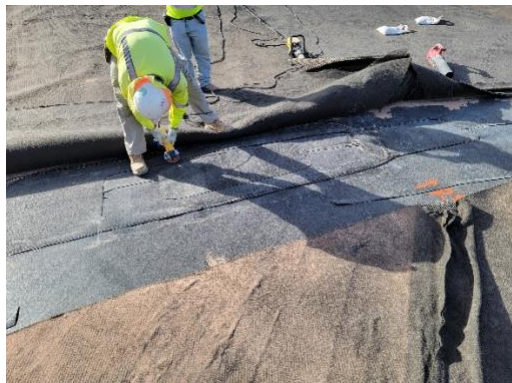
Filename: 20220521_075533
Installation crew cleaning repair for tracking destruct in Cell E1

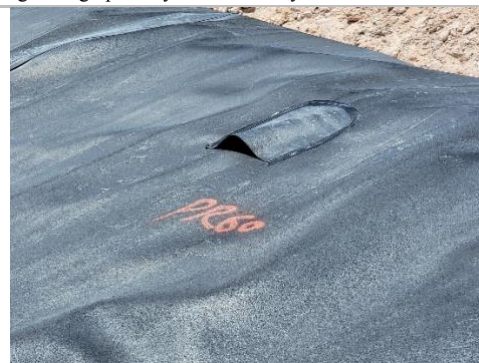
Filename: 20220528_120344
Cover fully welded over an air vent hole on the slope of the leachate pond
