RE: Rule 34 Variance Request –Produced Water Impoundment Construction on Unstable Area

Cave and Karst Resource Inventory Report WaterBridge Burton Flats I Pond Eddy County, New Mexico

July 20, 2022

PW-085B-20220515

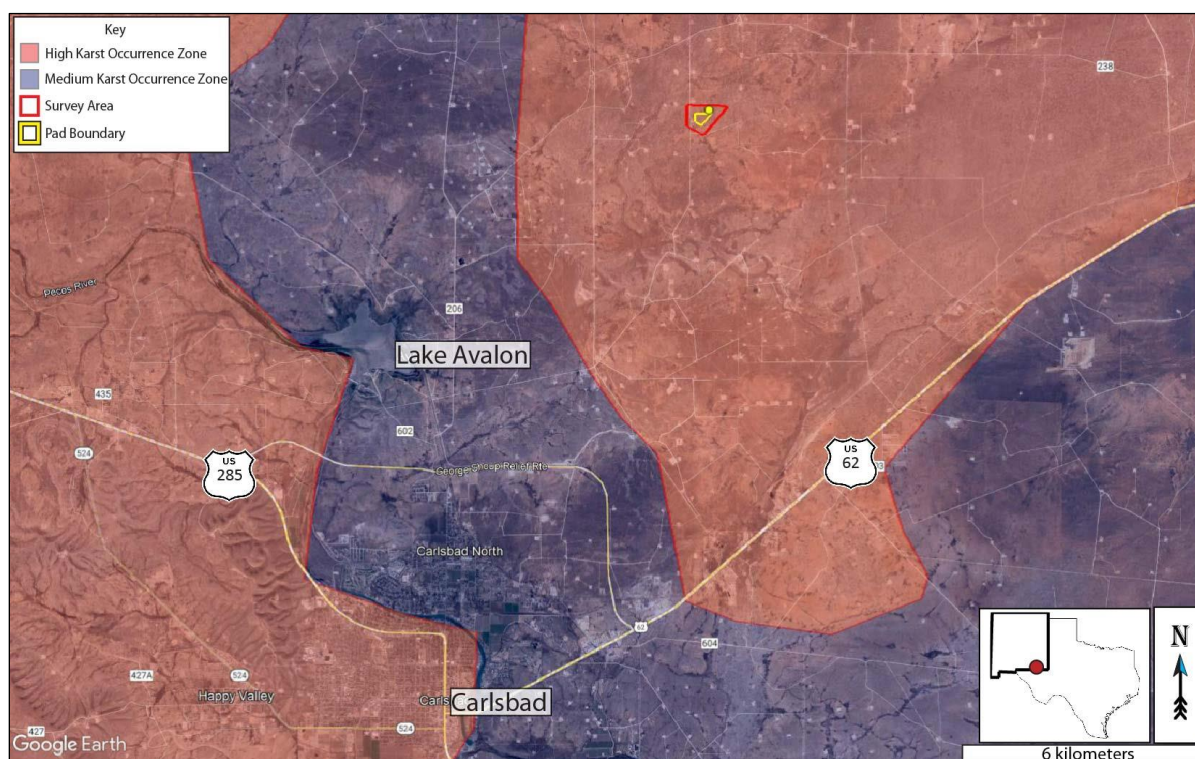
The Bureau of Land Management (BLM) categorizes all areas within the Carlsbad Field Office (CFO) zone of responsibility as having either low, medium, or high cave potential based on geology, occurrence of known caves, density of karst features, and potential impacts to freshwater aquifers^[1]. These designations are also recognized by the New Mexico State Land Office (NMSLO). This project occurs within a **HIGH** karst occurrence zone (**HKOZ**, **Figure 1**).

Figure 1: Karst occurrence overview. Background image: Google Earth. Image date: December 21, 2019. Datum: WGS-84.

A high karst occurrence zone is defined as an area in known soluble rock types that contains a high frequency of significant caves and karst features such as sinkholes, bedrock fractures that provide rapid recharge of karst aquifers, and springs that provide riparian habitat^[2].

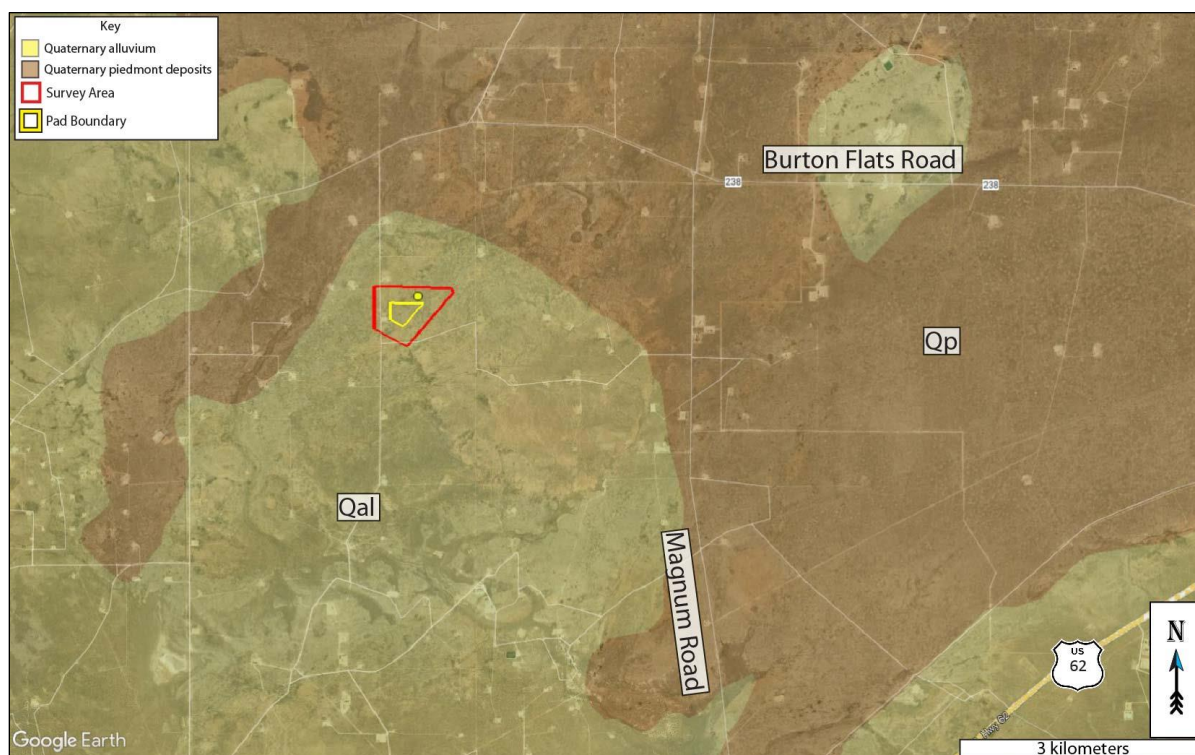
The area surveyed for the WBBF_PND project is located in a region locally known as Burton Flats at an elevation of 985 meters (3,231 feet), ± 1 meter (3.3 feet), and is underlain by the Permian Rustler (Pru) and Salado (Psl) Formations. The area is mantled by thin gypsiferous soils and Quaternary aeolian sands (Qal) and alluvial sands and gravels (Qp)^[7] between 0 and 6 meters in depth (**Figure 3**).

The Salado contains a layer of extremely soluble halite which can readily dissolve to create caves, sinkholes and other karst features; however, due to its extremely soluble nature, only non-soluble silt and sand remain from the dissolution of this layer at the surface^[8]. The Rustler Formation may be subject to collapse if a void has developed beneath it in the Salado Formation^[9].

This area is heavily karstified and has numerous sinkholes, swallets, caves, and other karst features within the survey area. Extreme caution is recommended during any surface activities including surface inspection, brush clearing, and trenching. The survey area is covered by the easily accessible Geologic Map of New Mexico (2003) at 1:500,000 scale^[7].

Figure 3: Geology overview. Map credit: The Digital Geologic Map of New Mexico in ARC/INFO Format^[10], and Google Earth. Image date: December 21, 2019. Datum: WGS-84.

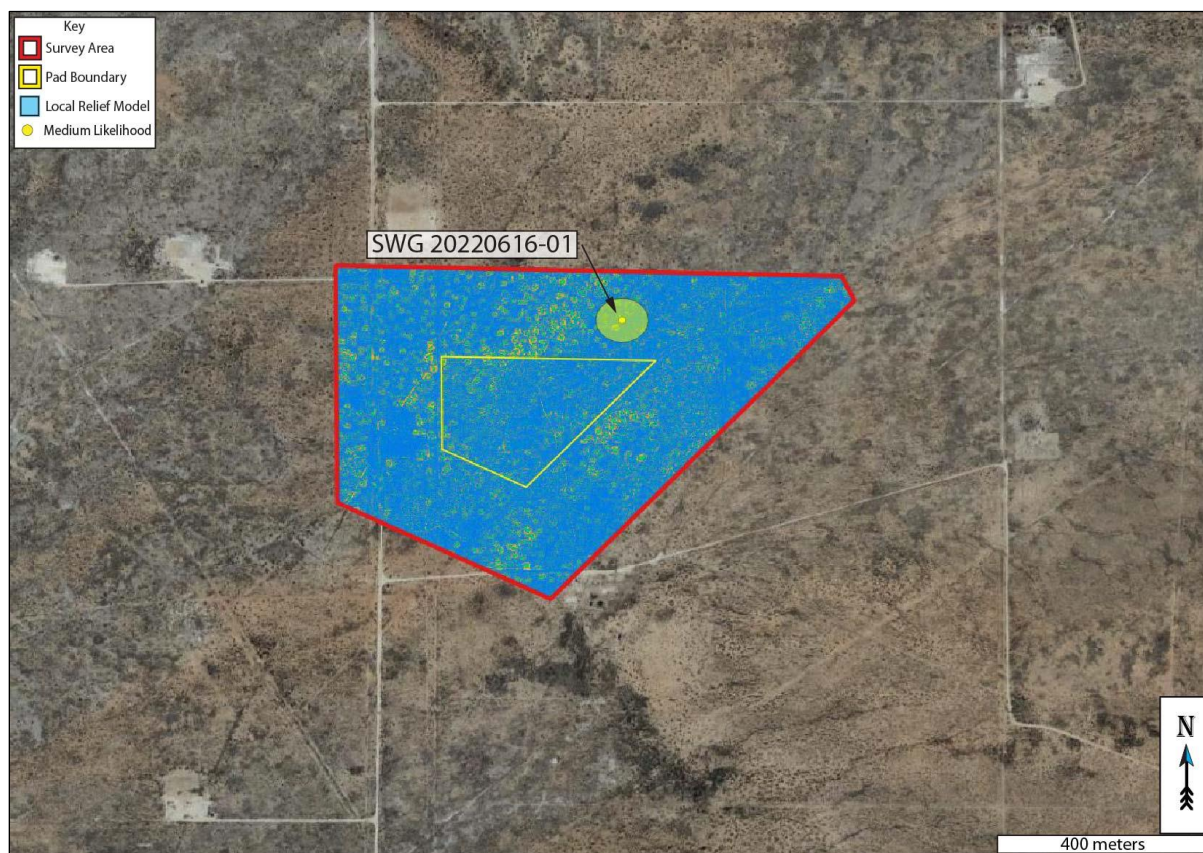
Figure 4: Survey overview. Yellow transparent circle is the feature buffer. Background image credit: Google Earth. Image date: December 21, 2019. Datum: WGS-84.

One medium likelihood surface karst feature is located within the aerial survey area (**Figure 4**, **Table 1**).

Medium likelihood surface karst features are ambiguous in aerial imagery and should be site-checked for verification if they impact the facility's location (**Figure 4** and **Table 1**). The feature identified in this report as medium likelihood may be a burrow or shadow; however, there is insufficient evidence of such and therefore this feature cannot be ruled out. This feature does not impact the planned infrastructure.

Feature ID	Type	Size (m)	Buffer (m)	Modifier	Notes	Easting	Northing
PKF 20220616-01	Closed Swallet	0.8	50	M	Possible Burrow	578952.077	3601990.259

Medium likelihood surface karst features are ambiguous in aerial imagery and should be site-checked for verification. This feature may be a burrows or shadow. Avoid this feature during site planning and while conducting surface activities near or within the feature buffer zone. In the event that infrastructure is to be placed near the feature identified as medium likelihood, a field check should be completed by a BLM-CFO-approved karst vendor to verify the identification prior to planning around it.
