**RF-11  
Salado Draw Section  
23 Recycling Facility  
and Containment-  
Facility ID  
[fTO1706148730]  
Annual Extension  
Approved**

**[4323] CHEVRON USA INC  
November 30, 2022**

## Recycling Facility and/or Recycling Containment

**C-147 Extension request (Salado Draw NM 1RF-11)**

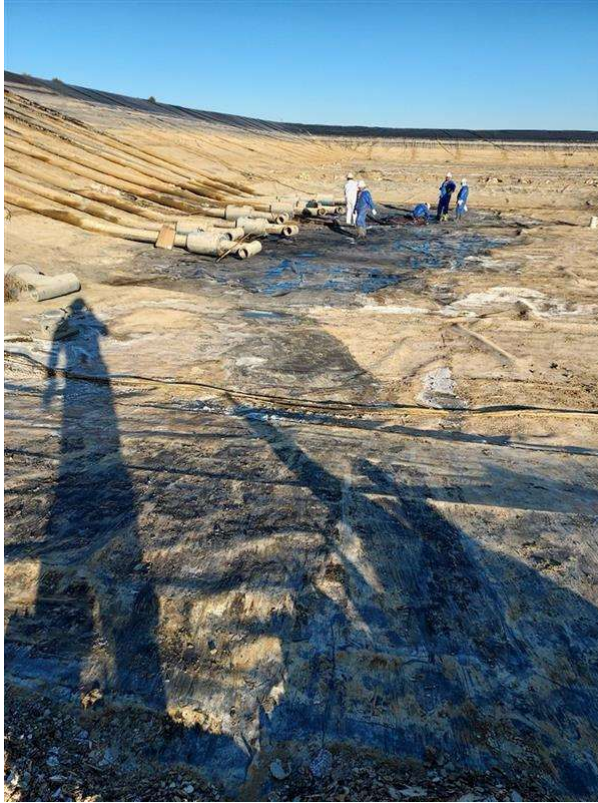
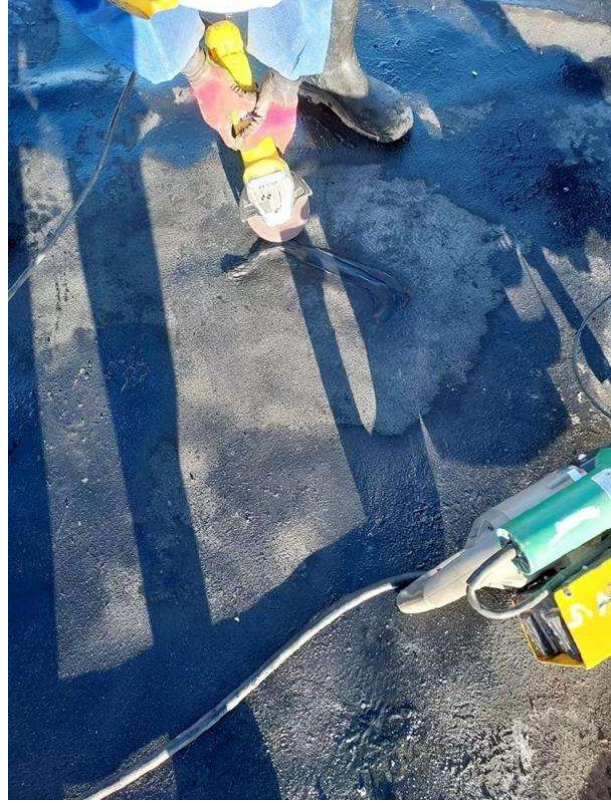
The liner was repaired on 10/25/22. However, the sump area had accumulated water, so they drained the water and found 2 small leaks. Water team drained sump and repaired both liner leaks on 11/14/22 and added 3-4 ft of water to verify. No issues of liner leaks resulted after this repair. We have attached the pictures that verify all 3 liner repairs.

This is the part of the weekly inspection records that says "tear found in liner above fluid level".

The annual extension request includes weekly inspection records showing that the pond was drained to repair the liner. We don't have any notification of that, nor did we receive an extension request to repair the liner

1RF-11: The liner was repaired on 10/25/22. However, the sump area had accumulated water, so they drained the water and found 2 small leaks. Water team drained sump and repaired both liner leaks on 11/14/22 and added 3-4 ft of water to verify. No issues of liner leaks resulted after this repair. We have attached the pictures that verify all 3 liner repairs.
