Cano San Andreas

Job Completion Report

Date Completed: Friday October 20, 2023
Project Title: Cano San Andreas Battery No. 6 Reclamation
Project Overview: Project Location: 33.632346, -103.857883 Start Date: 9/25/23 End Date: 10/20/23
Scope: Removal of surface contamination, equipment contents, power washing equipment for removal, testing materials for contamination (ex.NORM), demo, removal, and salvaging of any equipment and infrastructure on site. Cutting and capping flow lines within the red boundary as shown in the picture provided in the email sent EMNRD – Oil Conservation Division dated Wednesday 5/3/23. Objectives: <ul style="list-style-type: none"> • Removal of surface liquids. • Removal of surface level piping. • Removal of tanks and vessels. • Removal of tank concrete bases.
Waste Removal: Waste Removal Sites: Poly Pipe/Trash/Fiberglass/Sludge – Gandy Marley Inc. Commercial Landfill (NM-01-0019) P.O. Box 1658 Roswell, NM 88202 Liquids/Solids/Sludge – Sundance Services West, Inc P.O. Box 1737 Eunice, NM 88231 Steel – Roswell Recycling Center 1900 E. Poe Roswell, NM 88203

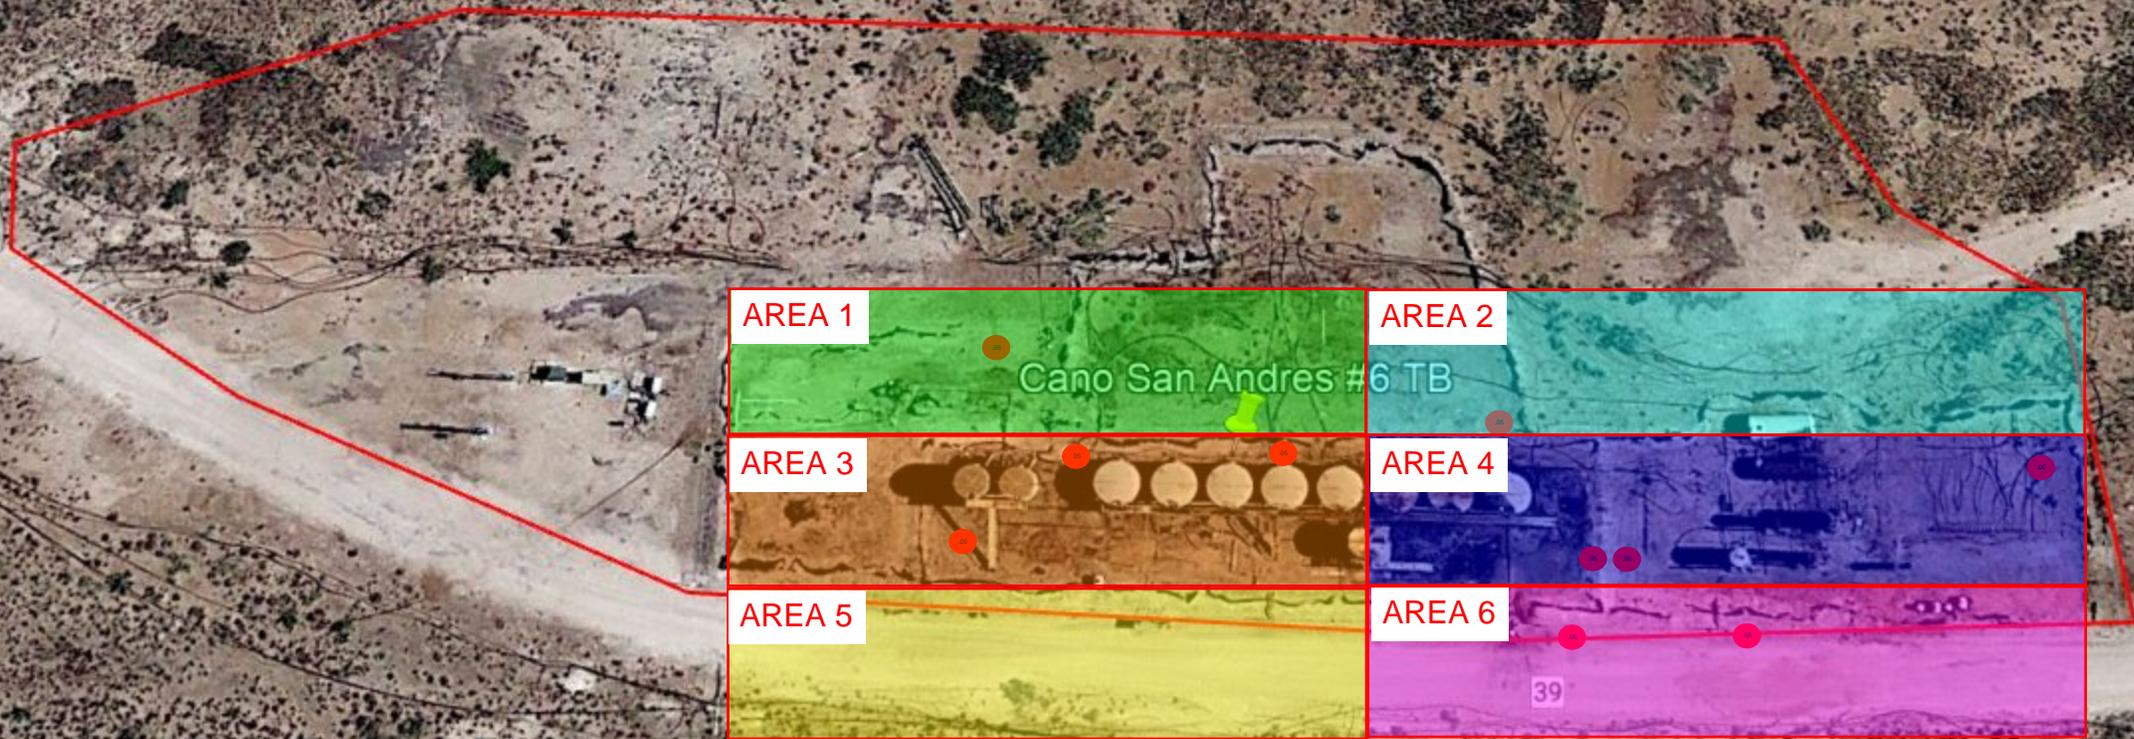
NORM DETECTED ●

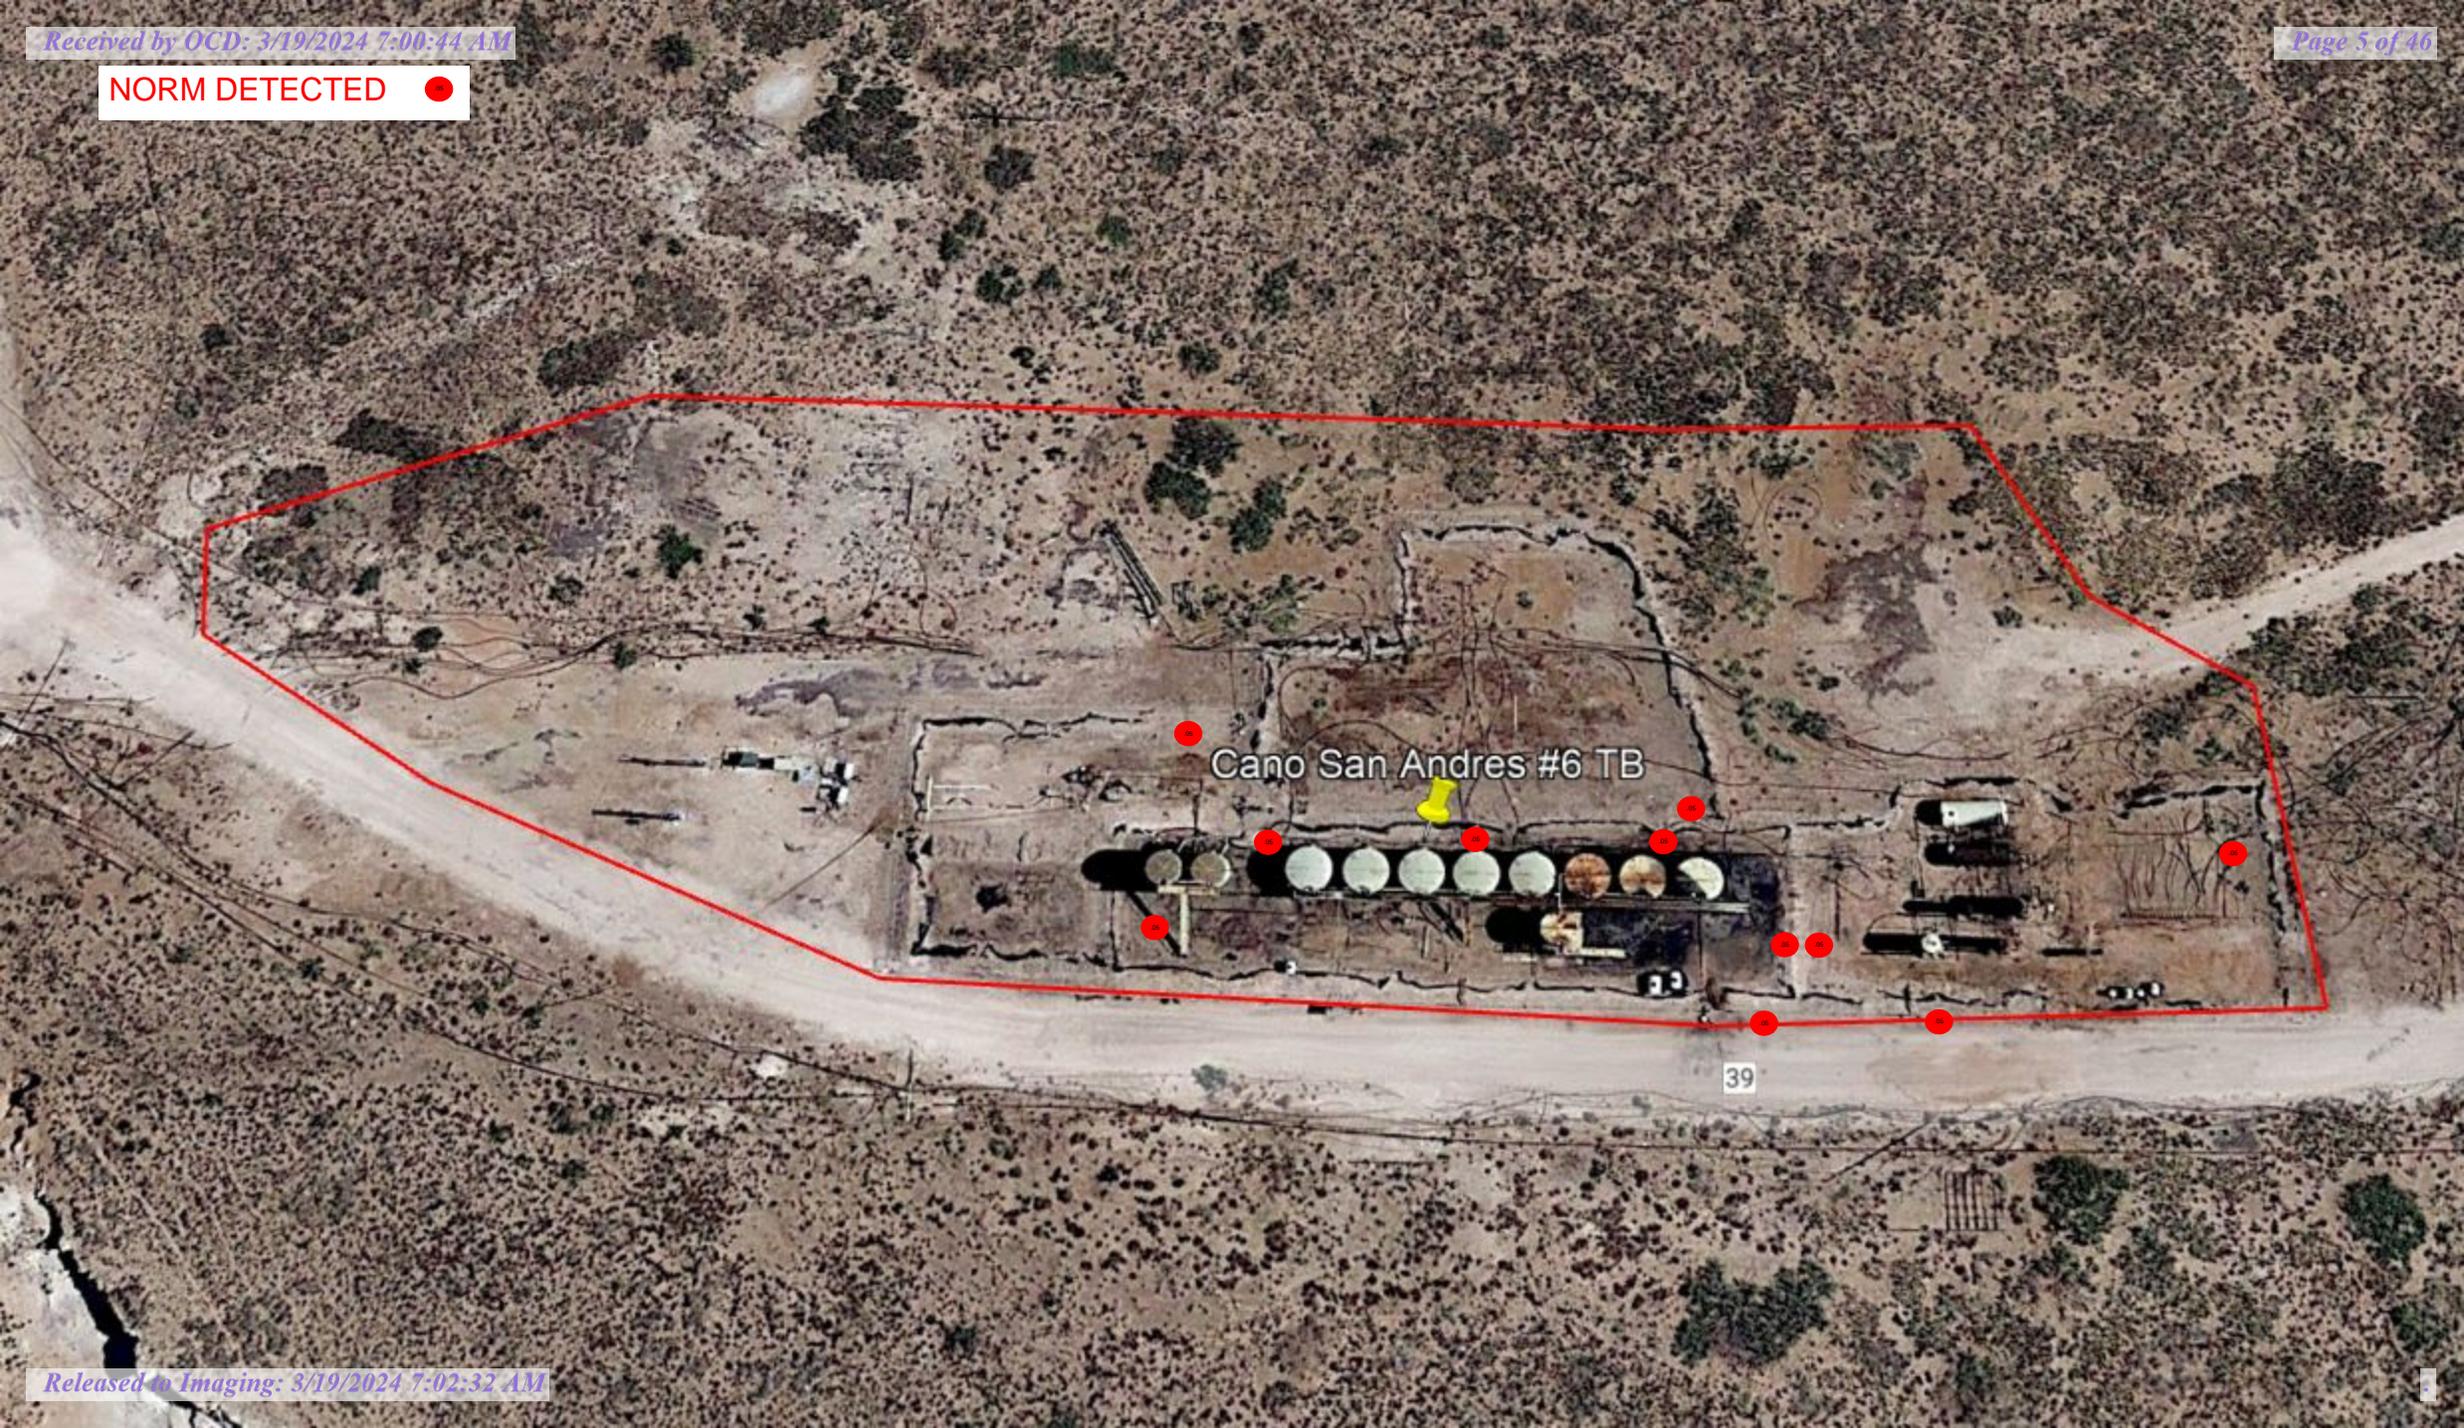
NORM DETECTED ●
