**LEA LAND LANDFILL  
LEA COUNTY, NEW MEXICO  
OCD FACILITY PERMIT NO. NM-1-0035  
ENGINEERING CERTIFICATION REPORT  
UNIT IIB-C CONSTRUCTION**

Prepared for  
Lea Land, LLC  
February 2025

Re: Engineering Certification Report – Unit IIB-C Construction  
Lea Land Landfill, LLC  
OCD Facility Permit No. NM-1-35  
Lea County, New Mexico

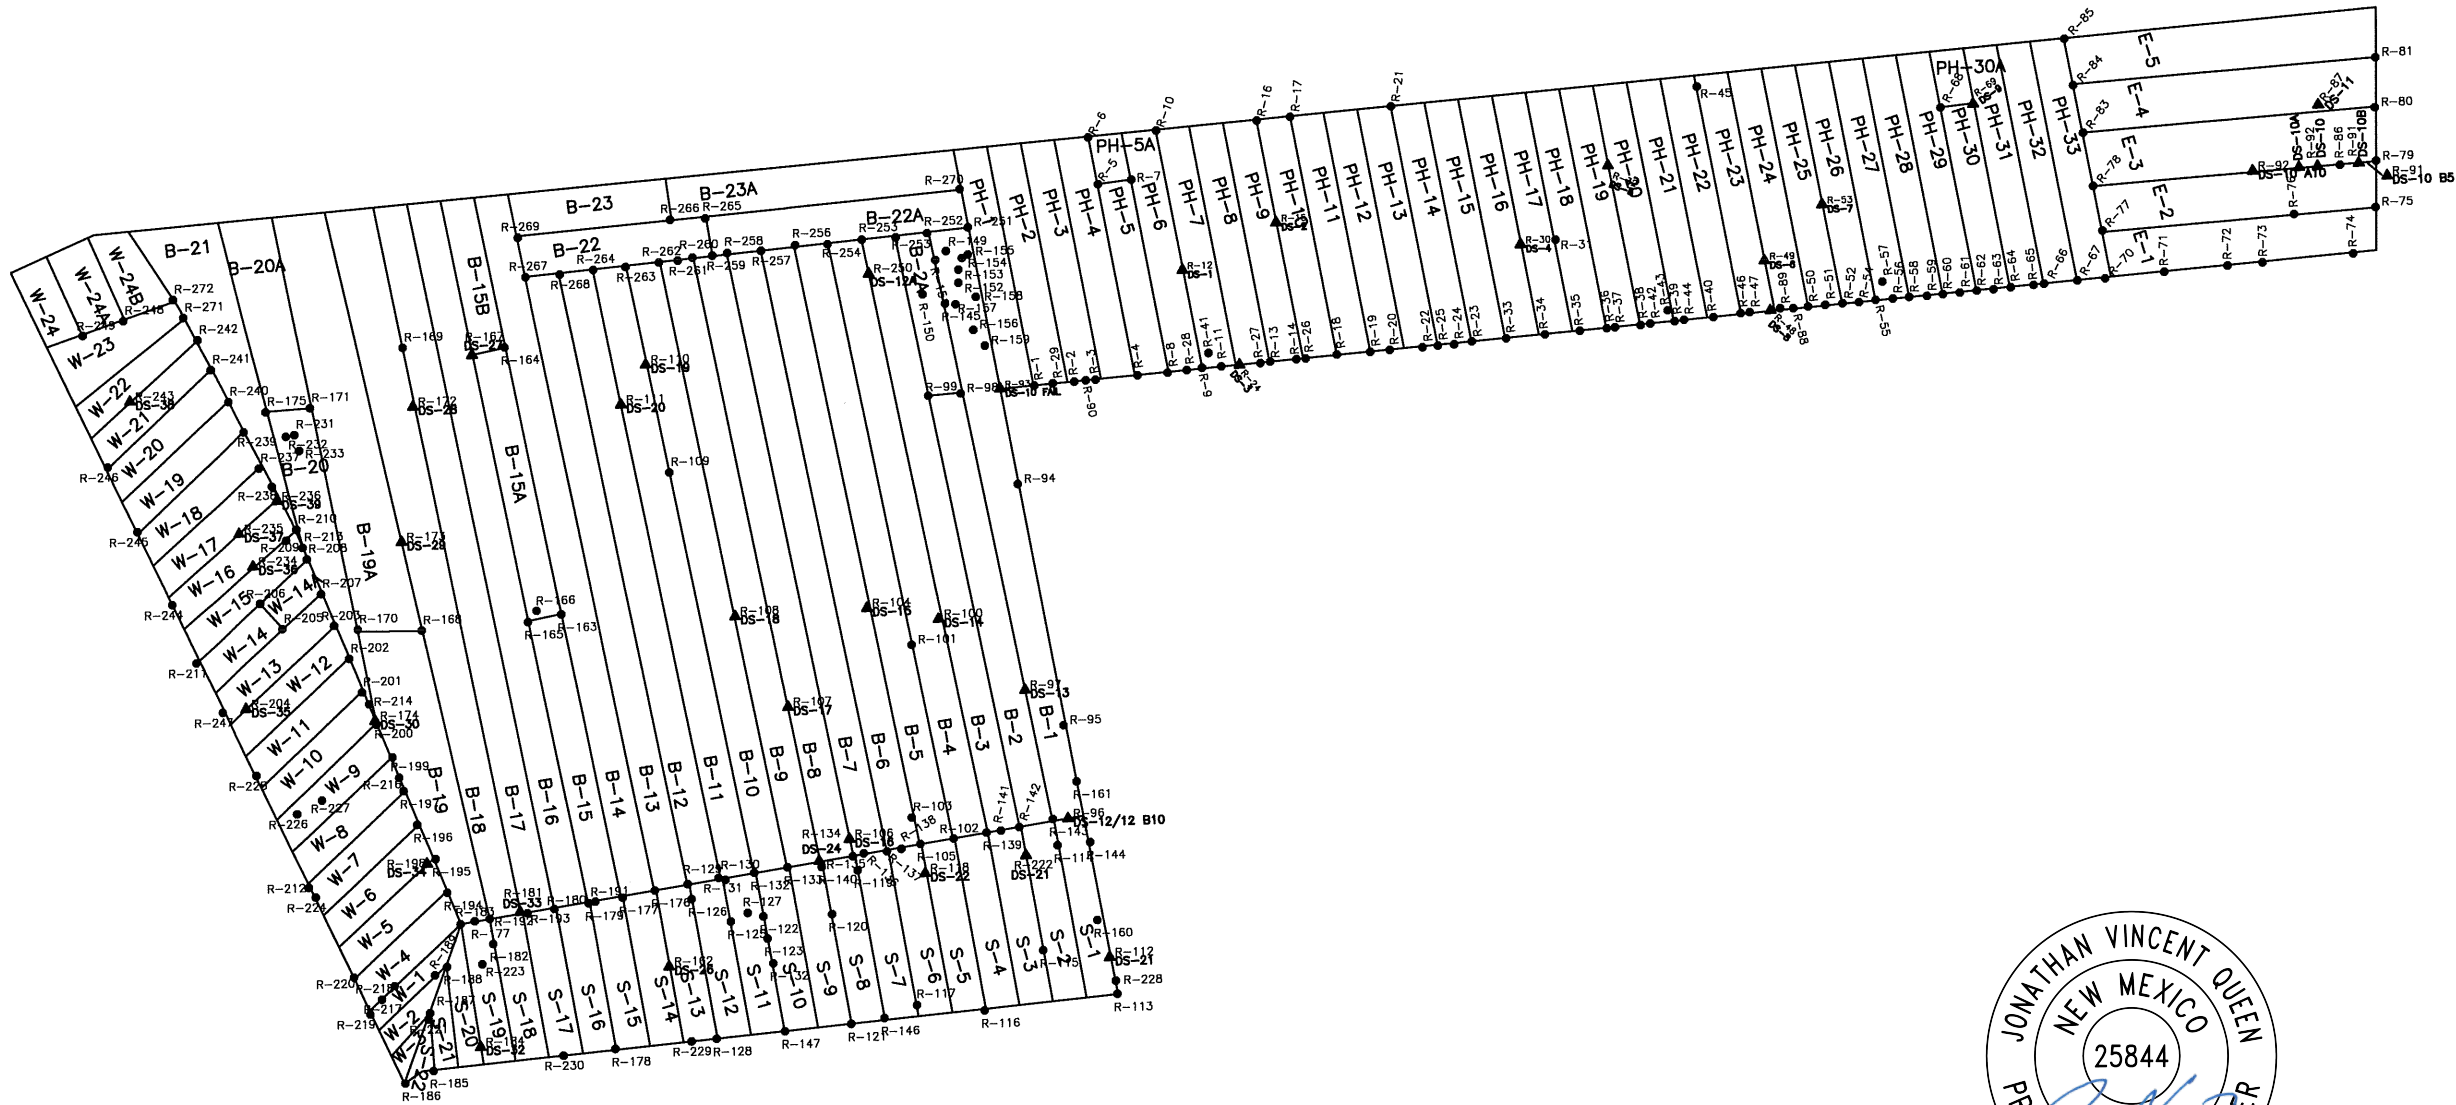
Repairs were performed at all seam intersections, destructive seam tests, air pressure tests, and all other locations where the CQA monitors determined that some form of repair was required. Repair locations are shown in Appendix A, on Drawings A10 and A11.
