**From:** [Shelly Cowden](#)  
**To:** "Venegas, Victoria, EMNRD"  
**Subject:** RE: 1RF-463 - JAVELINA FACILITY [FVV2108855989]  
**Date:** Monday, March 30, 2026 12:14:00 PM

I wanted to follow up regarding the inspection structure for the Javelina Recycling Facility and clarify how our current practices align with the approved permit requirements.

**New Mexico Recycling Facility Monthly Inspection**

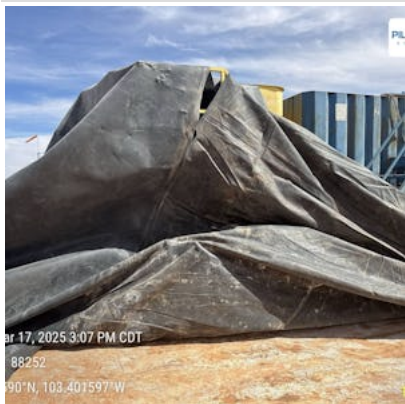
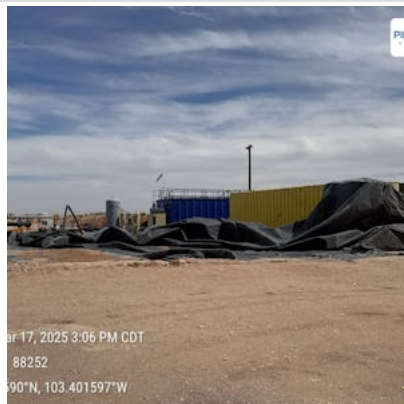
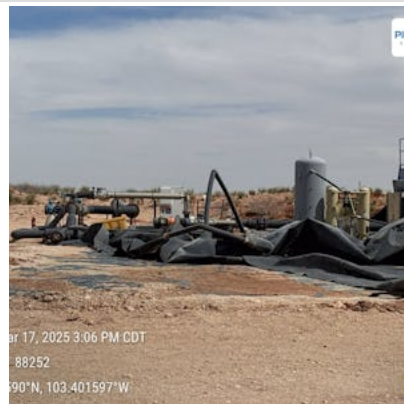
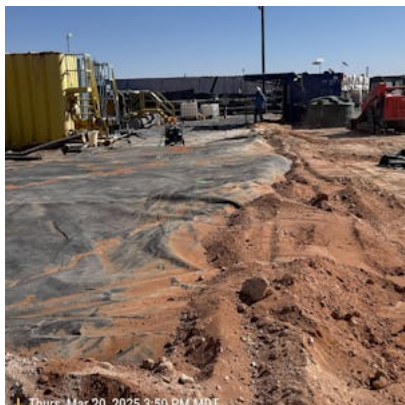
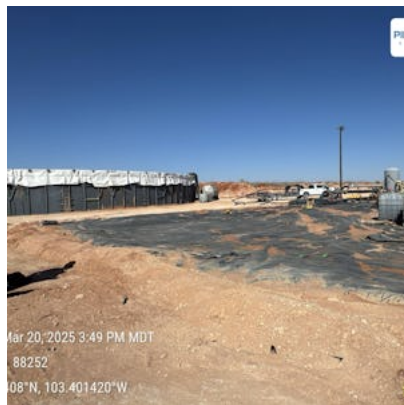
Is fencing and cattleguard in good condition?	Yes
Is there any evidence of spills or soil staining that have not been cleaned up?	No
Any migratory birds or wildlife discovered in the facility?	No
Are there any holes found in the containment liner?	Yes

<b>Any evidence of erosion on the outside slope of the facility?</b>	No
<b>Comments</b>	Liner sustained some wind damage and we've completed repairs

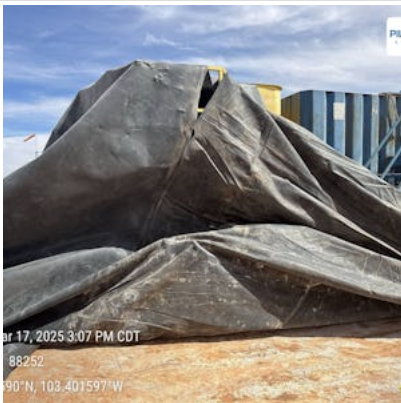
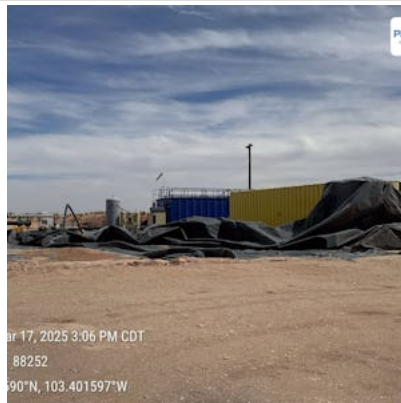
Read and record the fluid height of staff gauges	6'
Does the pond surface show visible oil?	No
Visually inspect containments liner	Wind damage on some of the liners, will schedule liner crew to fix

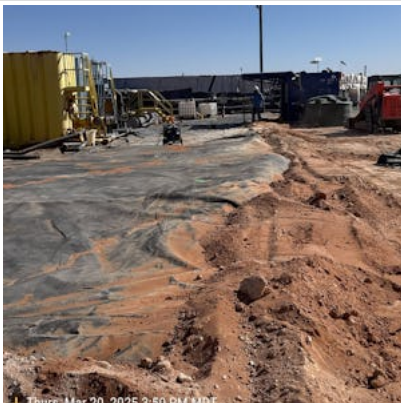
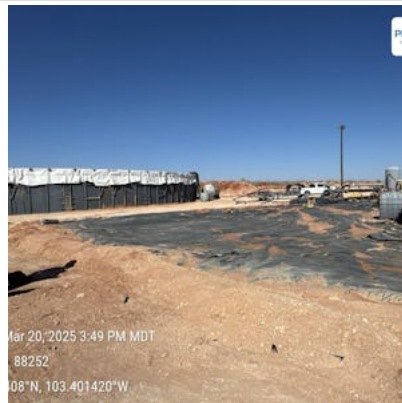
Read and record the fluid height of staff gauges	6'
Does the pond surface show visible oil?	No
Visually inspect containments liner	all containments/liners fixed
