Subject: Liner Inspection and Closure Report
Mean Green 23 Federal #1 Battery
Lea County, New Mexico
Incident # - NOY1823231809

Devon Energy Production Company (Devon) (Client) retained HRL Compliance Solutions, Inc. (HRL) to conduct a liner inspection and prepare this closure report for the release at the Mean Green 23 Federal #1 Battery pad (Site). The Site is located in Eddy County, New Mexico (Figure 1).

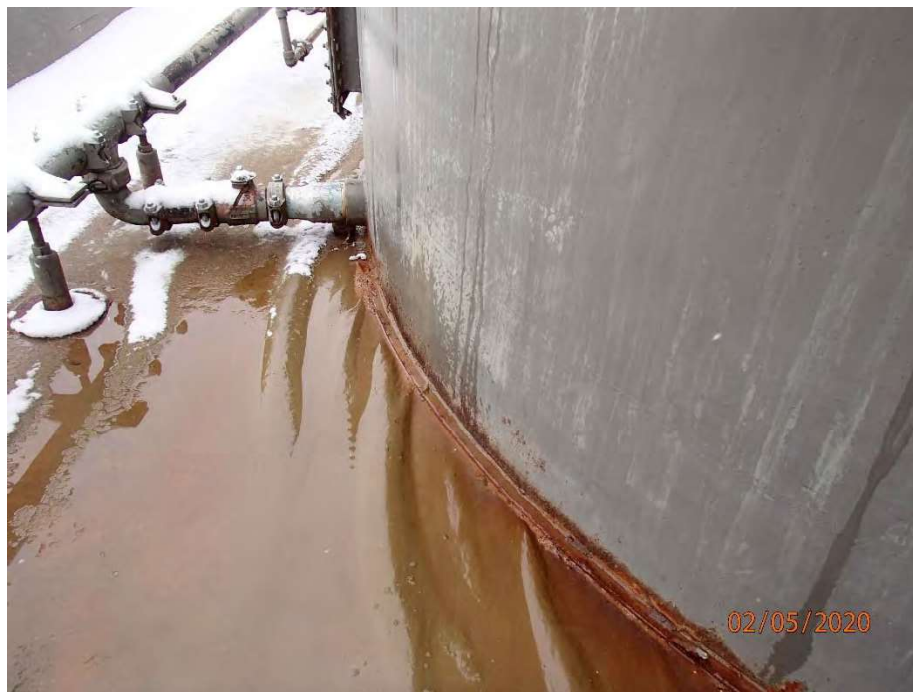
View of standing water and snow within the secondary containment.

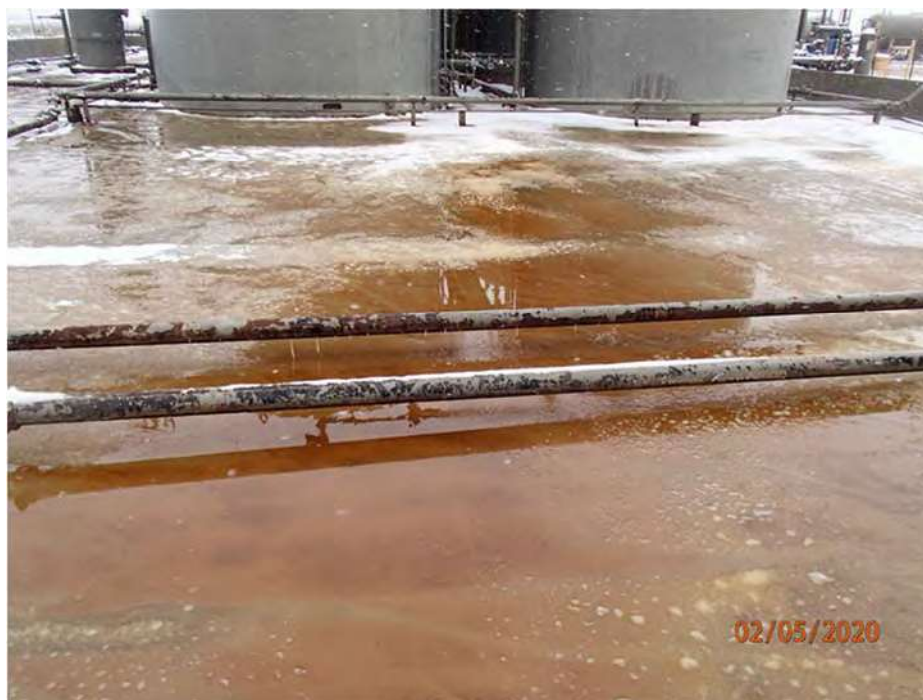
View of standing water and snow within the secondary containment.

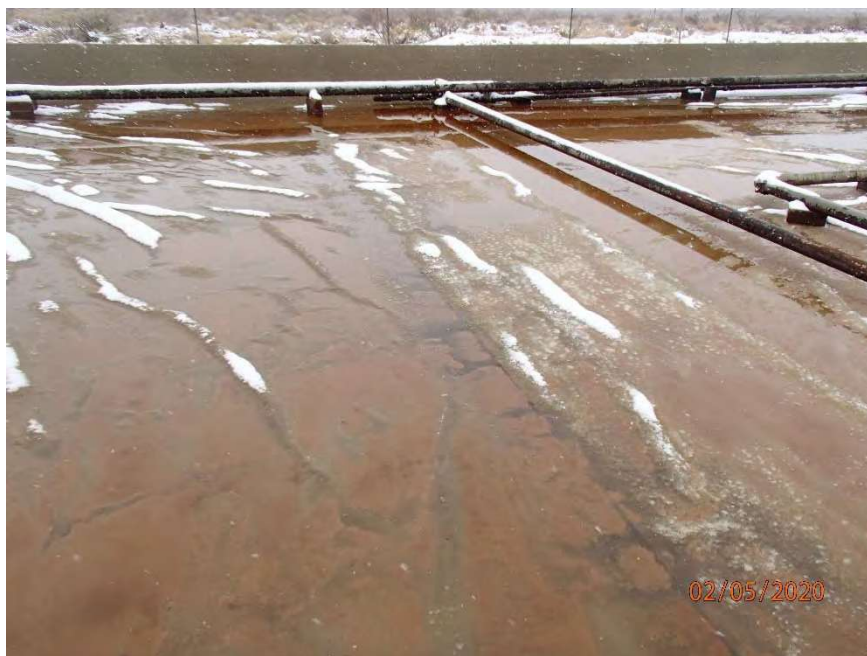
View of standing water in the secondary containment.

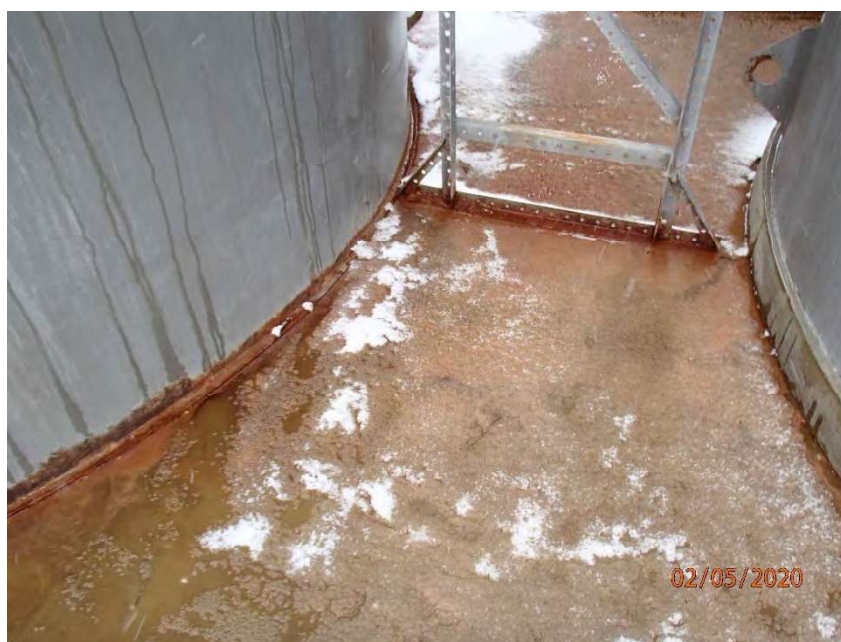
View of standing water between the tanks and rust on the bottom of the tank.

Rust on metal → evidence of liner holding water
