Request For Incident Closure

January 15, 2021

Re: Assessment and Closure Report
Strawberry 7 Fed #4H Battery
API No. 30-015-37258
GPS: Latitude 32.6686211 Longitude -103.9012527
UL "P," Sec. 7, T19S, R31E
Eddy County, NM
NMOCD Ref. ID NRM2029641459

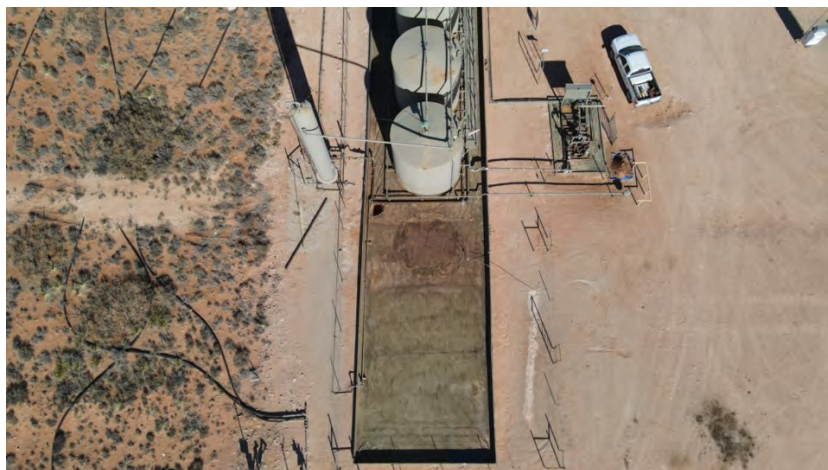
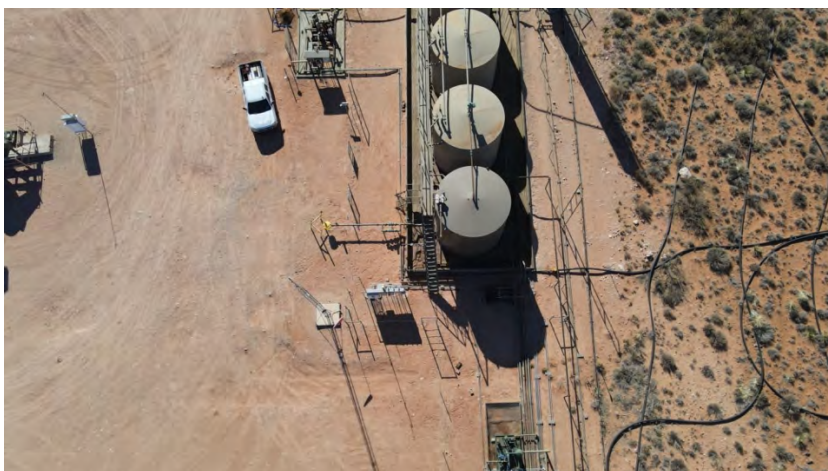
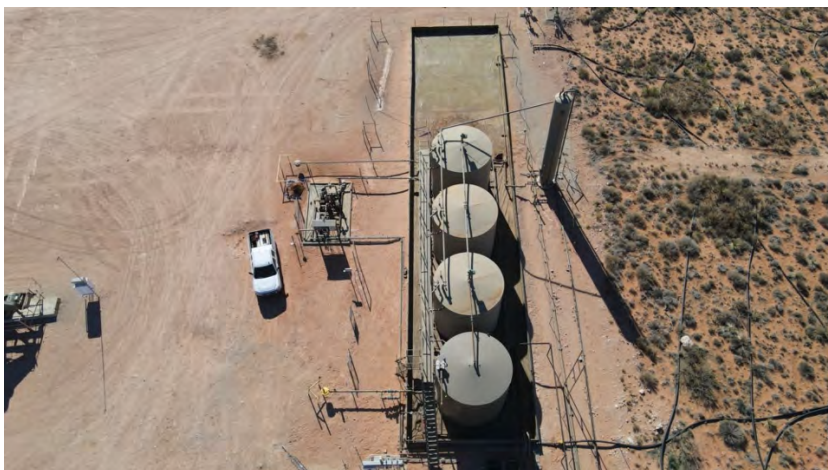
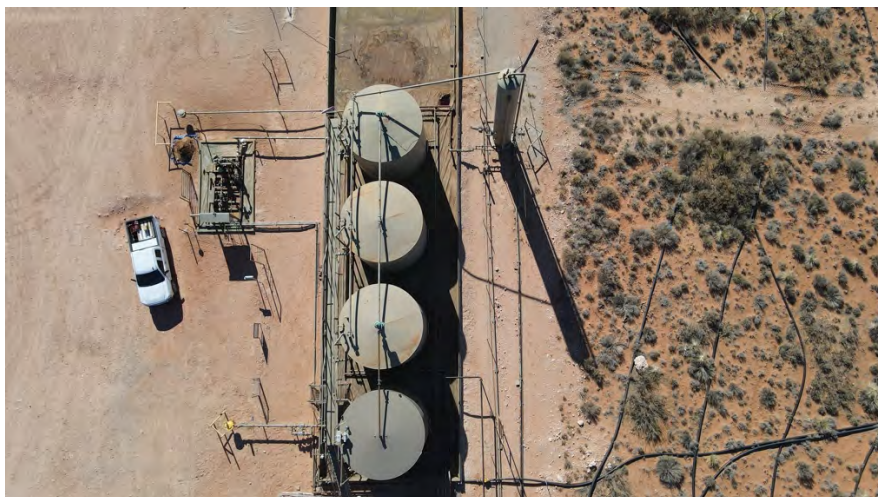
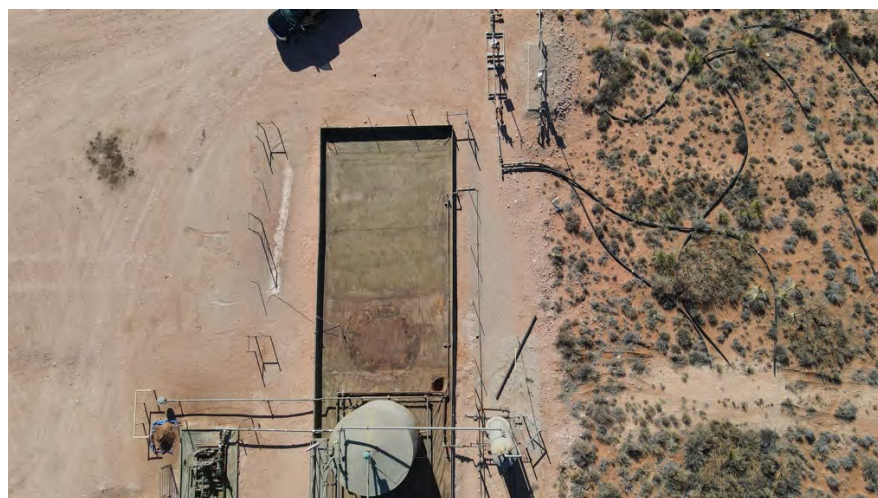
Liner Photos

NRM2029641459: On October 7, 2020, the lease operator found a tank had collapsed and was releasing fluids from the failed weld on the bottom of the tank. The fluids were contained in the engineered steel and poly lined containment. The lost fluids were calculated to be approximately 180 barrels (bbls) of produced water. A vac truck was dispatched and was able to recover the 180 bbls.

Visualization	Yes	No	Comments
Is there a tear in the liner?	<input type="checkbox"/>	<input checked="" type="checkbox"/>	
Are there holes in the liner?	<input type="checkbox"/>	<input checked="" type="checkbox"/>	
Is the liner retaining any fluids?	<input type="checkbox"/>	<input checked="" type="checkbox"/>	
Does the liner have integrity to contain a leak?	<input type="checkbox"/>	<input checked="" type="checkbox"/>
