SMA #5E29133, BG22

RE: LINER INSPECTION REPORT GREEN WAVE 20 CTB 3 (NRM2014570121)

Appendix A PHOTO LOG & FIELD NOTES

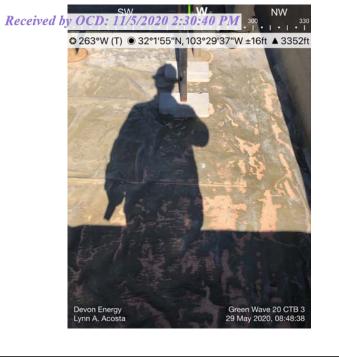
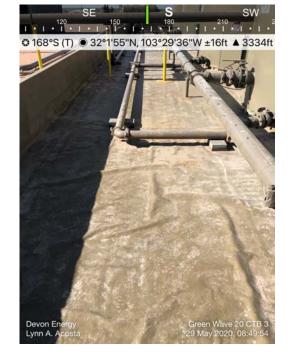
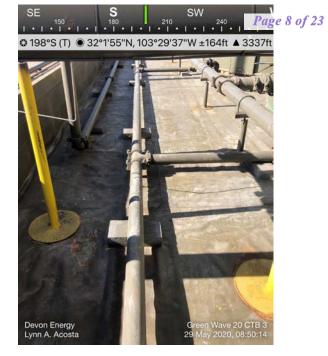
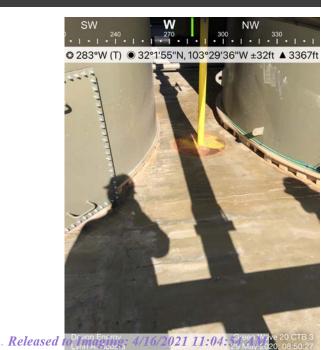
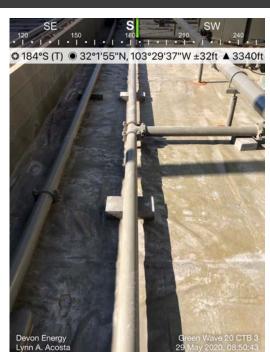
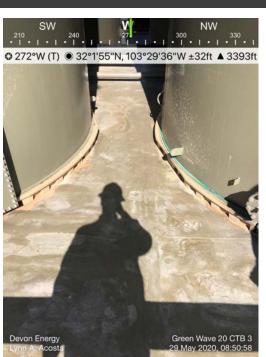
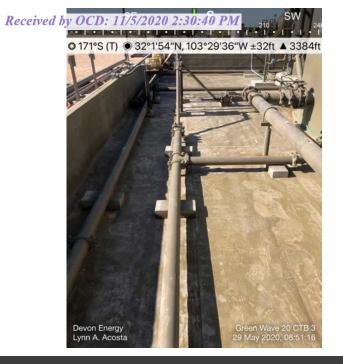
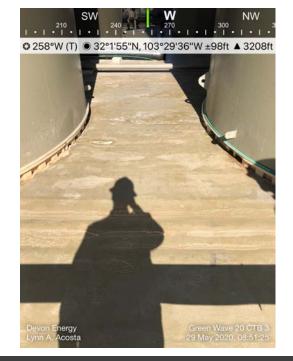
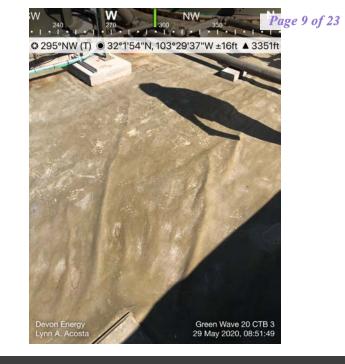
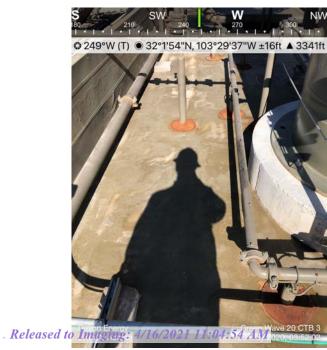
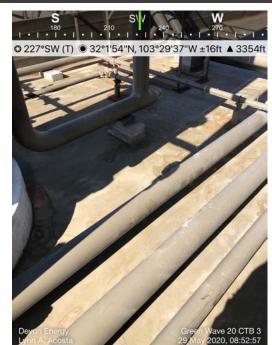
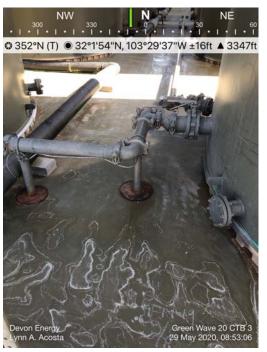
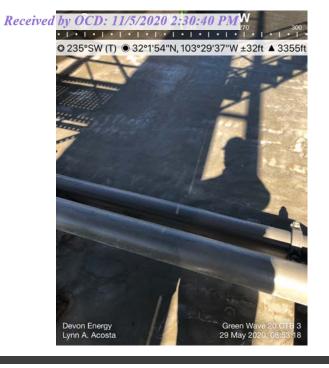
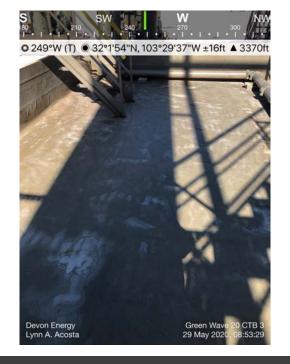
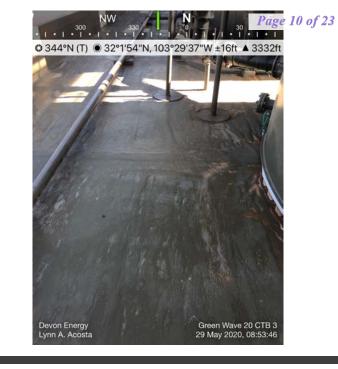
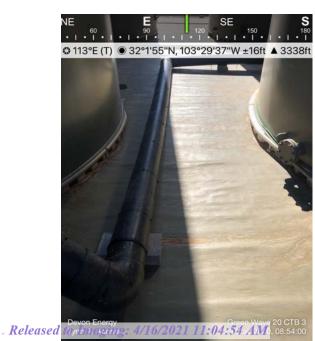
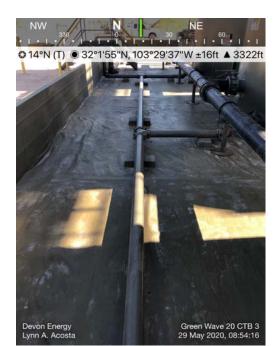
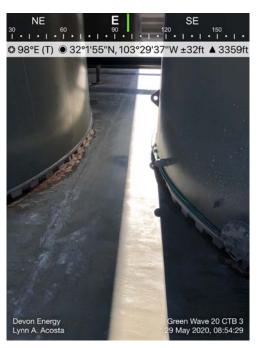
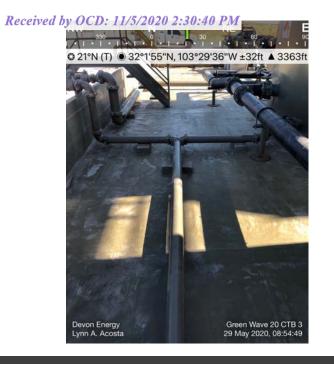
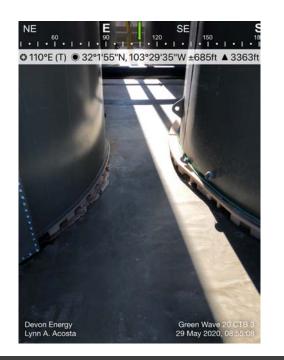
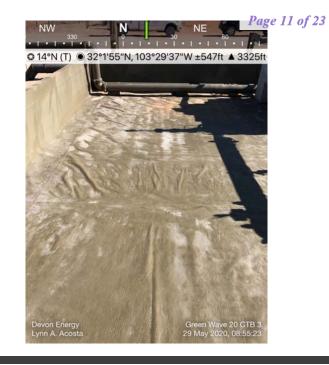
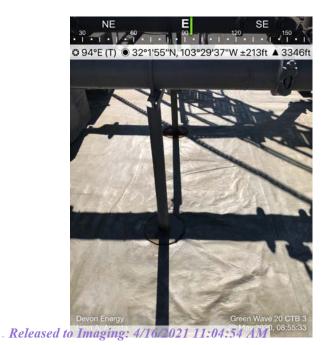
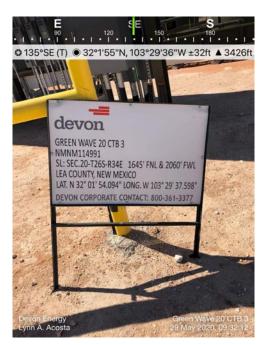
At the request of Devon Energy, on May 29, 2020, SMA conducted a liner integrity inspection per the requirements of 19.15.29.11.A(5)(a) NMAC. NMOCD was notified on May 27, 2020 that the liner inspection was to occur. After a thorough visual inspection of the liner for the tank battery containment, SMA concluded that the liner appeared to be intact and had the ability to contain the leak in question. The ball valve from which the release occurred was identified, and SMA verified that the release did not occur outside of the lined containment. A photo log and field notes of the inspection is included in Appendix A.

· Arrived on Sile (8:00) Received by OCD: 11/5/2020 2:30:40 PM Green Wave 20 CTB 3" DVN Acc Page 12 of 23
Tom bynum was on sile as well, he is a devan representative
" Walted to Pol and described what had occurred. Release did in fact stay in containment
Began to walk containment and search for any tears or other potential compromises throughout containtment.
- no indication of failures were observed during walk through of containment
- Liner did remain intact
Began to take andos of contamment.
Mapped containment as there is no updated arenal Cotage of mi
o left site
Released to Imaging 4/16/2021 11:04:54 AM NSN: 7530-01-577-8866 Rete in the Rain.

SMA recommends no further action for this release.
