**Re: CVU 106/136
Remedial Plan #: 1RP-2642 and 1RP-3244
2018 Annual Vegetation Monitoring Report
Lea County, New Mexico**

2018 ANNUAL VEGETATION MONITORING REPORT

CVU 106/136

CVU 106/136
Lea County, New Mexico
1RP-2642-0 and 1RP-3244

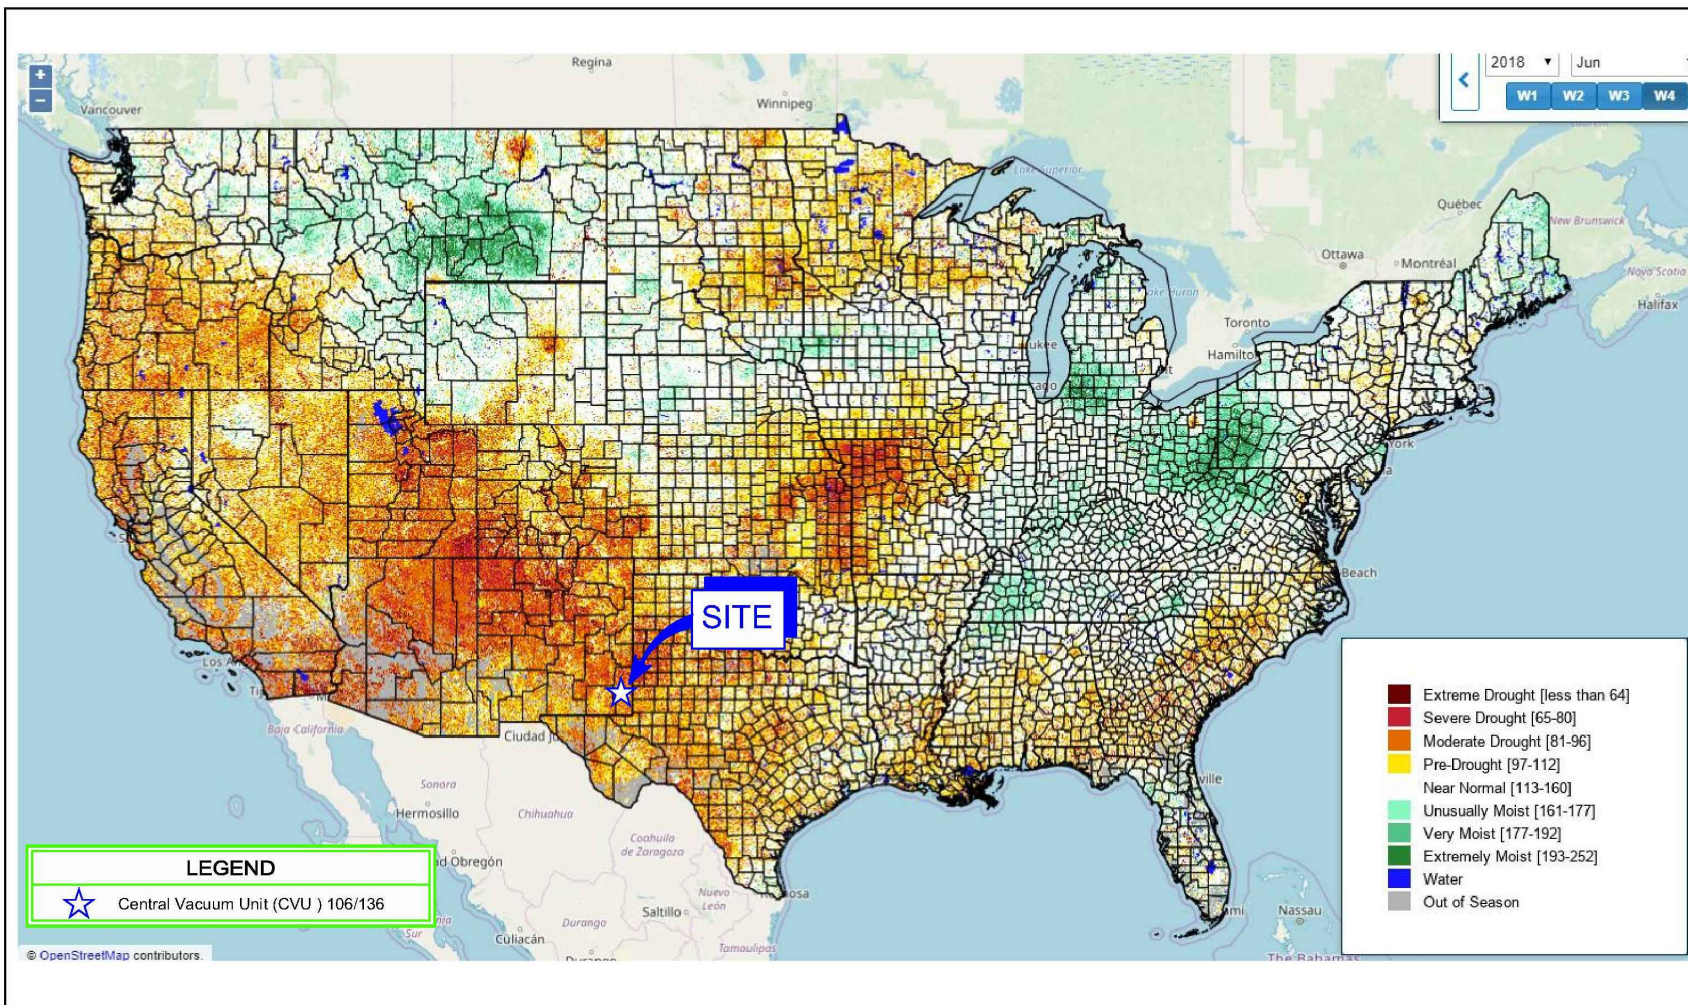
USGS VEGETATION DROUGHT
RESPONSE INDEX - JUNE 2018

The first half vegetation-monitoring event occurred on June 26, 2018 (eight months following the initial reseeding activities). Grasses and flowering shrubs had just begun surfacing through the topsoil. Those that had appeared were green and thriving on the Site (Appendix A: Photos 1 and 2). The vegetation is patchy, but otherwise appears to be in the same condition as within the surrounding area. Regional water conditions are moderate to severe drought based on the USGS Vegetation Drought Response Index for June 2018 (Figure 2).

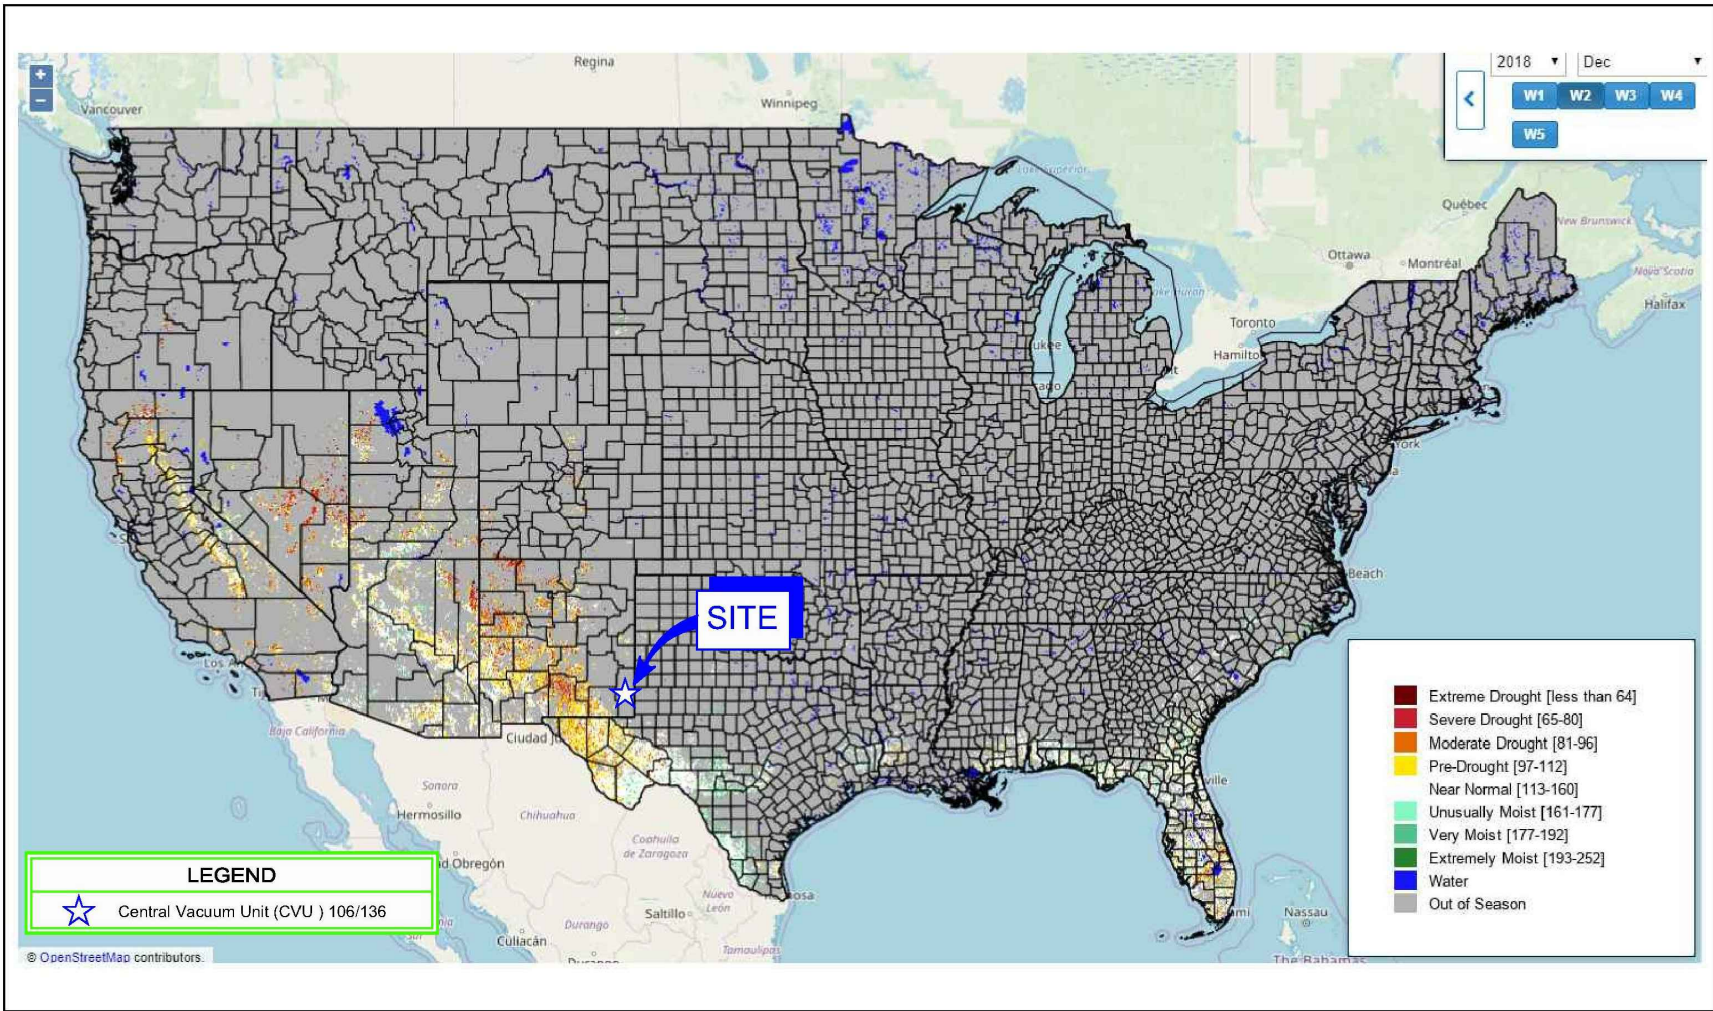
**USGS VEGETATION DROUGHT
RESPONSE INDEX - DECEMBER 2018**

The second half vegetation-monitoring event occurred on December 18, 2018 (fourteen months following the initial reseeding activities). The majority of the vegetation has dried out and gone dormant due to worsening drought conditions in the region and seasonal conditions (Appendix A: Photos 3 and 4). Only a few patches of grass remain green and present on the Site. The vegetation within the remediated area continues to fill in compared to past monitoring events but remains slightly patchy. Regional water conditions are pre-drought to severe drought for available locations based on the USGS Vegetation Drought Response Index for December 2018 (Figure 3).

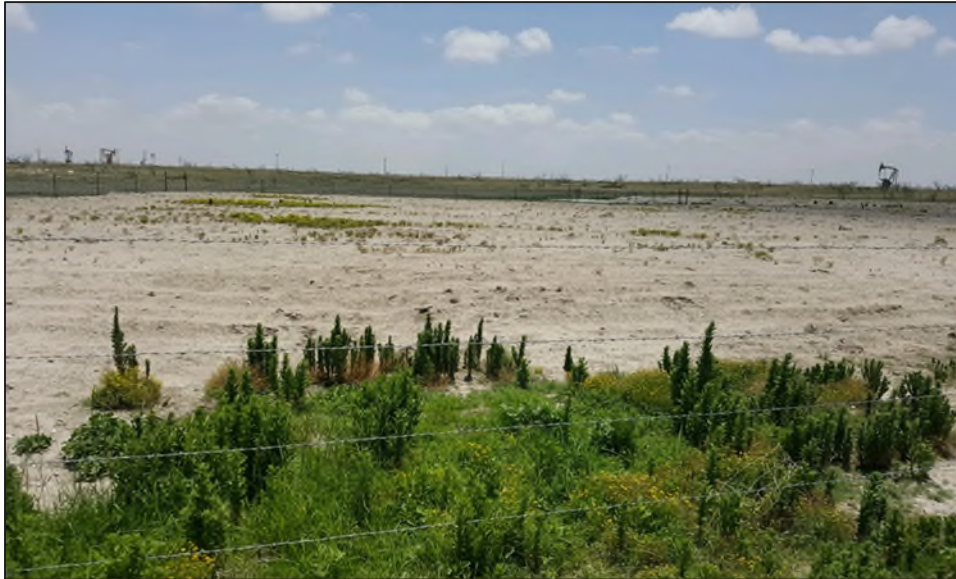
Photo: 1

First vegetation-monitoring event that occurred on June 26, 2018 (eight months after reseeding which occurred in October 2017). Plants have begun growing on-Site. Site vegetation is green and active similar to the surrounding vegetation.

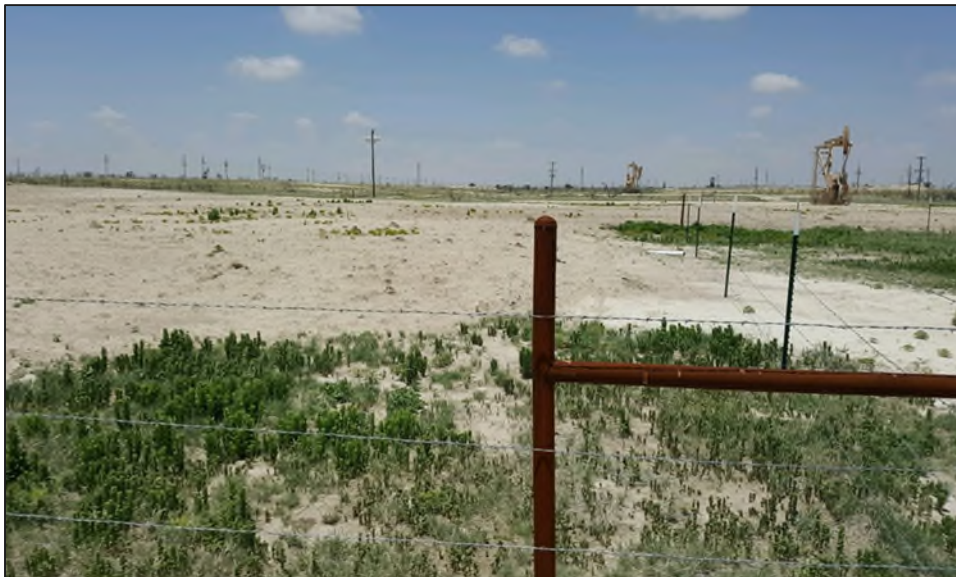
Photo: 2

Additional view of first vegetation monitoring event (June 26, 2018). Both grass and flowering shrubs have begun to grow within the remediated area on the Site.

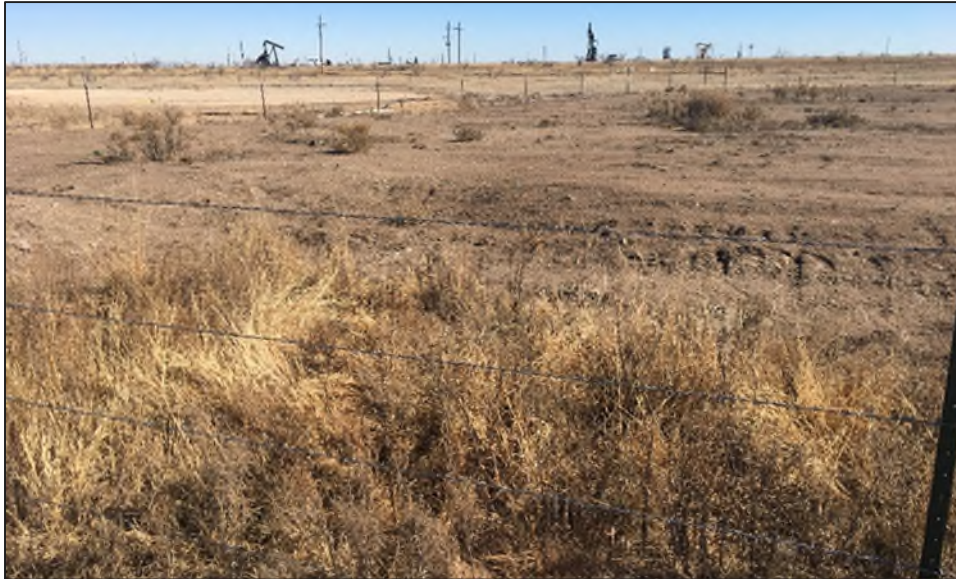
Photo: 3

Second vegetation monitoring event that occurred on December 18, 2018 (fourteen months following reseeding). Vegetation on-Site vegetation appears dormant, mirroring off-Site conditions.

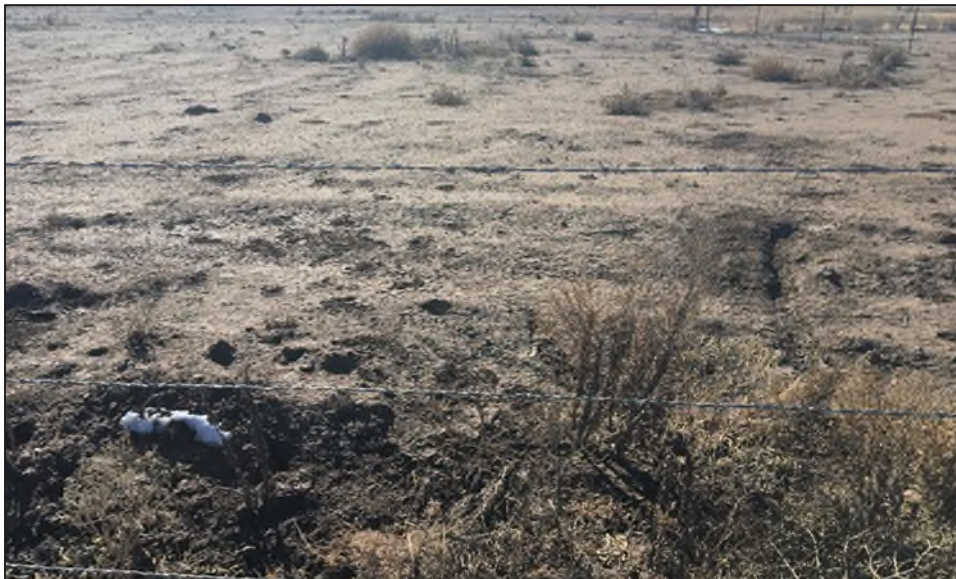
Photo: 4

Additional view of second vegetation-monitoring event (December 18, 2018). Another view showing the on and off-Site vegetation yellowed, likely dormant due to season. Note the snow/ice on the ground.
