# Remediation and Reclamation Summary Report

## Chalupa #4 SWD – South Remediation Area 1RP-4632 Lea County, NM

**October 29, 2019**

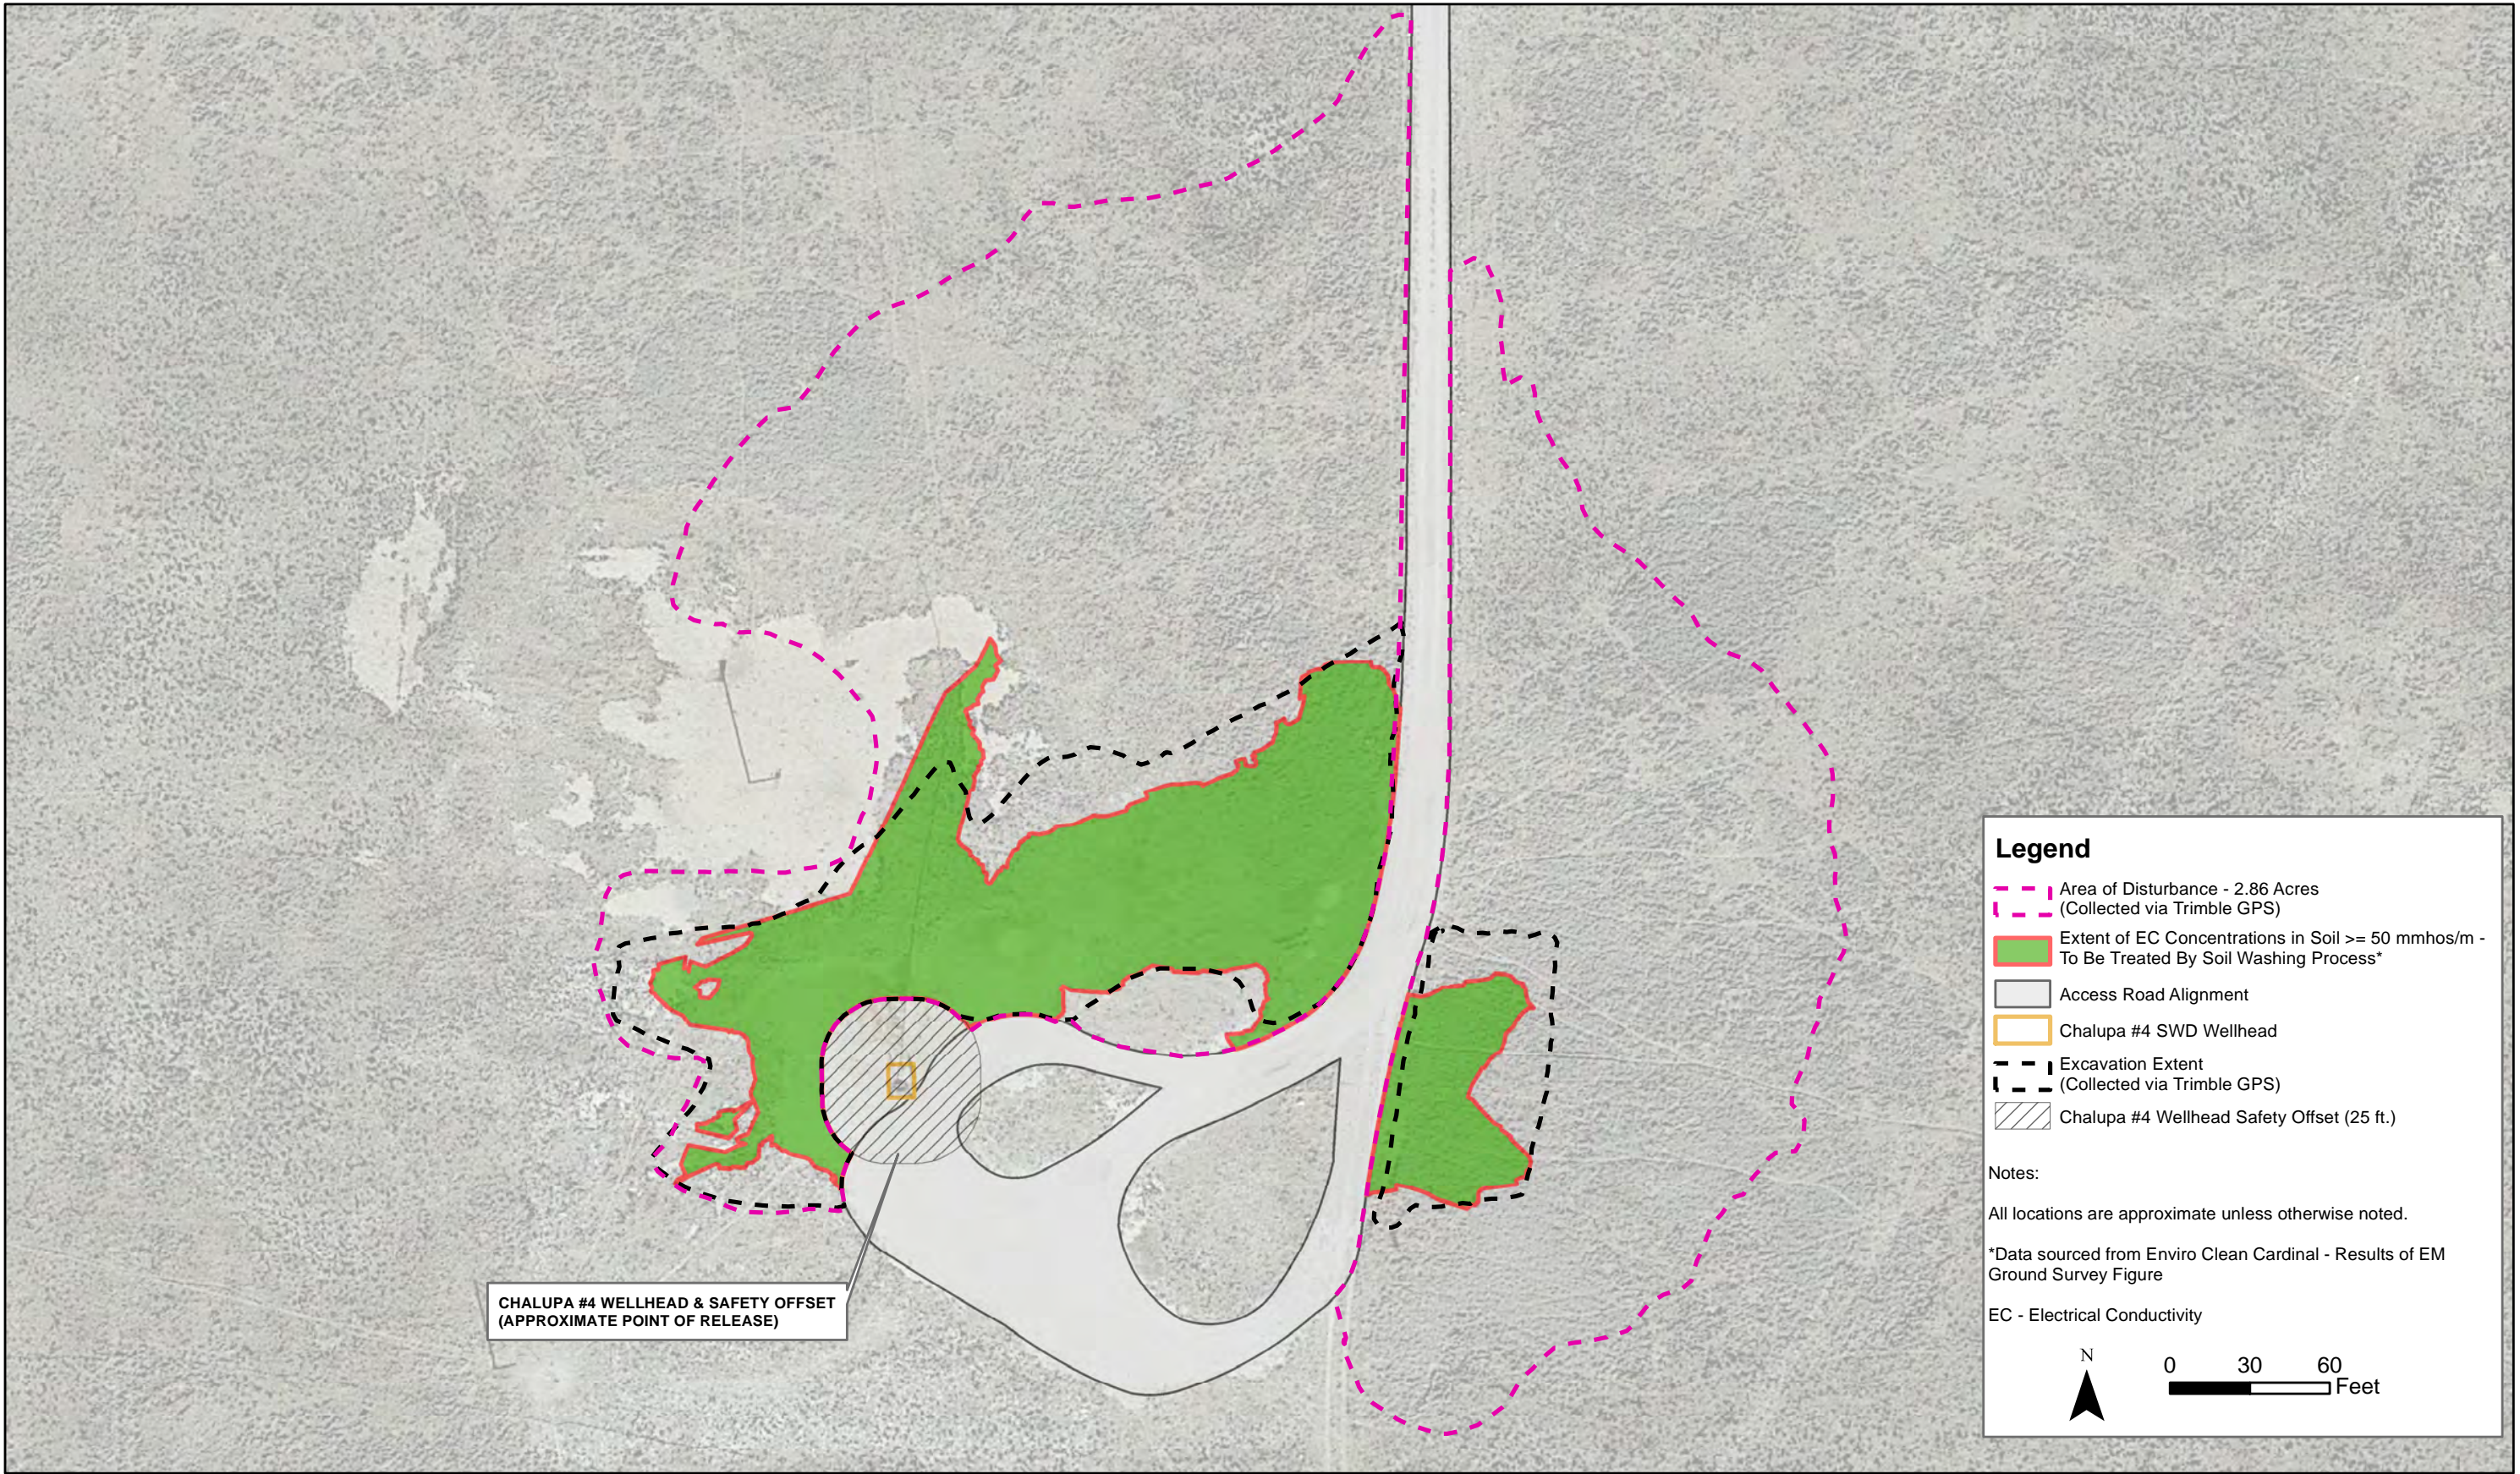
Figure  
2

On February 23, 2017 FEM discovered a release of produced water at the Site from a clamp securing a hose to the Chalupa #4 SWD wellhead that failed, releasing saltwater on the ground surface. The release occurred in the SRA as displayed on Figure 2, which is approximately 2,500-feet south of the tank battery location. Approximately 125 bbls of saltwater were released to the ground surface and approximately 25 bbls were recovered. On March 6, 2017, FEM submitted a Release Notification Corrective Action Form C-141 to the NMOCD for the release and the NMOCD established a maximum permissible chloride level in soil of 600 milligrams per kilogram (mg/kg). On behalf of FEM, Enviro Clean Cardinal, LLC (ECC) performed initial Site investigation activities which included a walkover survey using an EM-38 electrical conductivity (EC) meter and soil boring activities to delineate the horizontal and vertical extents of chloride impacts. As presented in the *Release Characterization Report* that was submitted to the NMOCD on February 16, 2018, the lateral extents of chloride impacts in the SRA covered approximately 0.64 acres and extended vertically to between 34 and 59 feet below ground surface (bgs).

Southern Release Area  
Soil Remediation  
Layout Map

Between May 8 and 19, 2019, approximately 4,091 cubic yards (yd<sup>3</sup>) of chloride impacted soil was transported under waste manifest procedures to an approved off-Site disposal facility (Gandy Marley Inc.) located near Caprock, NM. On May 20, 2019, prior to backfilling activities, a 20-millimeter thick linear low-density polyethylene (LLDPE) sealed liner manufactured by Raven Industries, Inc. was installed at the base of the excavation area. On May 22-23, 2019, approximately 3,422 yd<sup>3</sup> of clean sand was used to backfill the bottom of the excavation up to 18 inches bgs and approximately 1,315 yd<sup>3</sup> of a clean organic topsoil was backfilled and compacted within the disturbed area to match the previous grade.

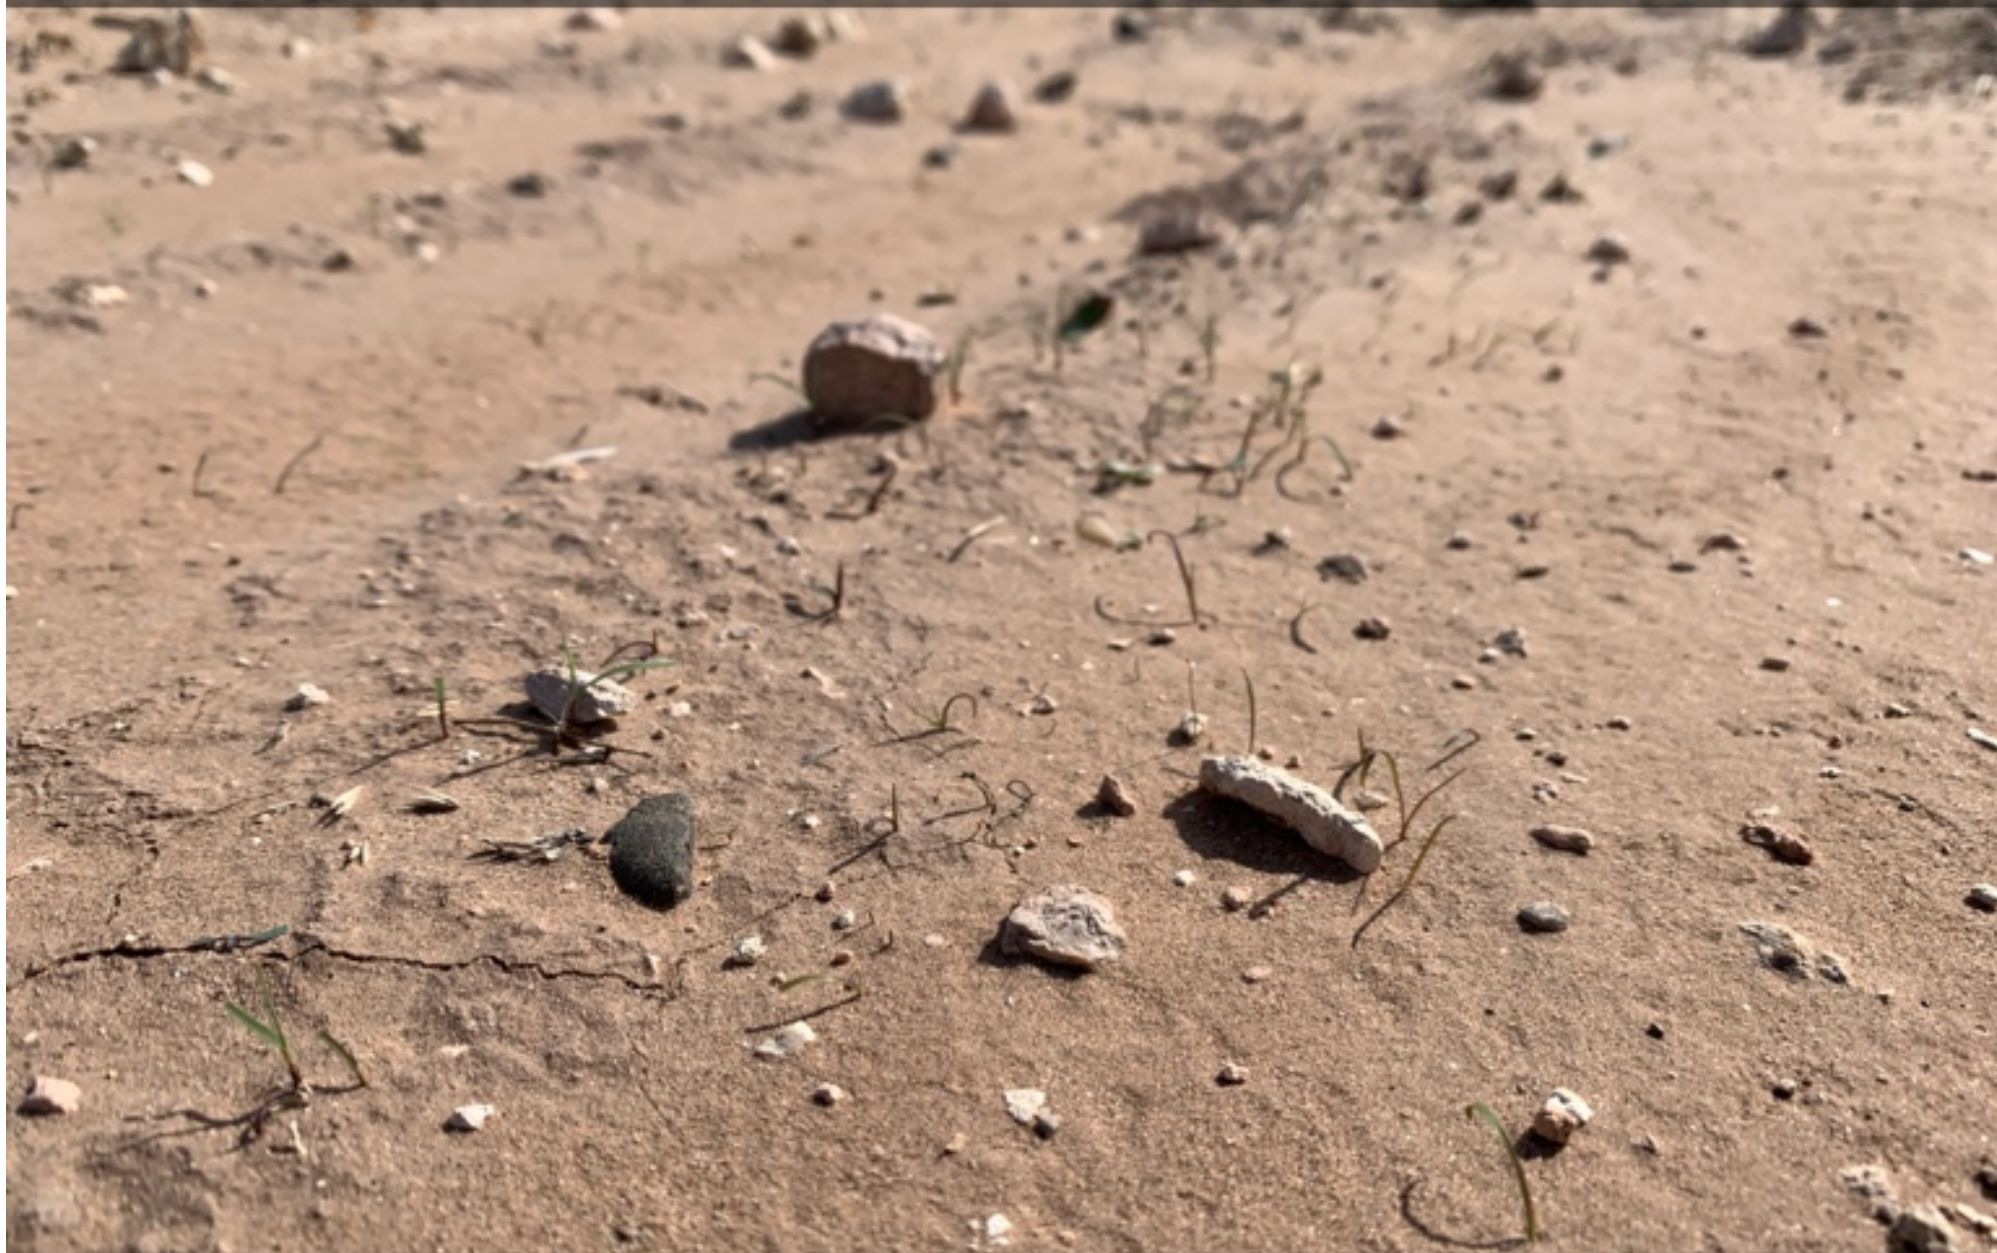
FEM Chalupa

On June 6, 2019, the NMSLO approved an amended seed mixture to be used at the Site and on September 11, 2019, prior to heavy precipitation events that were forecasted for the area, re-seeding activities were performed at the Site using a tractor with a drop seed tiller. During a Site visit on October 8, 2019 to observe vegetation re-growth at the Site, Tasman personnel observed sprouted seedlings throughout the disturbed area indicating that the re-seeding effort has successfully propagated vegetation at the Site. Photos of the observed seedlings are provided in Appendix A.

Seedlings

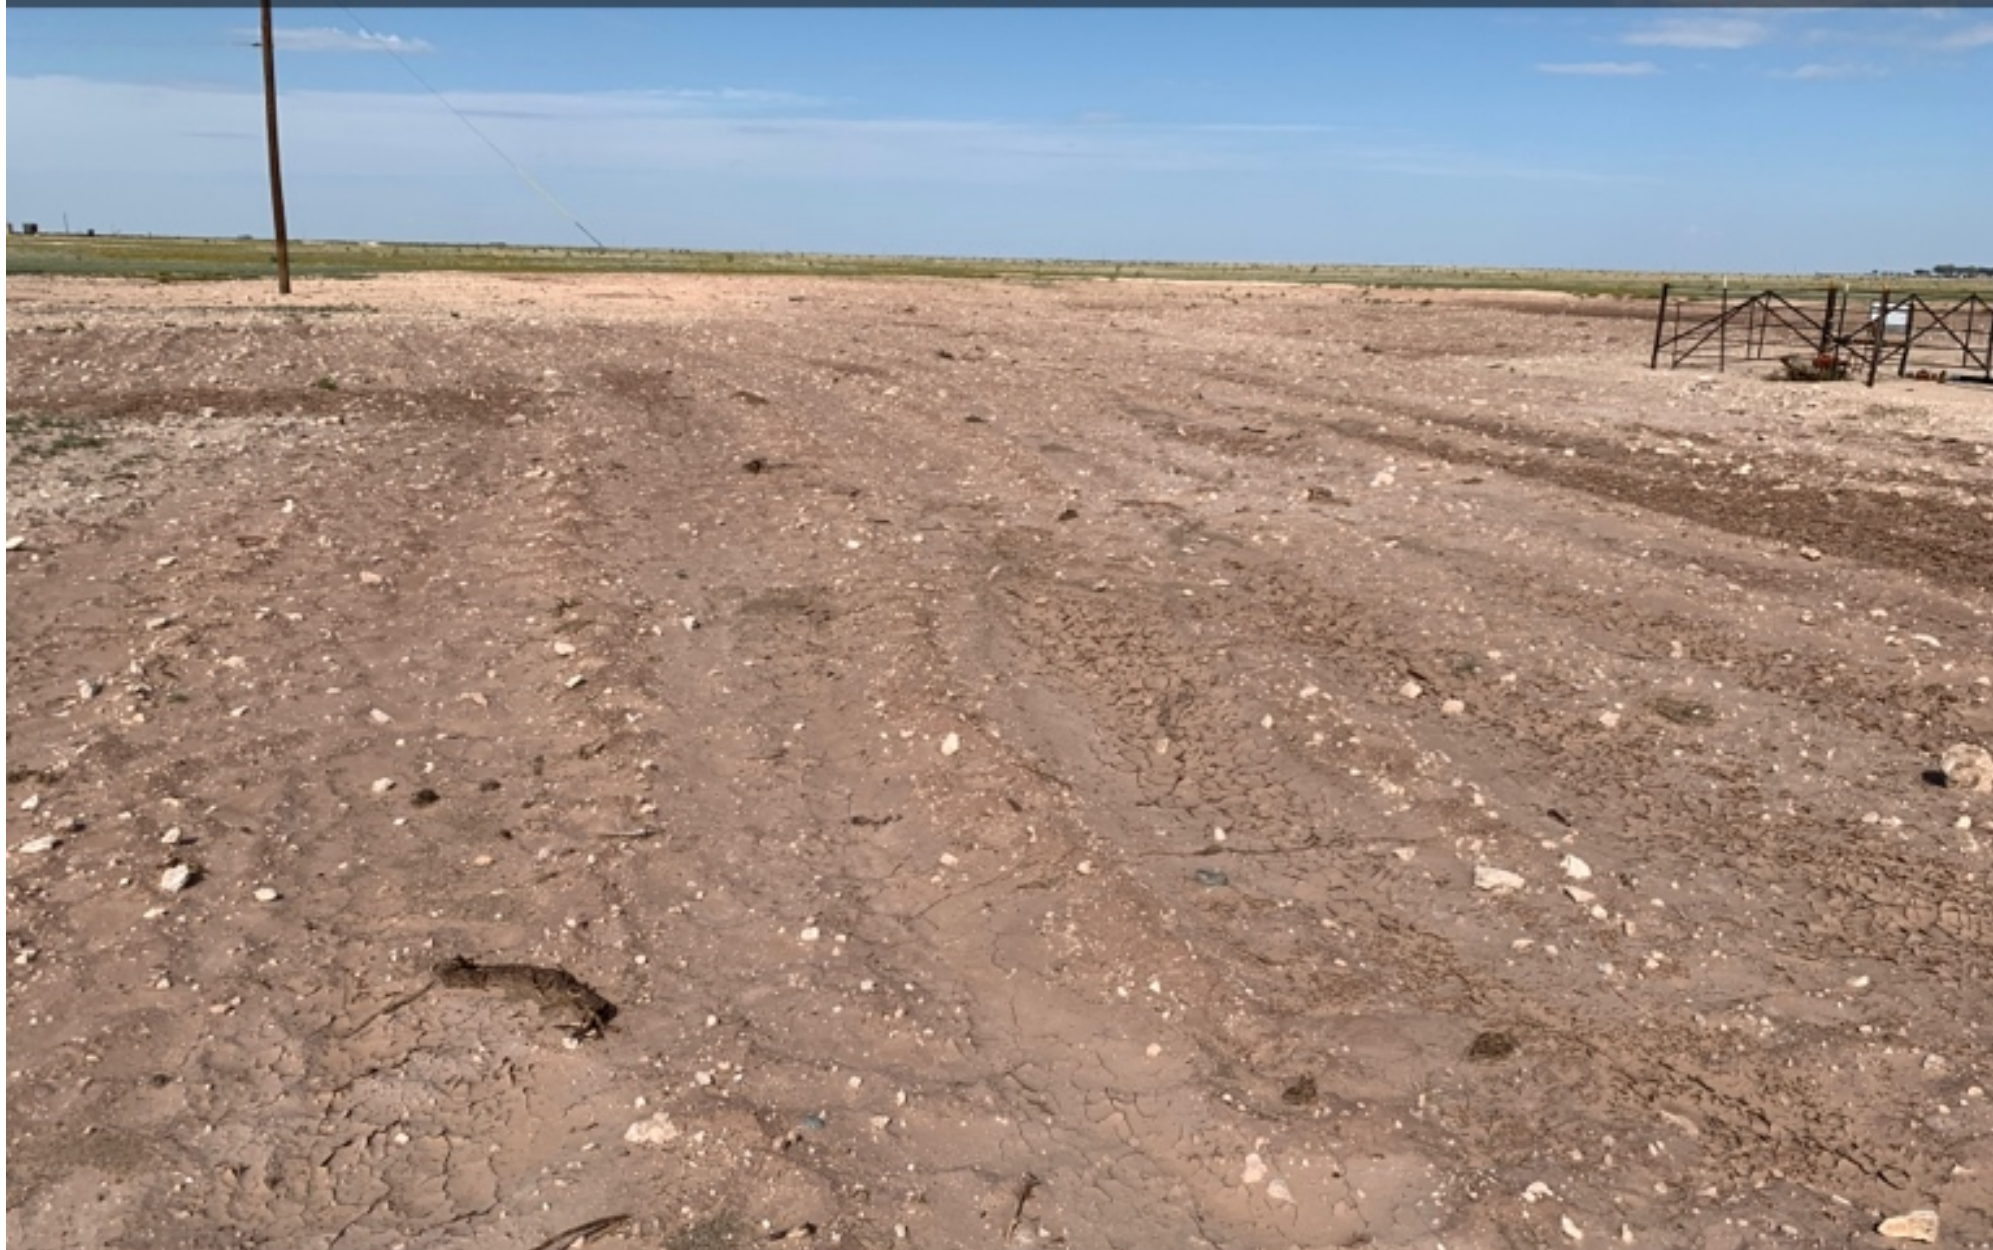
FEM Chalupa

Southern Area

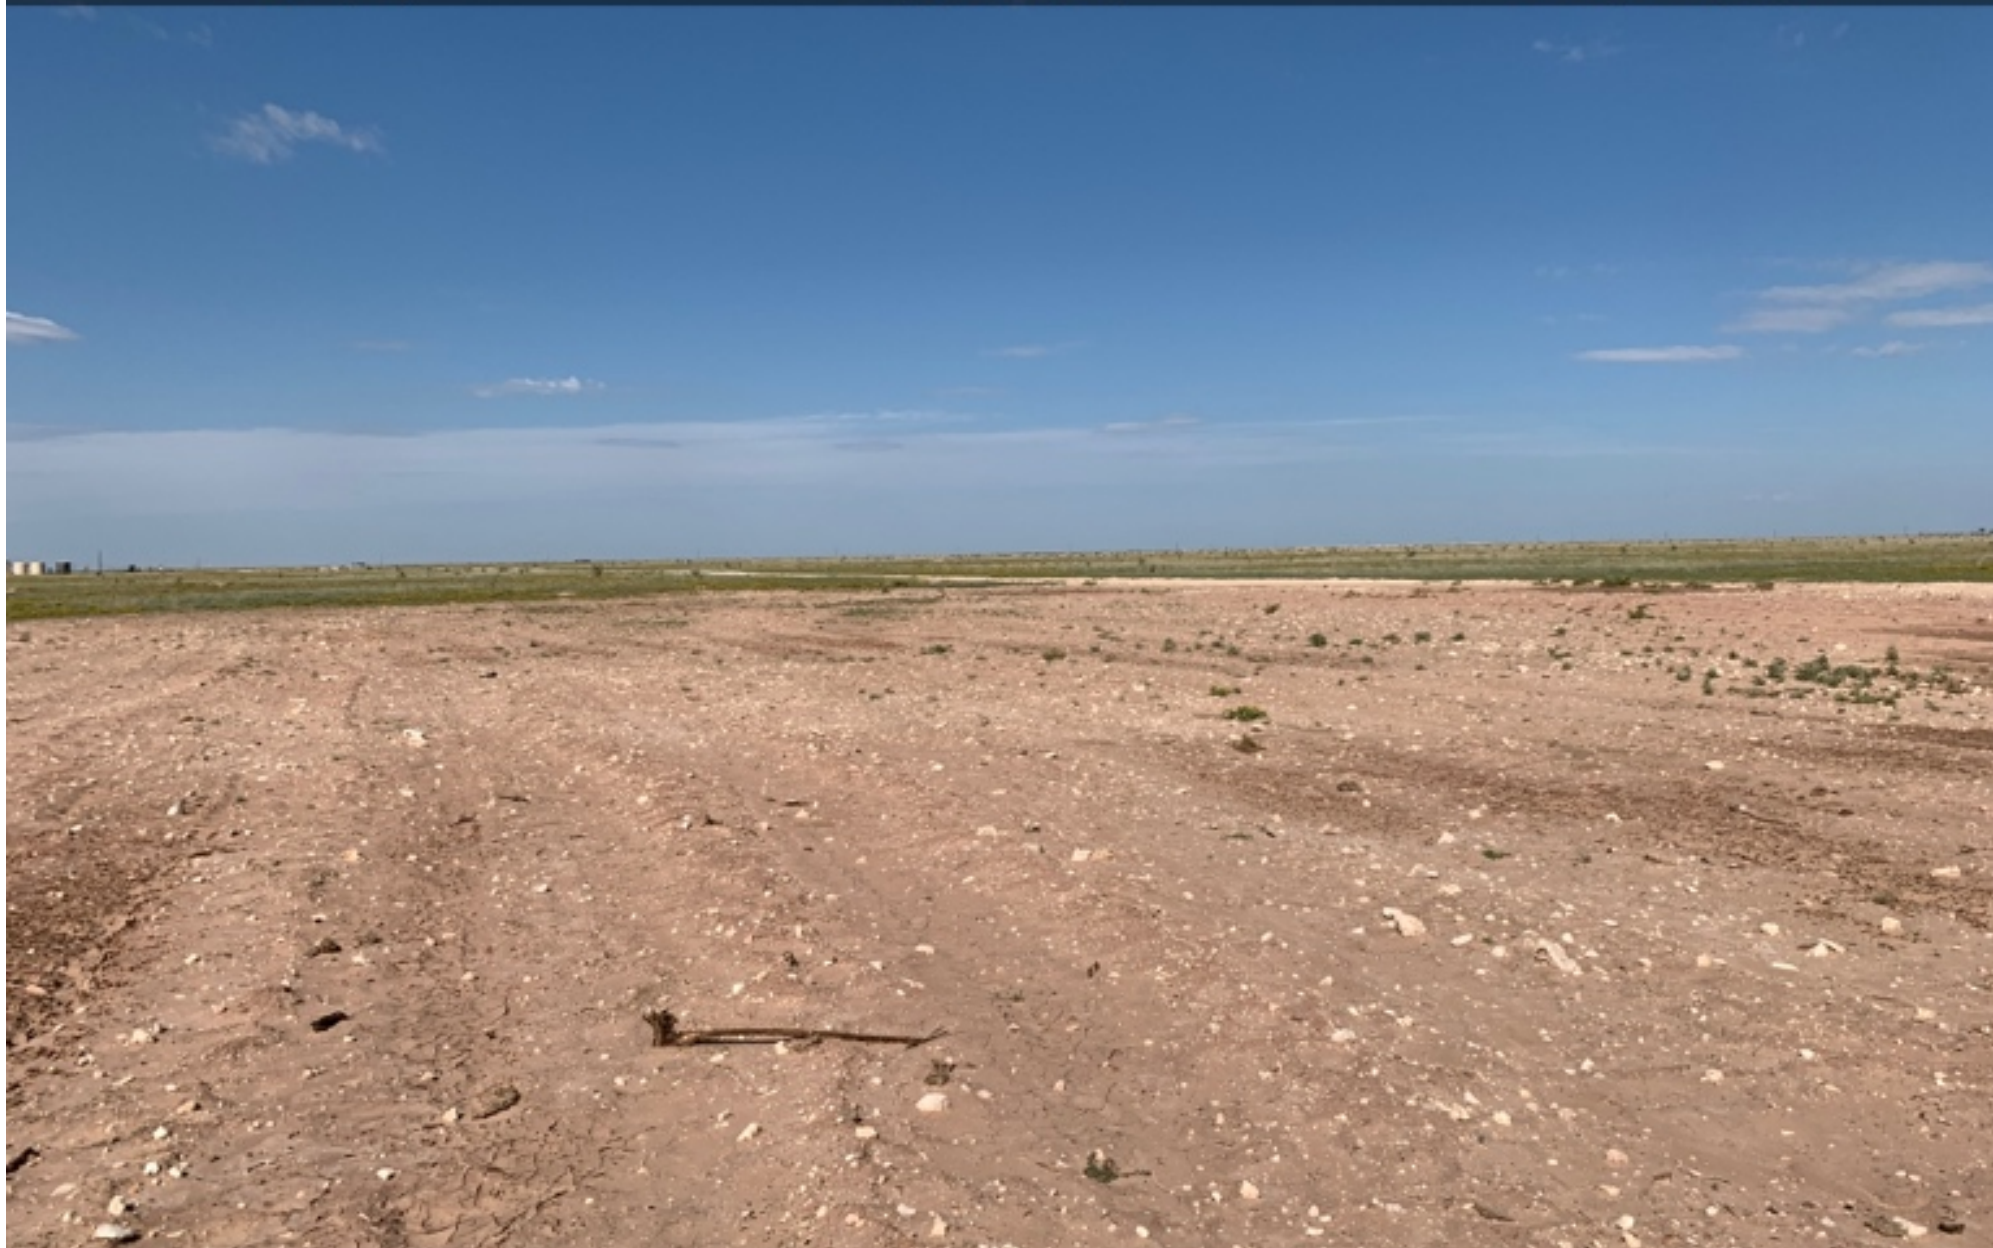
FEM Chalupa

Southern Area

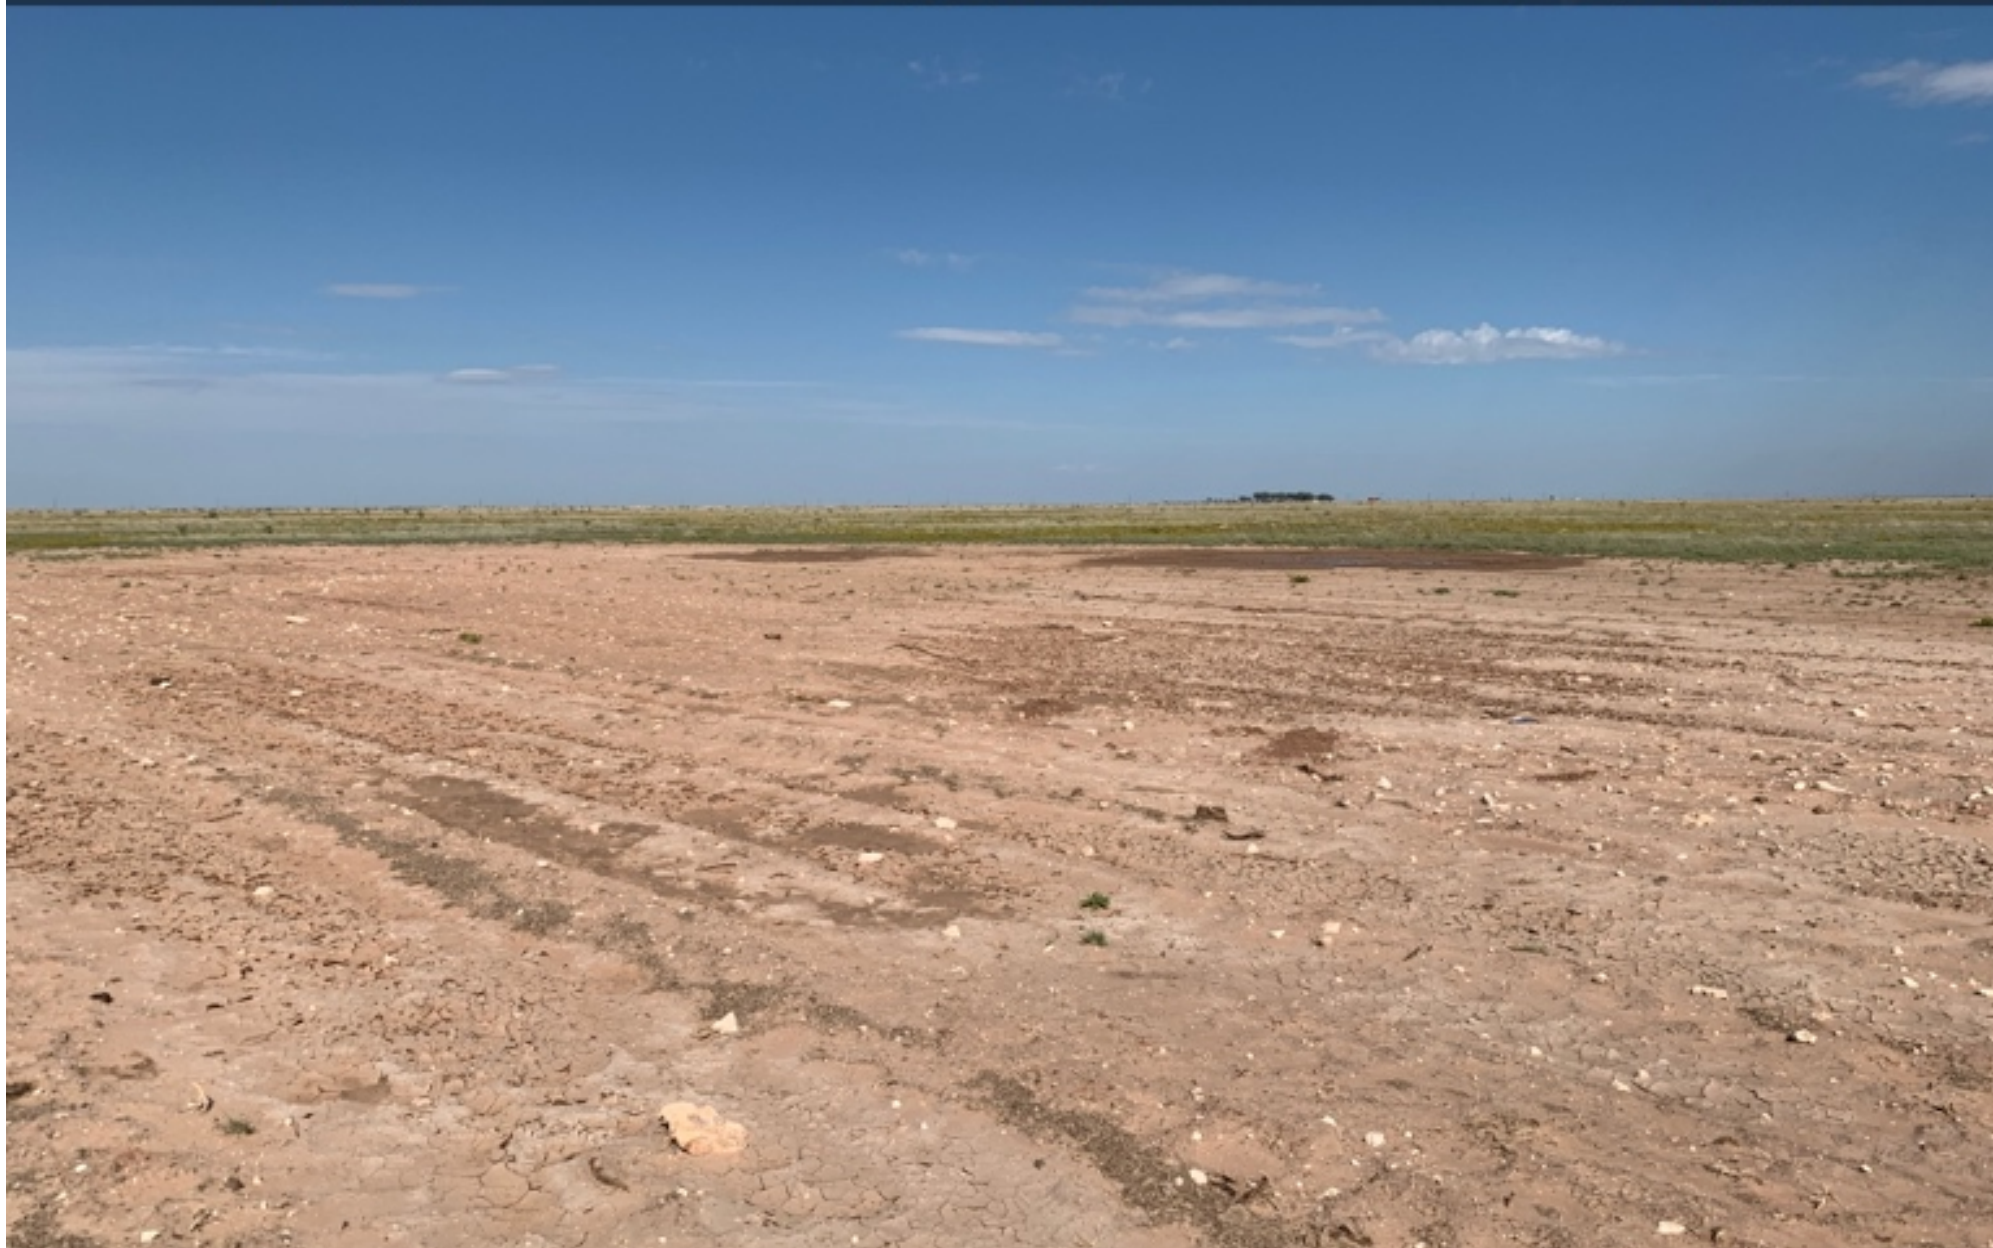
FEM Chalupa

Southern Area
