Remediation and Reclamation Summary Report

Chalupa #4 SWD – North Remediation Area 1RP-4633 Lea County, NM

October 29, 2019

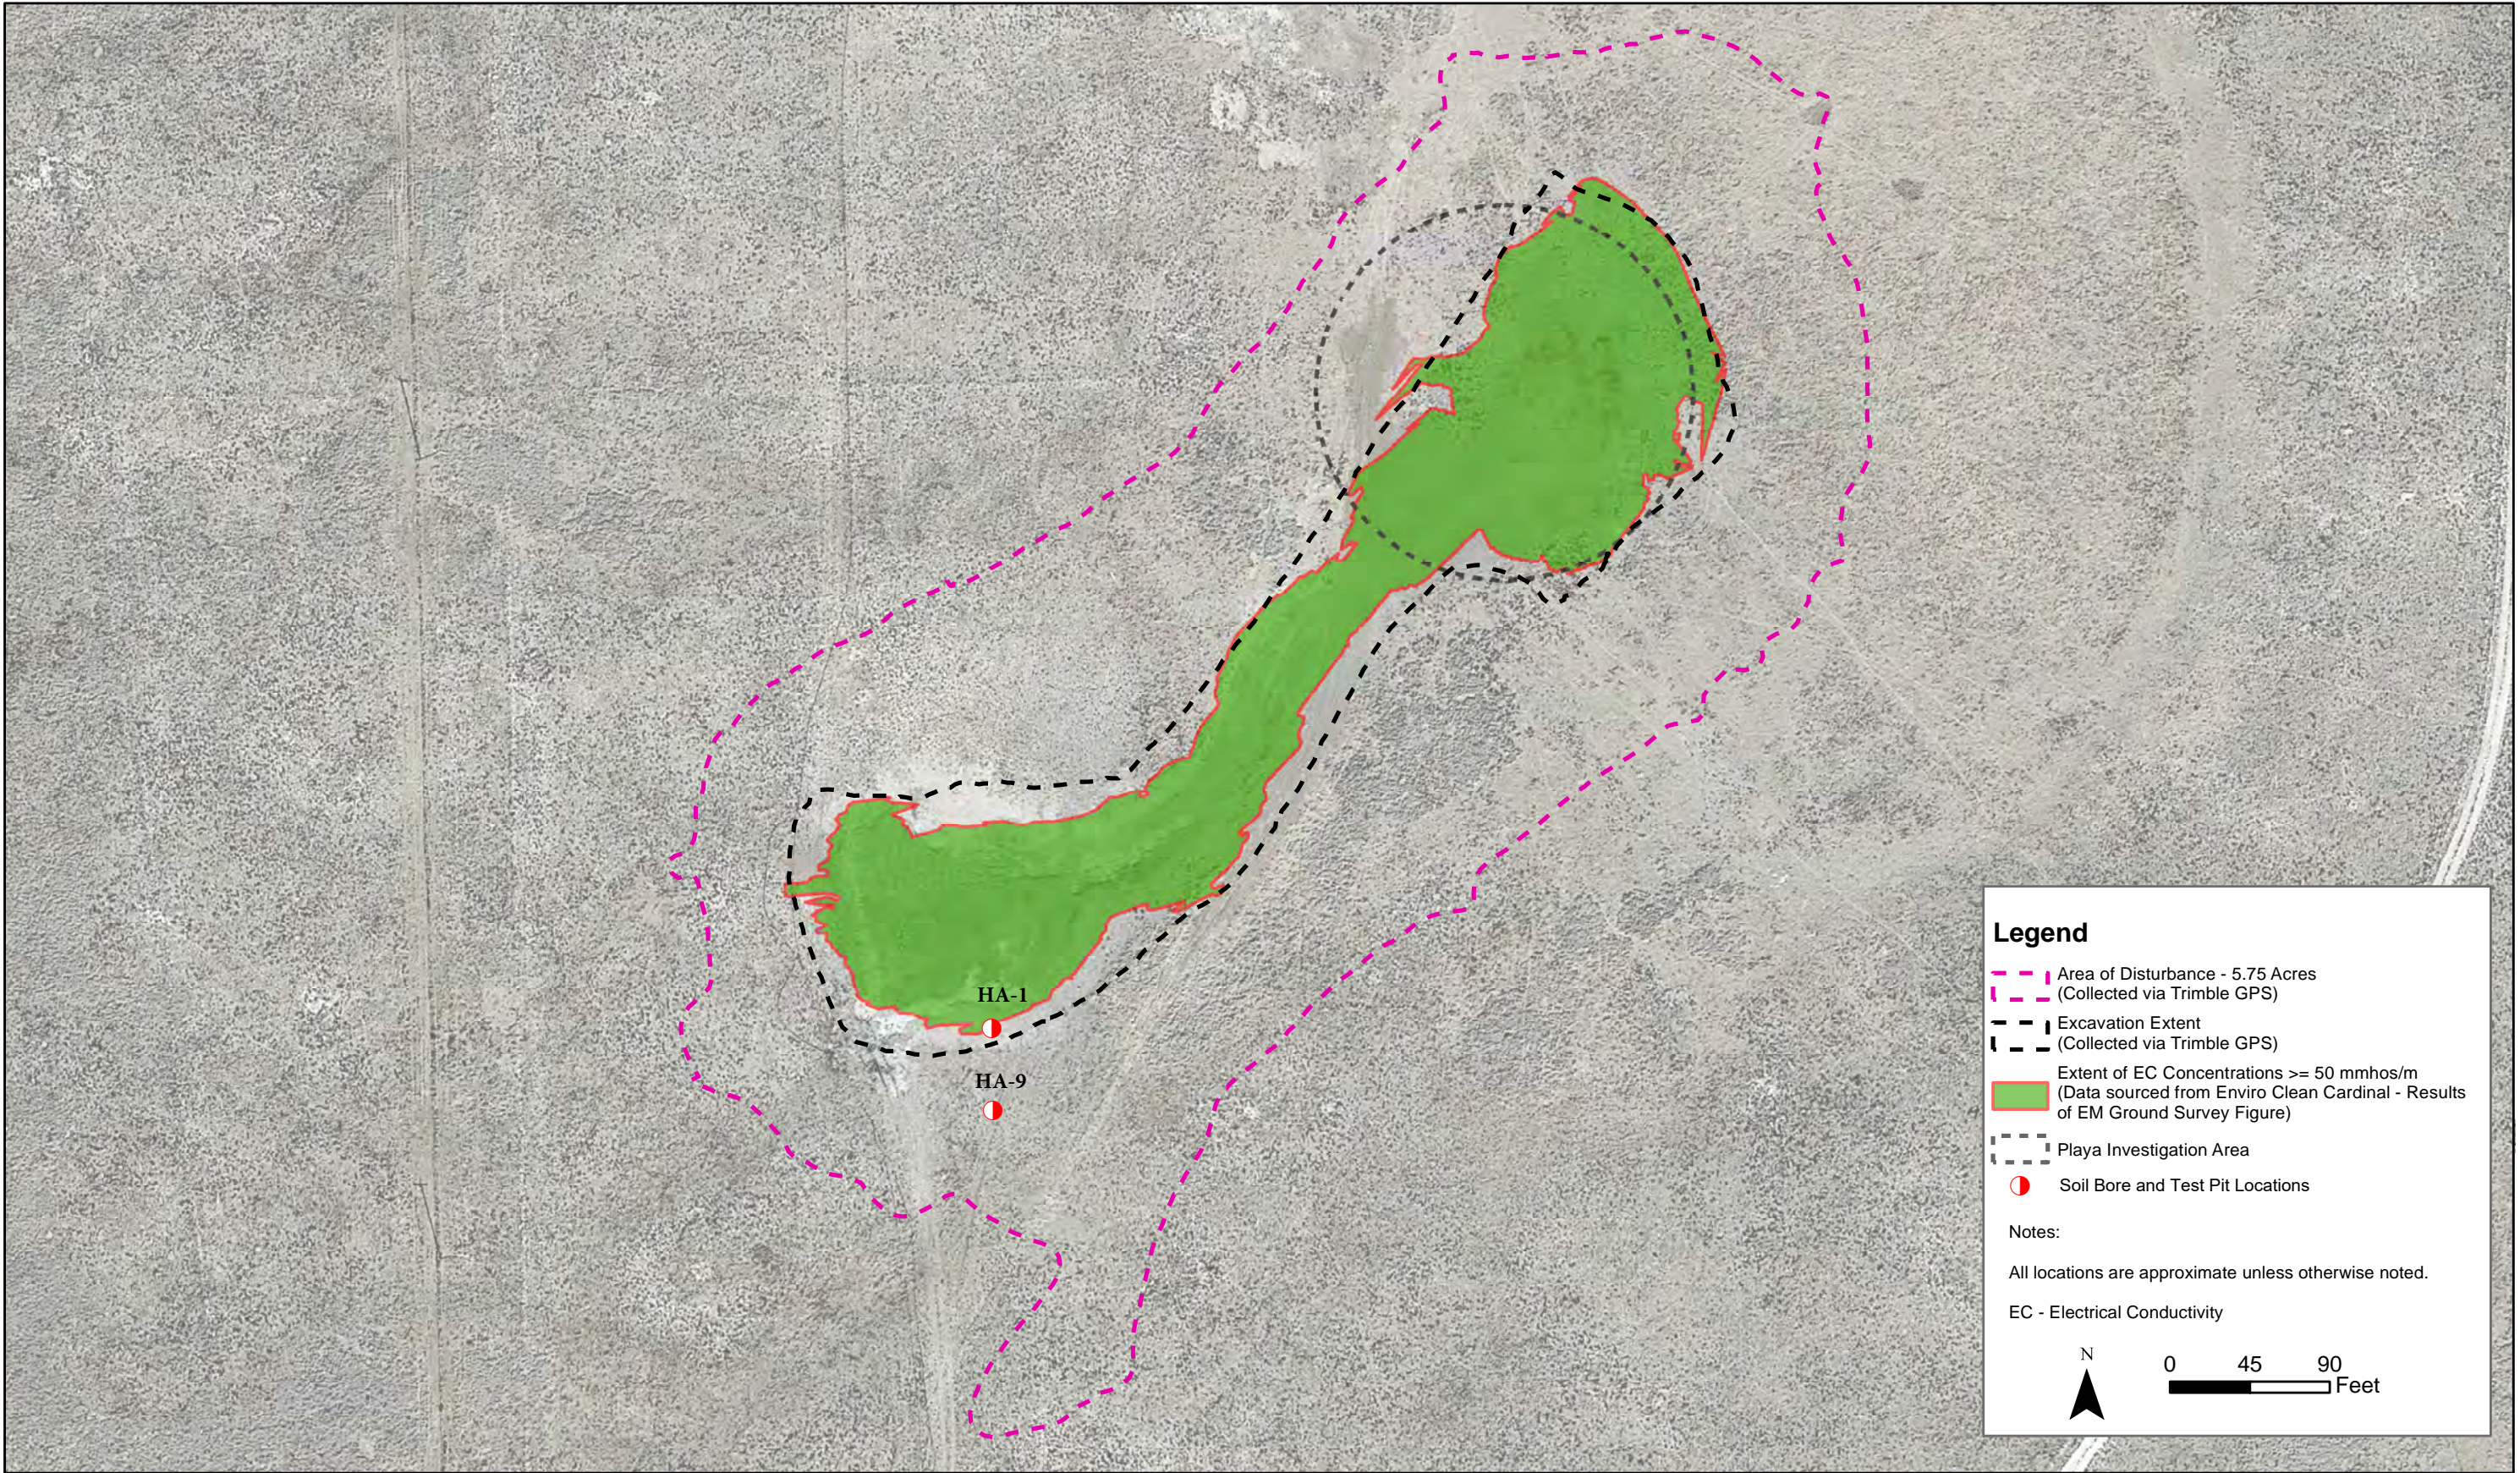
On March 2, 2017 FEM discovered a release of produced water at the Site from a leak that developed in the pipeline connecting FEM's tank battery to the Chalupa #4 injection well. The release occurred in the NRA as displayed on Figure 2, which is approximately 600-feet south of the tank battery location. Approximately 25 bbls of saltwater were released to the ground surface and approximately 15 bbls were recovered. On March 6, 2017, FEM submitted a Release Notification Corrective Action Form C-141 to the NMOCD for the release and the NMOCD established a maximum permissible chloride level in soil of 600 milligrams per kilogram (mg/kg). On behalf of FEM, Enviro Clean Cardinal, LLC (ECC) performed initial Site investigation activities which included a walkover survey using an EM-38 electrical conductivity (EC) meter and soil boring activities to delineate the horizontal and vertical extents of chloride impacts. As presented in the *Release Characterization Report* that was submitted to the NMOCD on February 16, 2018, the lateral extents of chloride impacts in the NRA covered approximately 1.76 acres and a depth of 9 to 14 feet below ground surface (bgs).

During the initial assessment and investigation, a potential playa was identified within the NRA at the location illustrated on Figure 2. Tasman performed a playa survey based on the New Mexico Rapid Assessment Method – Playa Wetlands Worksheet (Playa Worksheet) which involved Level 1 GIS database assessments and Level 2 field inspections.

To address NMOCD comments provided via e-mail on March 15, 2018, additional investigation activities including a test pit (HA-9) was advanced to five (5) feet bgs using a backhoe at the location illustrated on Figure 2 outside of the play to delineate chloride impacts south of soil boring HA-1. During test pit advancement, the soil lithology was observed as loam and broken caliche from the surface to 1-foot bgs, a hard layer of caliche rock from 1 to 2.5 feet bgs, and a firm layer of silty sand with inclusions of less dense caliche from 2.5 feet bgs to 5 feet bgs. Soil samples were collected at 1-foot intervals from the test pit and submitted to Cardinal Laboratories in Hobbs, NM for laboratory analysis of Chloride using National Environmental Methods Index (NEMI) Standard Method (SM) 4500-Cl B. The laboratory analytical results for chloride from test pit HA-9 ranged from 80.0 mg/kg at one (1) and three (3) feet bgs to 368 mg/kg at

On May 8, 2019, chloride impacted soil excavation activities were initiated within the NRA between the surface and approximately 4 feet bgs. However, during initial excavation activities, a very hard caliche layer was encountered within the in the first 18 inches of soil. Subsequent to further excavation and subsurface investigation, due to the volume and consistency of the caliche material, it was determined that the native material was not conducive to the preferred remedial alternative presented in the Remediation Work Plan which included on-Site treatment through excavation, impermeable liner installation, backfilling, and soil washing. Concerns that the liner and soil washing system would be severely damaged during backfilling and compaction of the native caliche material rendered the soil washing remediation approach infeasible. Therefore, soil remediation activities were transitioned to traditional dig and haul methods for subsequent disposal of the top 4 feet of impacted material and subsequent impermeable liner installation and backfilling using clean fill material that would not puncture the liner.

Between May 8 and 19, 2019, approximately 9,013 cubic yards (yd³) of chloride impacted soil was transported under waste manifest procedures to an approved off-Site disposal facility (Gandy Marley Inc.) located near Caprock, NM. On May 22, 2019, prior to backfilling activities, a 20-millimeter thick linear low-density polyethylene (LLDPE) sealed liner manufactured by Raven Industries, Inc. was installed at the base of the excavation area. On May 23, 2019, approximately 7,538 yd³ of clean sand was used to backfill the bottom of the excavation up to 18 inches bgs and approximately 2,897 yd³ of a clean organic topsoil was backfilled and compacted within the disturbed area to match the previous grade.

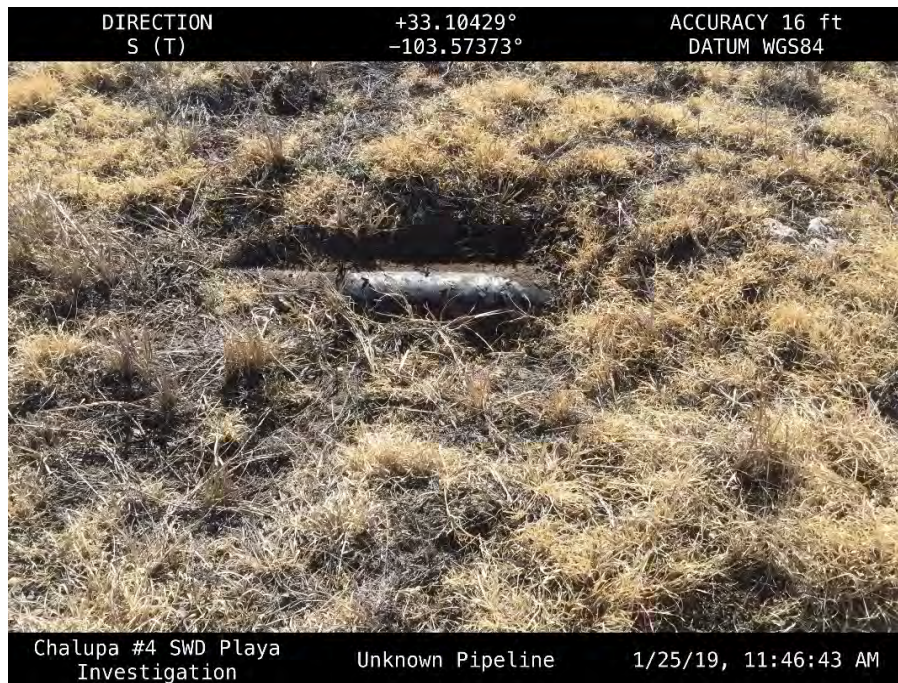
#12. Stressors: Undocumented pipeline through playa.

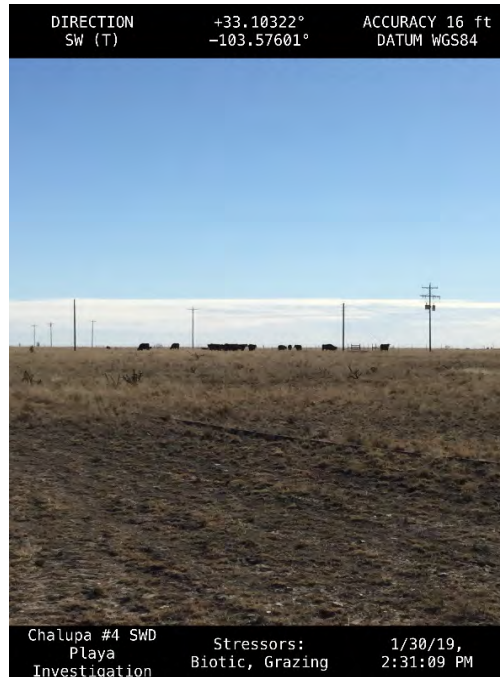
#13. Stressors: Grazing cattle nearby playa.

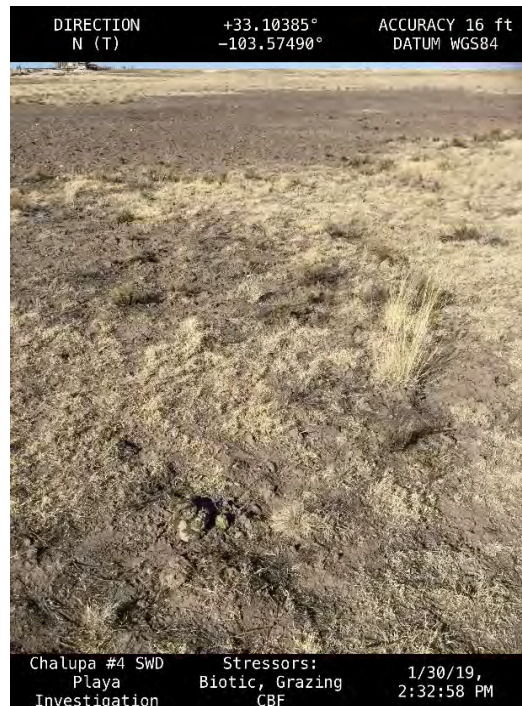
#14. Stressors: Cattle hoof prints and dung in playa.

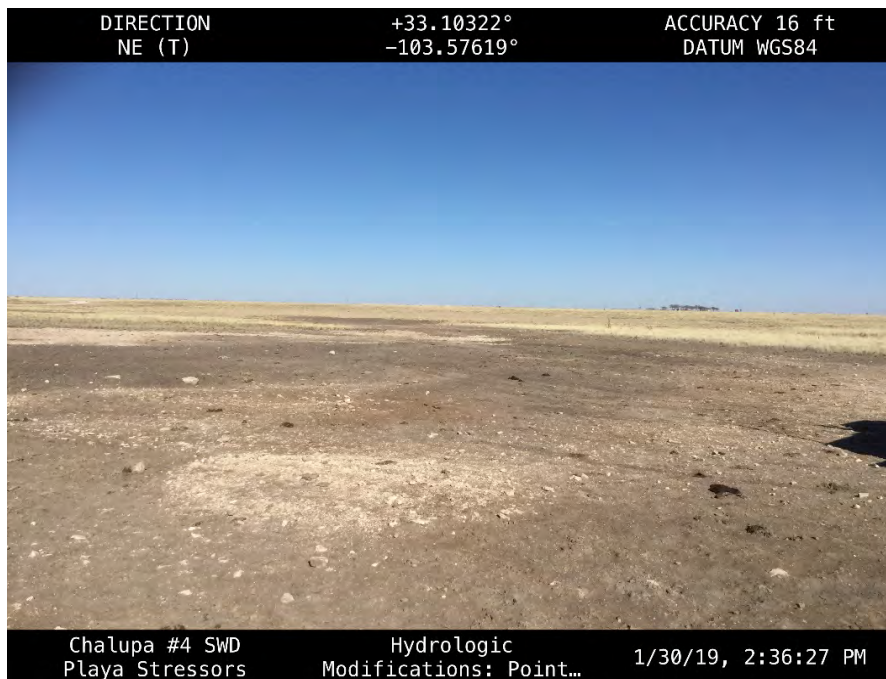
Areas of dead vegetation from SWD line rupture in the west towards the playa to the east. West side of playa has areas of dead vegetation from saltwater infiltration.

Natural water runoff in the north-northwest of the playa has been altered due to containment berms for SWD tank batteries and trenching from buried pipelines. Stream-like erosion occurred in the west of the playa in the natural landscape due to the saltwater line rupture.

#15. Stressors: SWD pipeline release into playa.

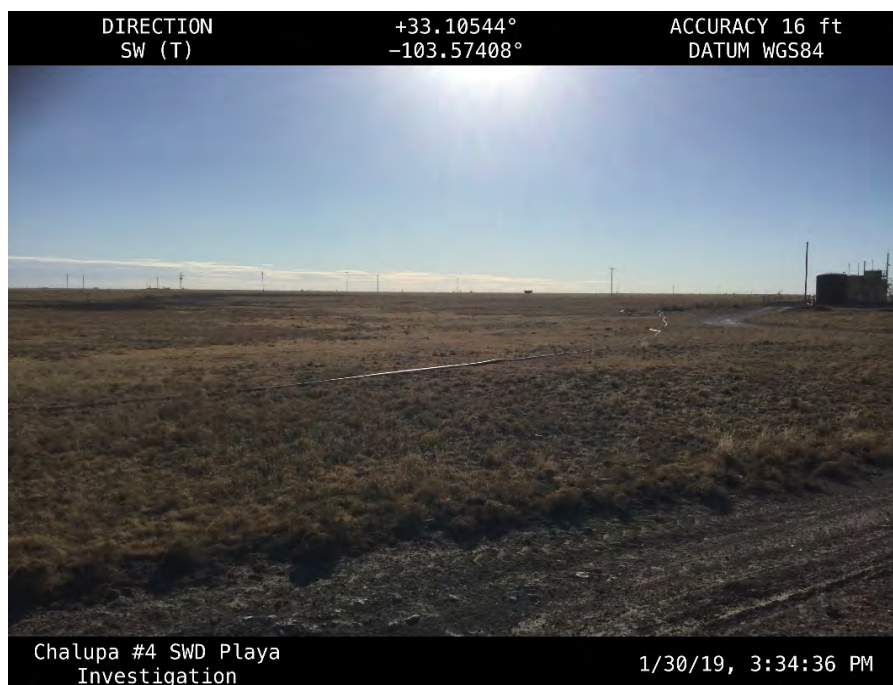
#16. Stressors: Aboveground SWD poly pipeline surrounding playa.

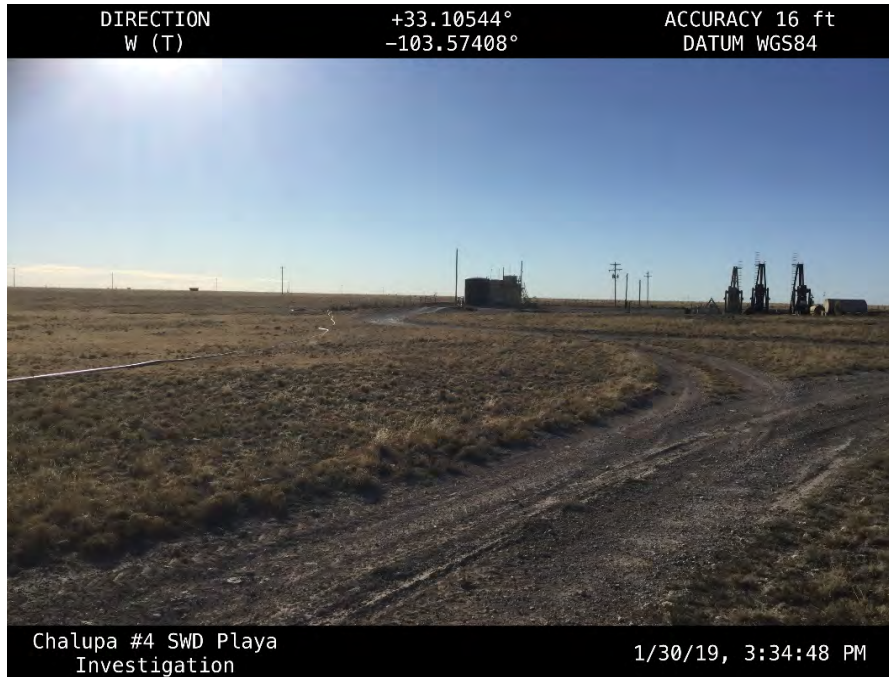
#17. Stressors: SWD Tank battery and containment berm upslope relative to playa.
