Pima Environmental Services, LLC.  
1601 N Turner, Suite 500  
Hobbs, NM, 88240  
575-964-7740

May 25<sup>th</sup>, 2021

**RE: Liner Inspection and Closure Report  
Mizar 11 Federal Com #001H  
API No. 30-015-41964  
GPS: Latitude 32.68198 Longitude -103.84817  
UL "D", Section 11, Township 19S, Range 31E  
NMOCD Reference No. NAB1803054013 (2RP-4592)  
Pima Project No.: 1-63**

On May 21<sup>st</sup>, 2021, after sending the 48-hour notification email, Pima Environmental conducted a liner inspection at this location. The liner inspection form and photographic documentation can be found in Appendix C.

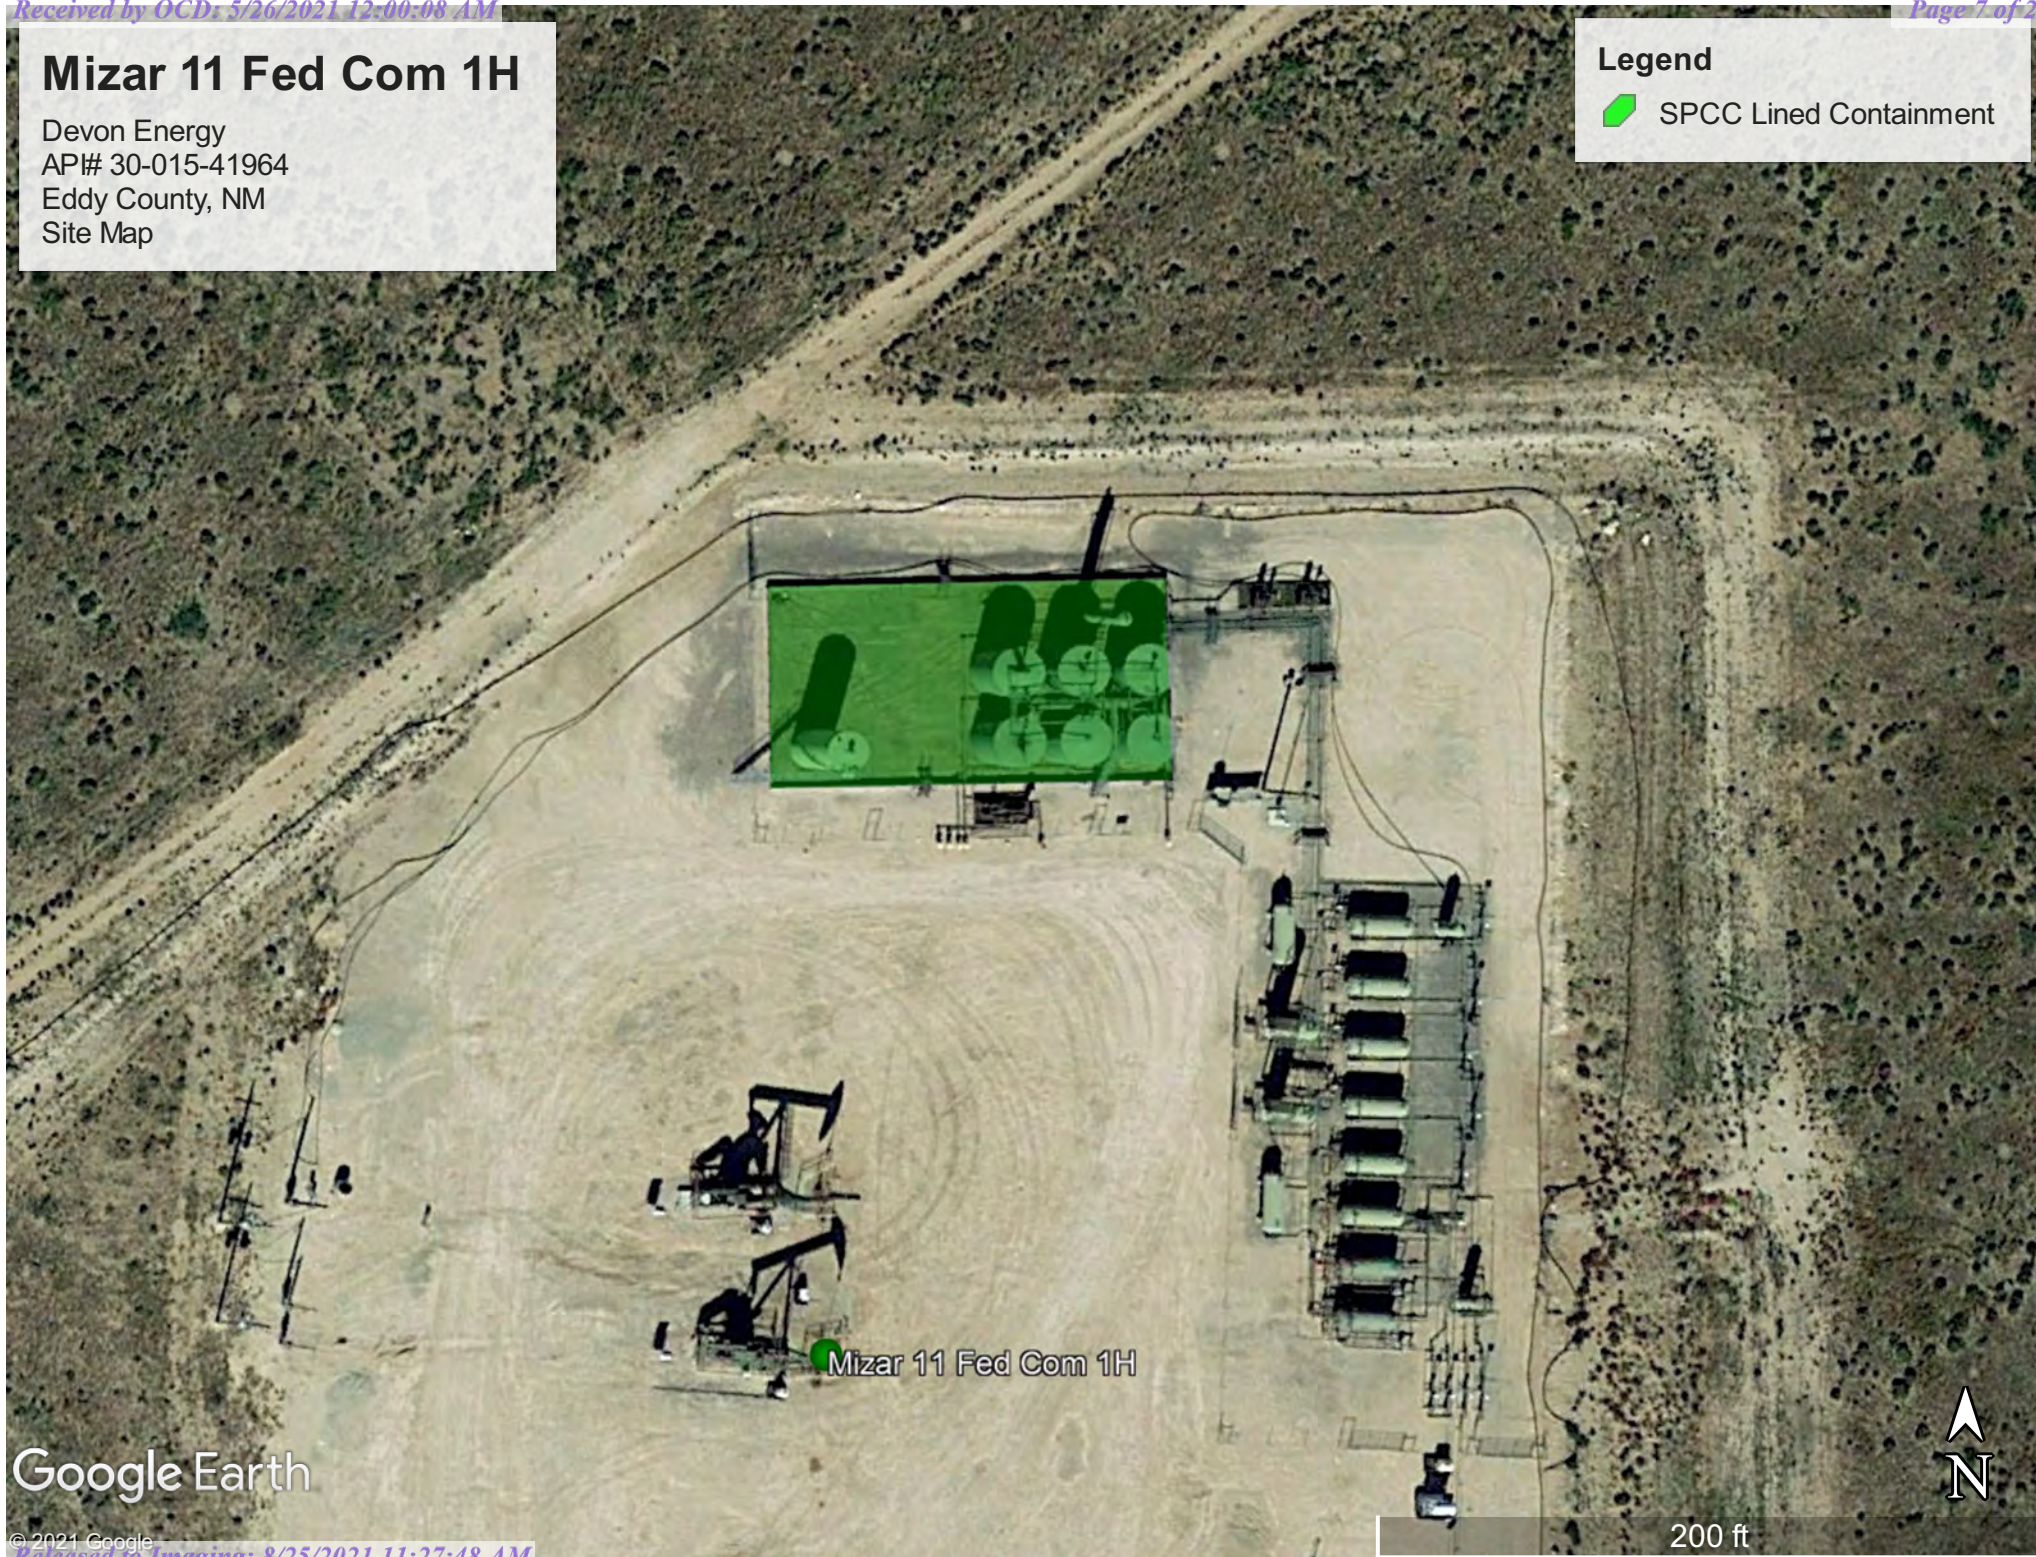
Devon Energy  
API# 30-015-41964  
Eddy County, NM  
Site Map

SPCC Lined Containment

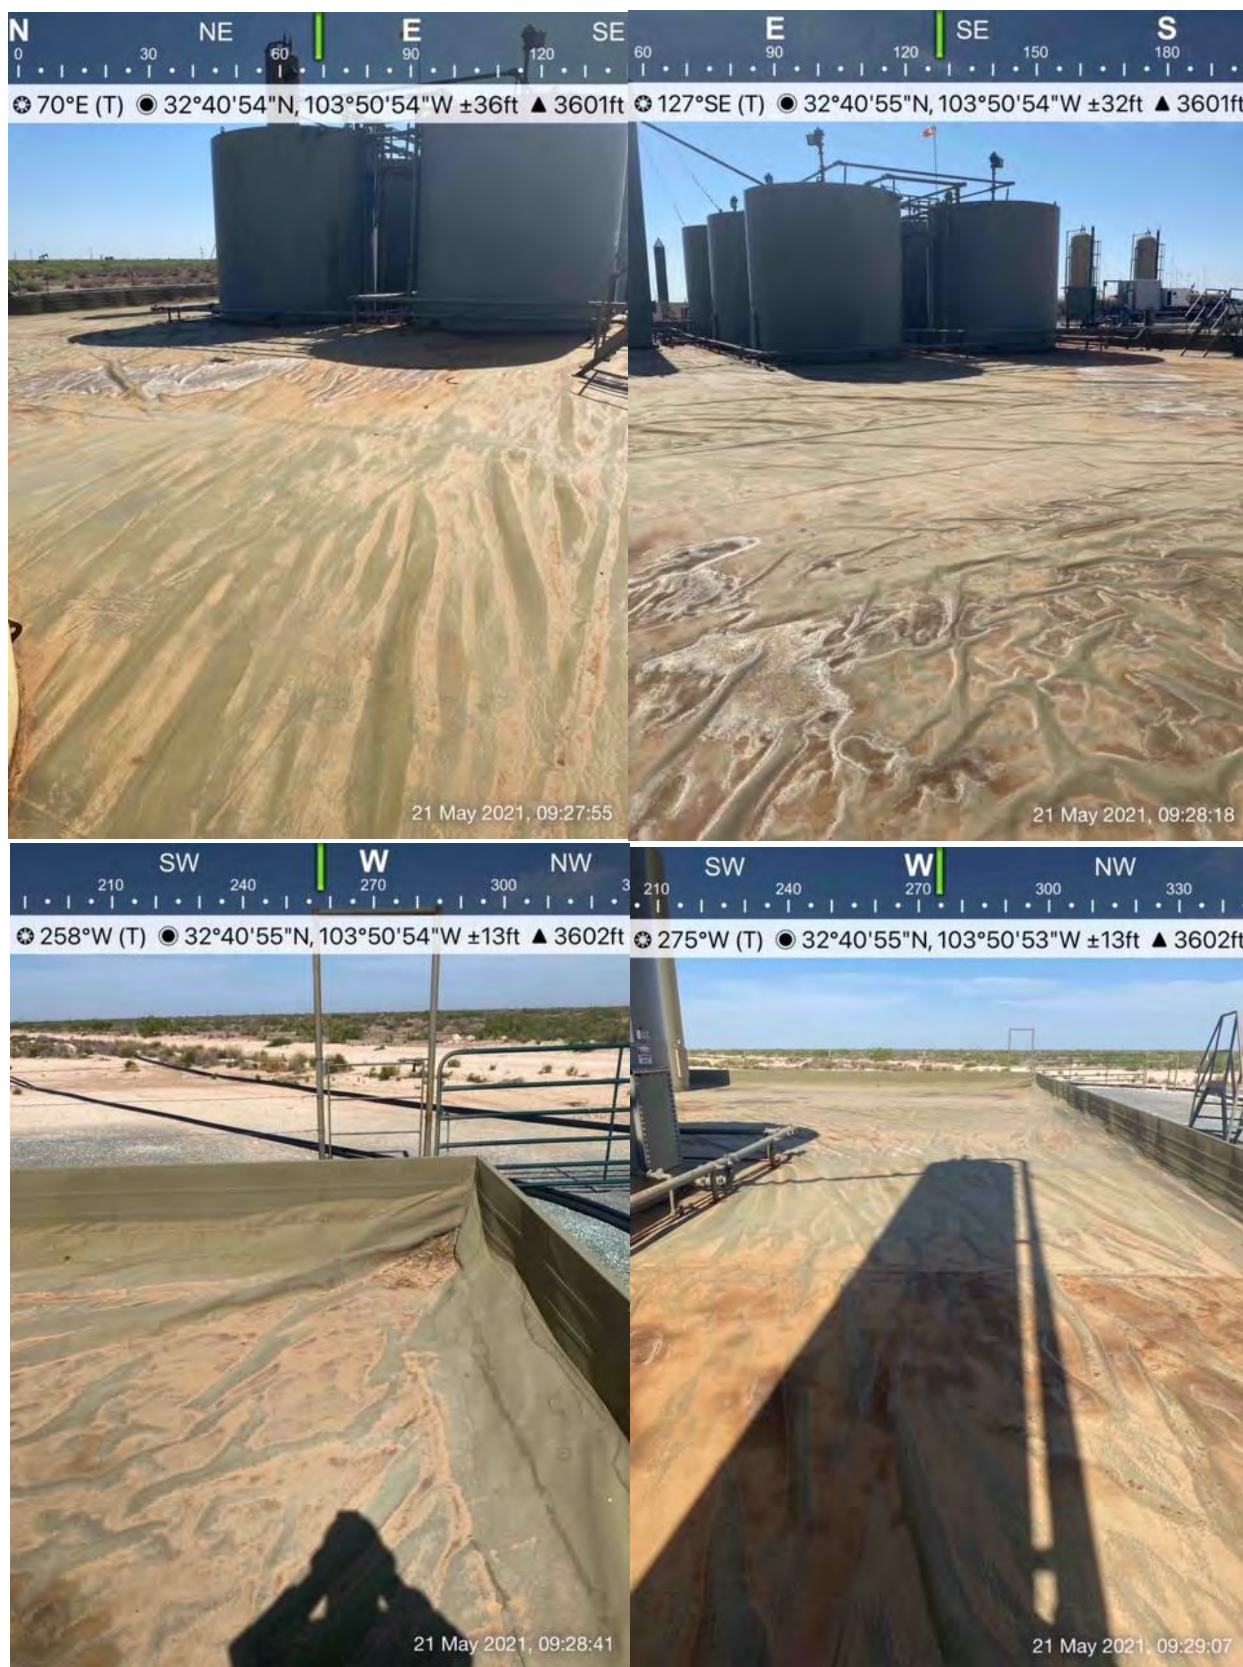
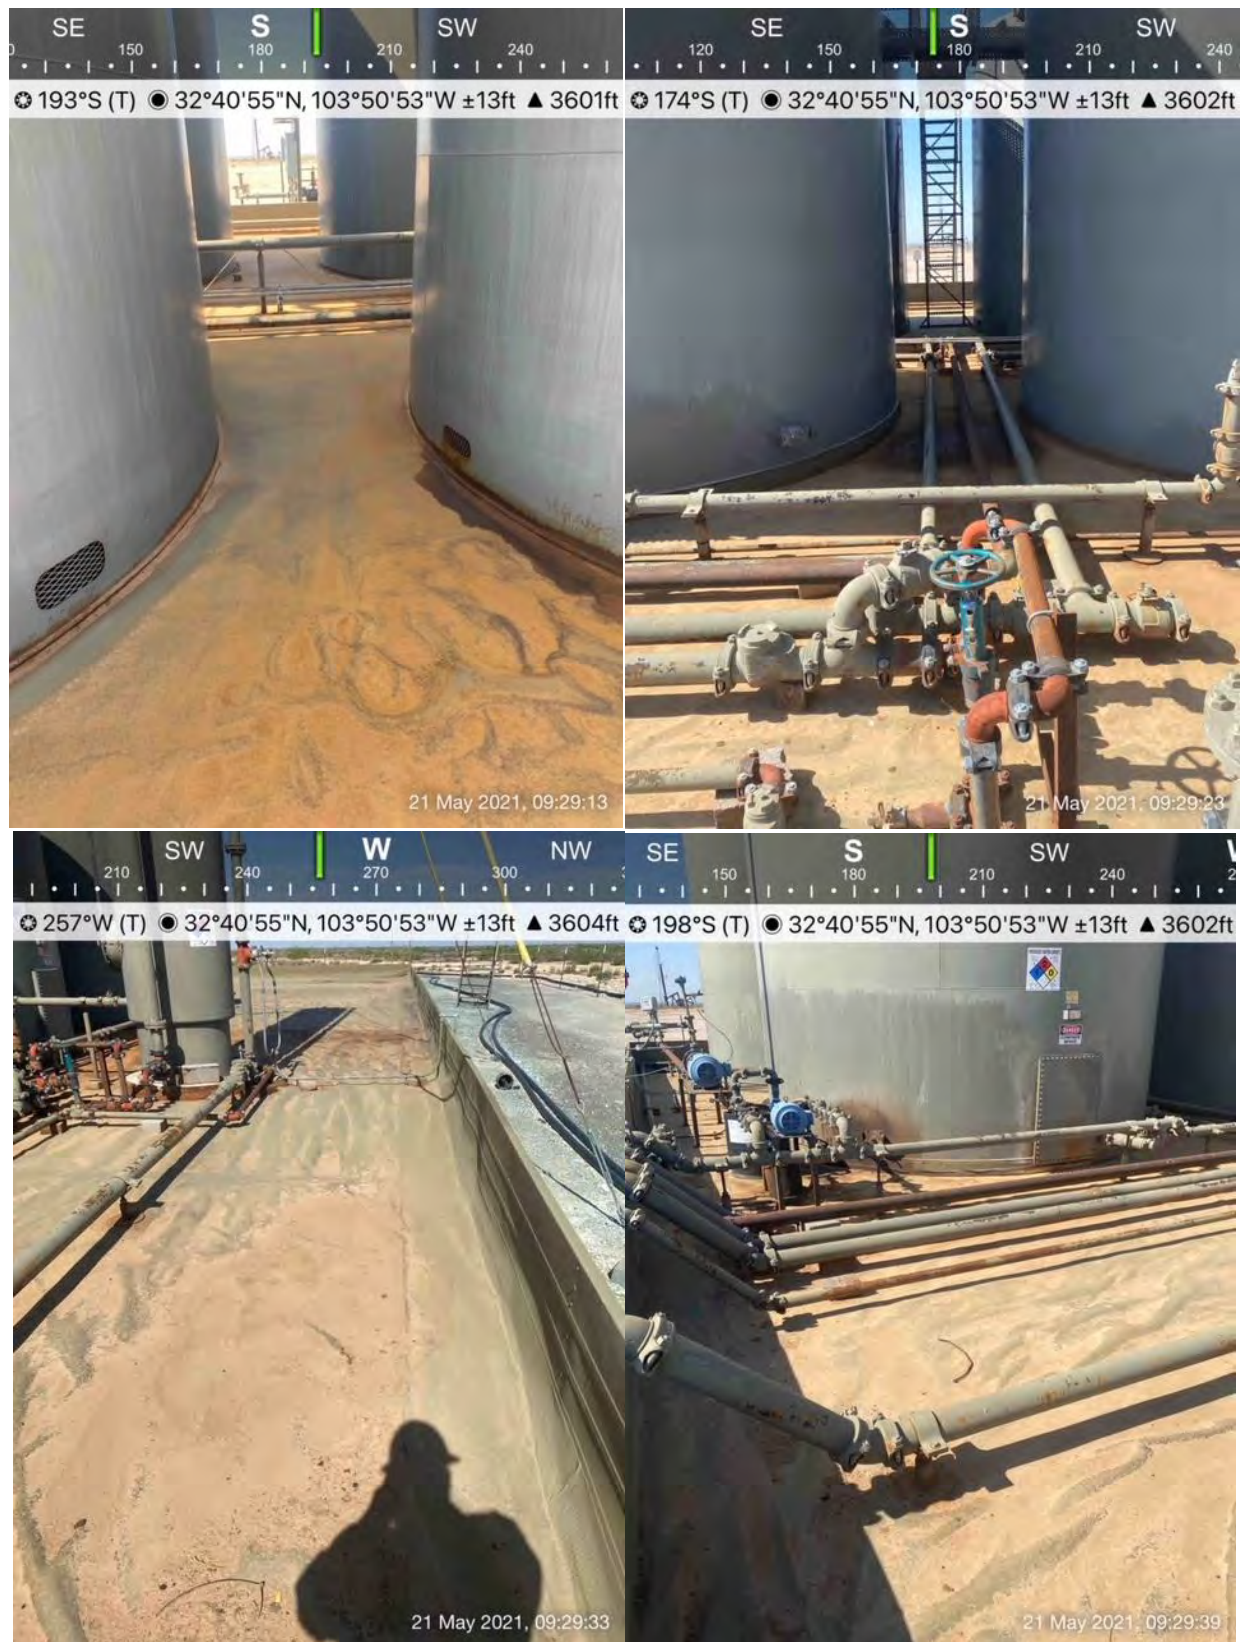
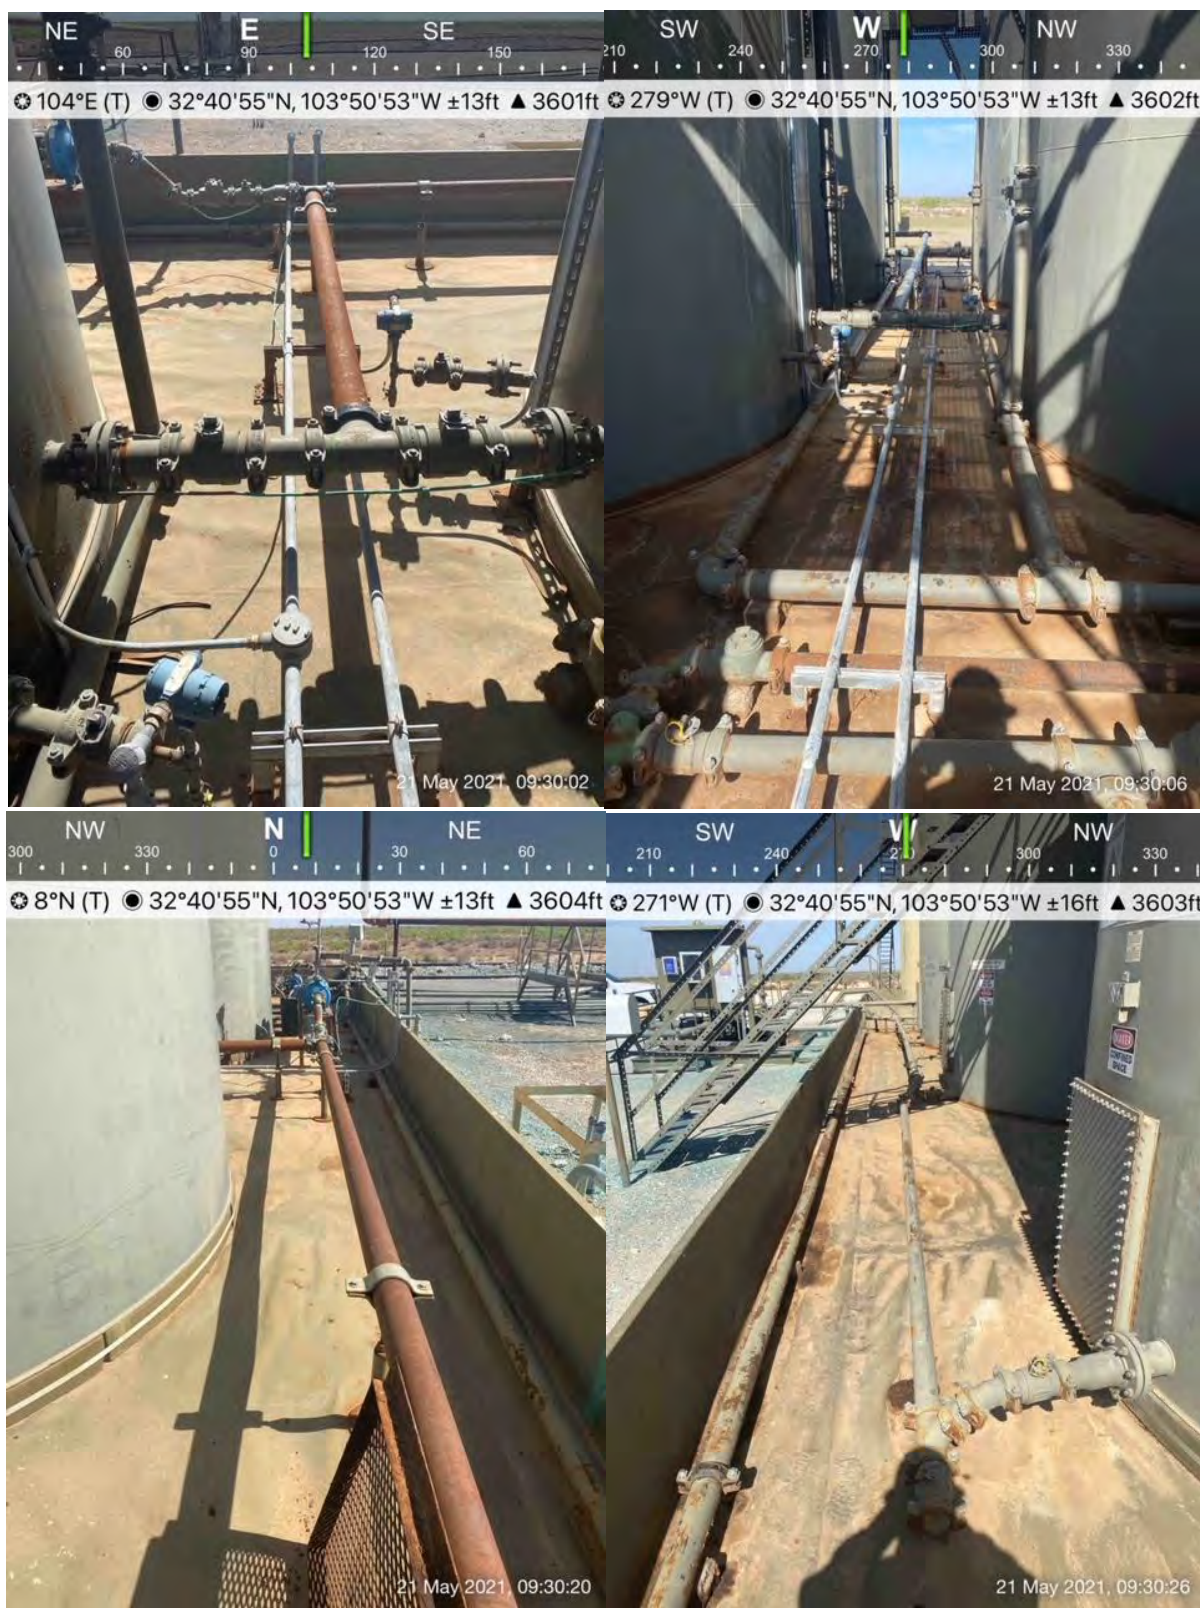
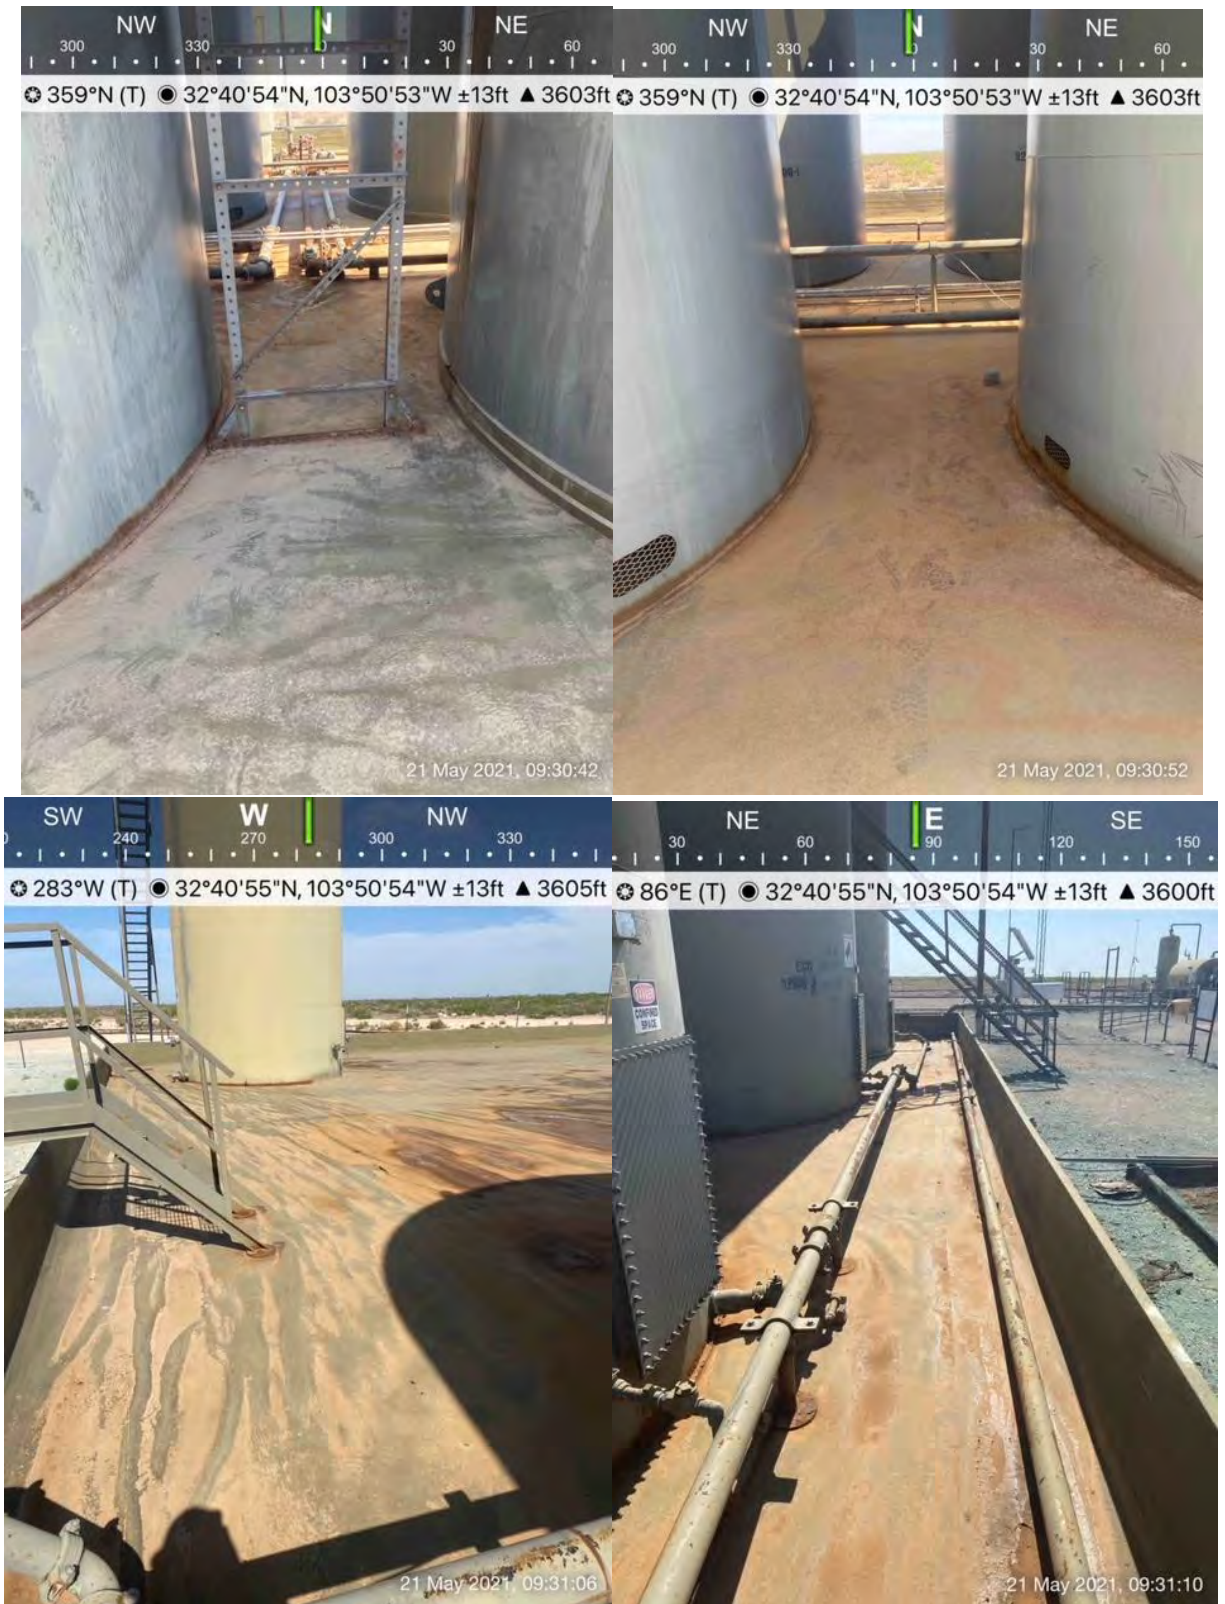
Photographic Documentation

Visualization	Yes	No	Comments
Is there a tear in the liner?		X	
Are there holes in the liner?		X	
Is the liner retaining any fluids?		X	
Does the liner have integrity to contain a leak?	X
