Release Notification

Site Name FRPC 4 1	Site Type Gas Well
Date Release Discovered 9/25/2019 @ 3:15pm	API# (if applicable) 30-045-31995

**Subject: Remediation and Deferral Report – Subsequent Liner Installation Letter
FRPC 4-1
Hilcorp Energy Company
San Juan County, New Mexico
NMOCD Incident Number: NCS1929541151**

PHOTOGRAPHIC LOG		
HILCORP ENERGY COMPANY	FRPC 4-1 SAN JUAN COUNTY, NEW MEXICO	TE017819013

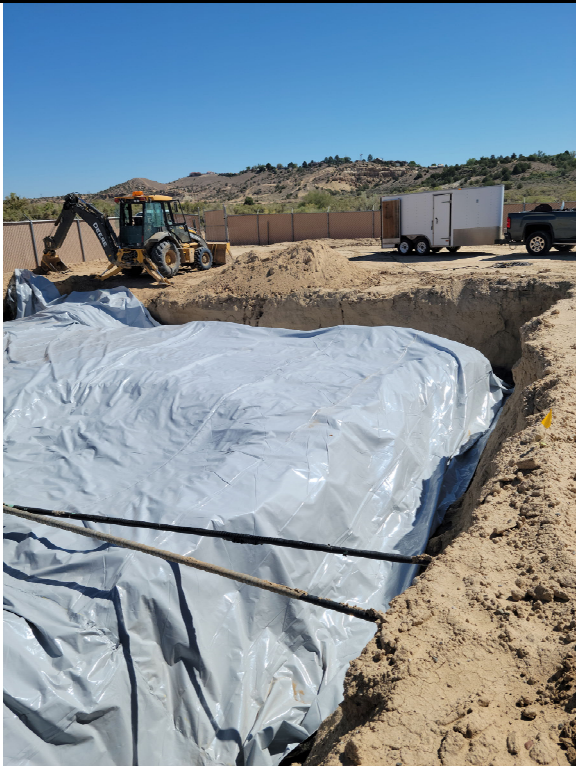
Photo No.	Date	
5	8/24/2021	
View of eastern edge of the 20-mil liner.

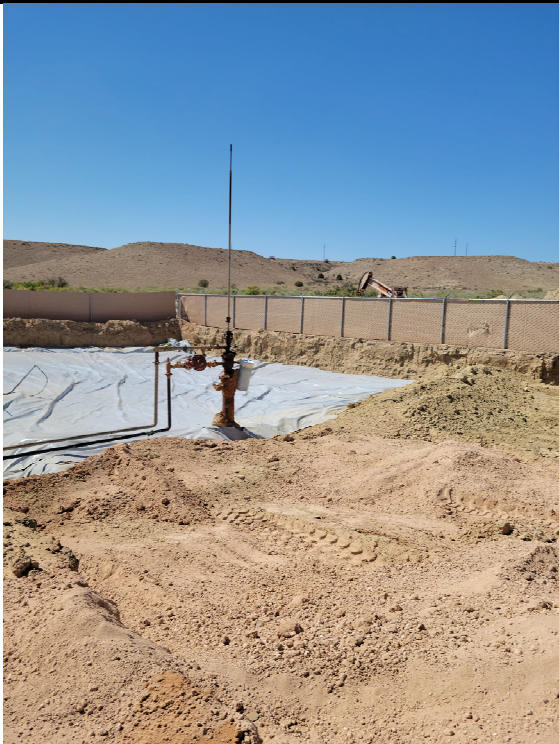
Photo No.	Date	
6	8/24/2021	
View of the south edge of the 20-mil liner.
